## Environmental Assessment Office Inspection Record

<b>Project Name:</b>	Wolverine Coal Project	<b>Inspection Status:</b>	Final
<b>Certificate #:</b>	M04-01	<b>Inspection No:</b>	FY17/18-11
<b>Certificate Status:</b>	Certified	<b>Inspection Date:</b>	2017-06-20
<b>Region:</b>	Peace	<b>Office:</b>	Victoria
<b>Trigger:</b>	Planned	<b>Inspector Name(s):</b>	Justin Carlson (EAO) Mike Olsen (MEM) Victor Marques (MEM) Laurie Meade (MEM)
<b>Location Description:</b>	Approximately 25km west of Tumbler Ridge.	<b>Sector:</b>	Mines
<b>Latitude:</b>	+055.05995°	<b>Longitude:</b>	-121.25178°
<b>Incidents of Non-Compliance Observed</b>	Yes		
<b>Non-Compliance Decision Matrix Level:</b>	Choose an item.	<b>Non-Compliance Decision Matrix Category:</b>	Choose an item.
<b>Inspection Summary:</b>	<p>This record details the results of an inspection against conditions attached to Environmental Assessment Certificate (EAC) # M04-01, that occurred on June 20, 2017. The inspection was conducted by Justin Carlson, Compliance and Enforcement Officer, BC Environmental Assessment Office (C&amp;E Carlson) and the following representatives from the Ministry of Energy and Mines: Mike Olsen, Inspector of Mines -

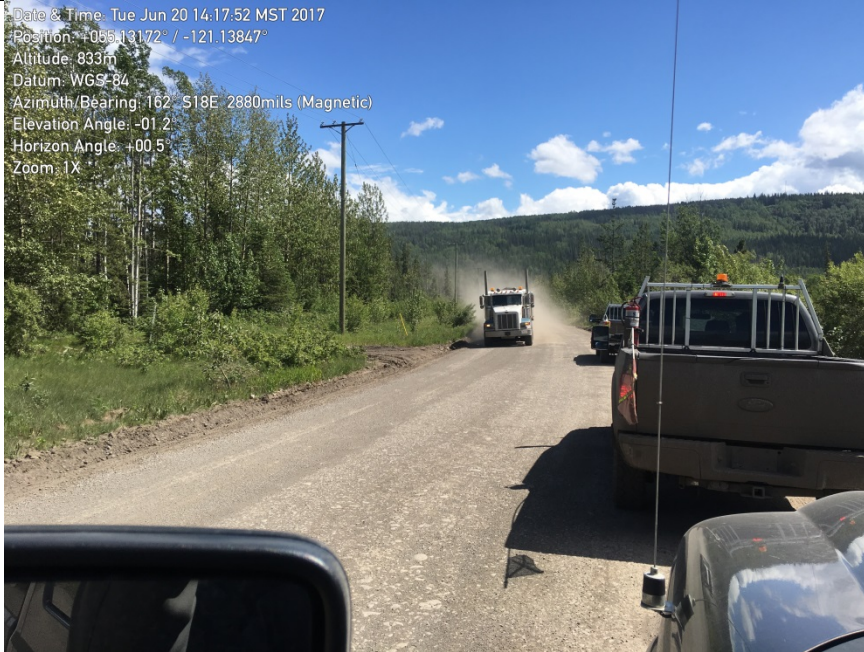
<b>Types of Compliance:</b>	Operations
<b>Requirement Description:</b>	<p>Condition #1</p> <p>The Project must be designed, located, constructed and operated in accordance with the Conditions of this Certificate and the documents and correspondence listed in Schedule A (the Holder's commitments in Schedule A are summarized for ease of reference in Schedule B), and must comply with all of the Conditions of this Certificate to the reasonable satisfaction of the Minister.</p>
<b>Findings:</b>	<p>C&amp;E Carlson observed trucks from the Wolverine Mine site with fully covered loads travelling from the Wolverine Mine northeast on the Wolverine FSR to Highway 29. Trucks were going north on Highway 29 through Chetwynd and then proceeding west on Highway 97 to the Willow Creek FSR. Trucks from Wolverine Mine and Brule Mine were depositing their loads at the Willow Creek Mine loadout for transportation by rail.</p> <p>See the attached images:</p>

Truck travelling northeast on Wolverine FSR towards Highway 29.

<b>Actions Required by Proponent(s) &amp; Additional Comments:</b>	
CONUMA COAL RESOURCES LIMITED HAS BEEN ISSUED AN <b>ORDER</b> UNDER SECTION 34 OF THE ENVIRONMENTAL ASSESSMENT ACT ON JUNE 30, 2017. THIS ORDER WAS ISSUED TO ADDRESS THE NON-COMPLIANCES OBSERVED WITH THE REQUIREMENTS OF CONDITION #1 OF ENVIRONMENTAL ASSESSMENT CERTIFICATE M#04-01. FAILURE TO COMPLY WITH THIS ORDER MAY RESULT IN ADDITIONAL ENFORCEMENT UNDER THE ENVIRONMENTAL ASSESSMENT ACT.	
<b>Inspection Conducted by:</b> Justin Carlson	
<b>Signature:</b> Justin Carlson, Environmental Assessment Compliance and Enforcement Officer	<b>Date Signed:</b> 2017-07-13
<b>Enclosure(s) to Proponent(s) &amp; Description:</b>	
<b>Regulatory Consideration:</b>

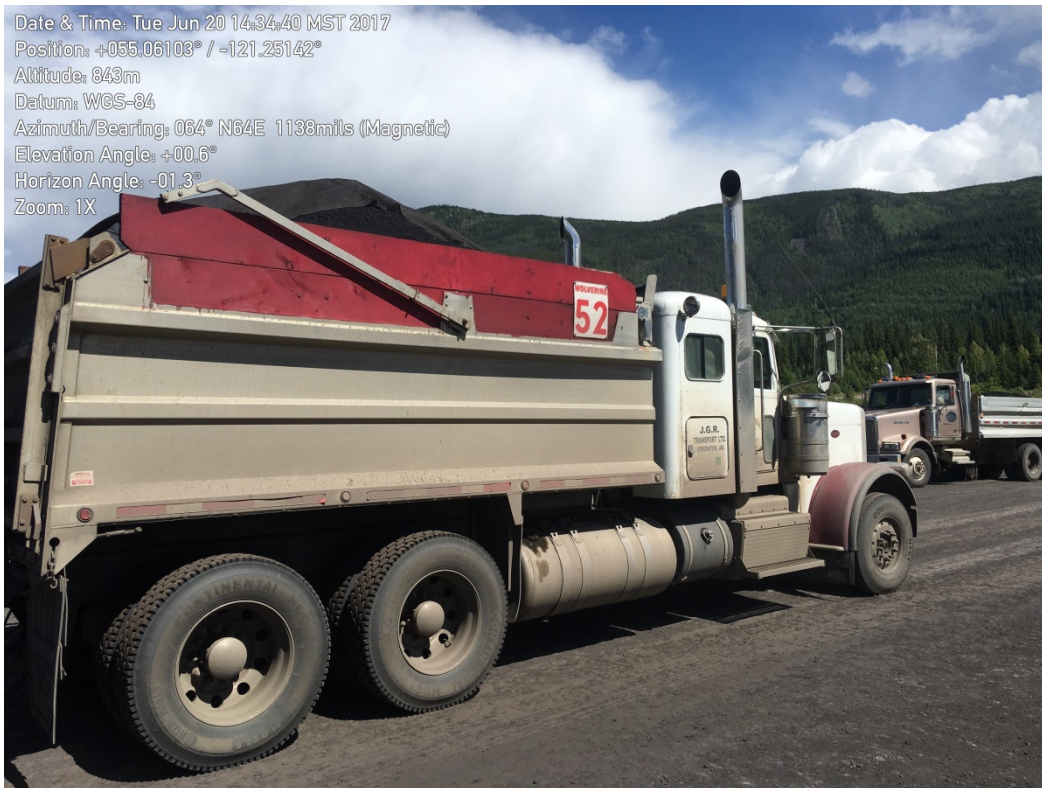
Wolverine truck on site with card identifying Truck number and mine location.

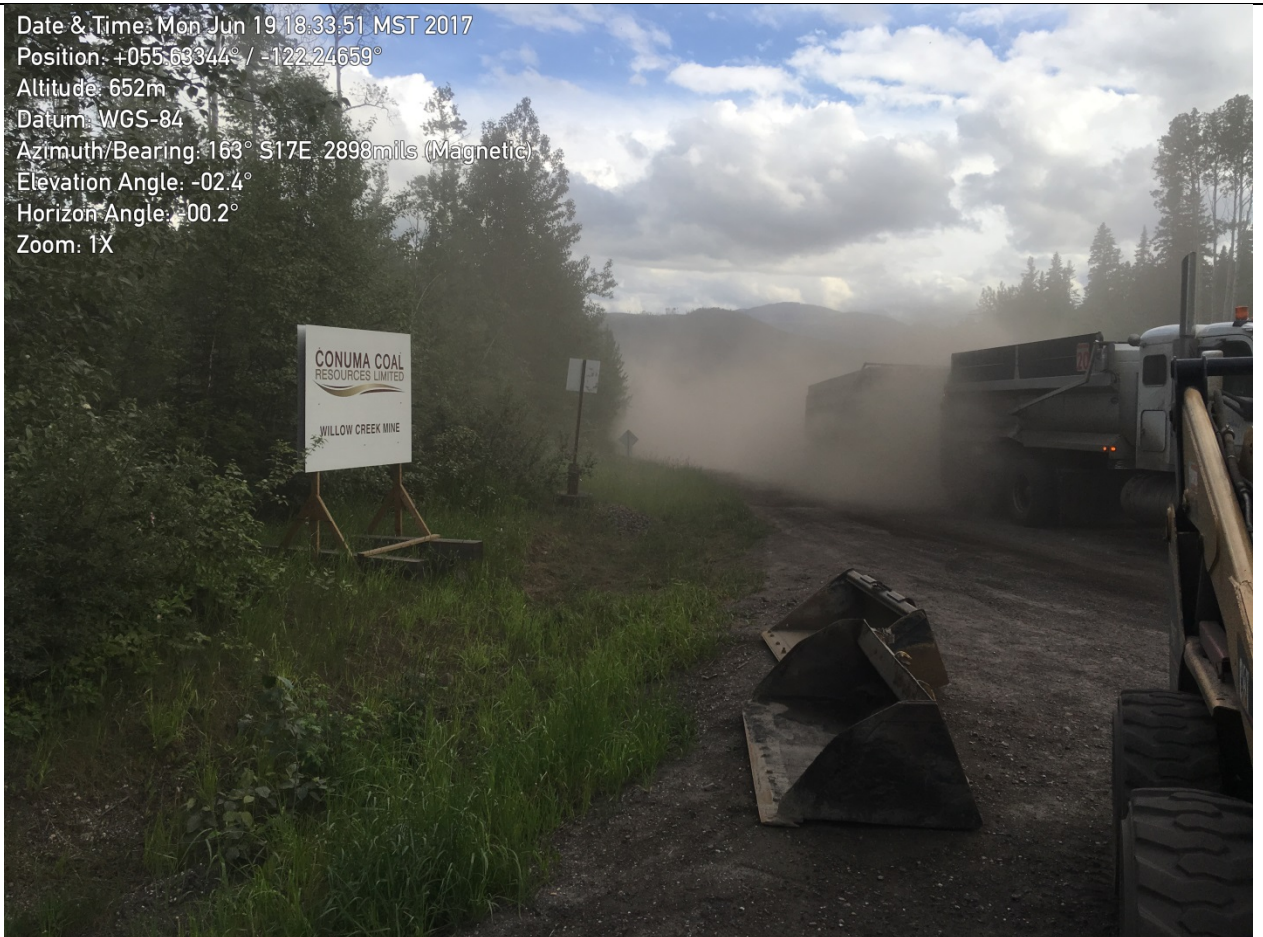
Wolverine Truck#20 seen leaving the Willow Creek Mine FSR on June 19, 2017.

The documents attached to schedule A of EAC#M04-01 state that coal would leave the Wolverine Mine site via the loadout facility and rail site located adjacent to the Wolverine Mine. Product coal is to be loaded on trains and then transported via train to Ridley Island for shipping to export markets.

<p>loadout on Wolverine reactivates this September.</p> <p>The Project was not operating in compliance with the requirements of this condition on the date of inspection. On June 30, 2017, an Order to Cease was issued to address this non-compliance.</p> <p>The Order can be found on the EAO public website <a href="#">here</a>.</p>
<b>Compliance:</b>	Out

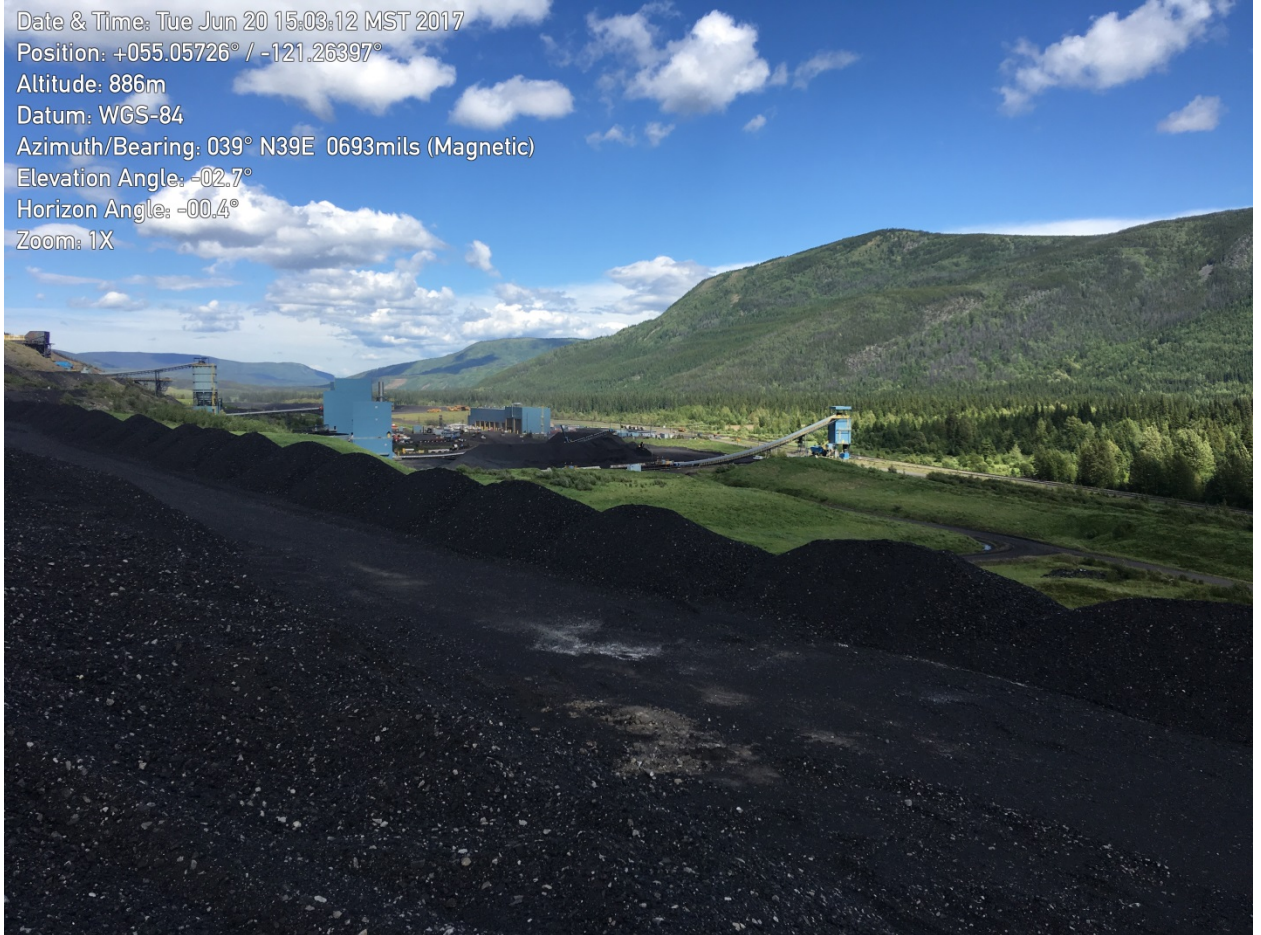
Overview of the coal processing and loadout facility on Wolverine.

C&E Carlson spoke with CALDWELL during this inspection regarding the transportation of coal from Wolverine to Willow Creek and CALDWELL stated that this activity has been ongoing since January 2017 as the railway tracks adjacent to Wolverine are currently in disrepair. CALDWELL stated that track repairs are underway and she is unaware of when those repairs will be completed.
