INSPECTION RECORD

Project Name:	Site C Clean Energy Project	Inspection Report Status:	FINAL
Certificate #:	E14-02	Inspection No:	FY17/18-15
Certificate Status:	Certified	Inspection Date:	2017-06-19 to 2017-06-23
Region:	Peace	Office:	Victoria
Trigger:	Planned	EAO Inspector(s):	Chris Parks, Senior Compliance and Enforcement Officer (C&E Parks)
Sector:	Energy	Location:	56°11'37.72"N, 120°54'26.66"W
Location Description:	The Site C Project is an up-to 1100 megawatt hydroelectric facility located approximately 7 km southwest of Fort St. John BC. The Project includes an approximately 77km transmission line consisting of two 500kV lines connecting the Project to the existing Peace Canyon Substation. The coordinates provided are for the Site C dam location.		
Incidents of Non-Compliance Observed	Yes		
Inspection Summary:	<p>C&E Parks inspected the Site C Clean Energy Project (Project) between June 19 and 23, 2017. The inspection focussed on the Dam Site Area, Highway 29 realignment works in the Cache Creek and Halfway River areas, the Portage Mountain Quarry access road, and the Trapper Main transmission line access road.</p> <p>C&E Parks completed a verbal debrief of inspection observat

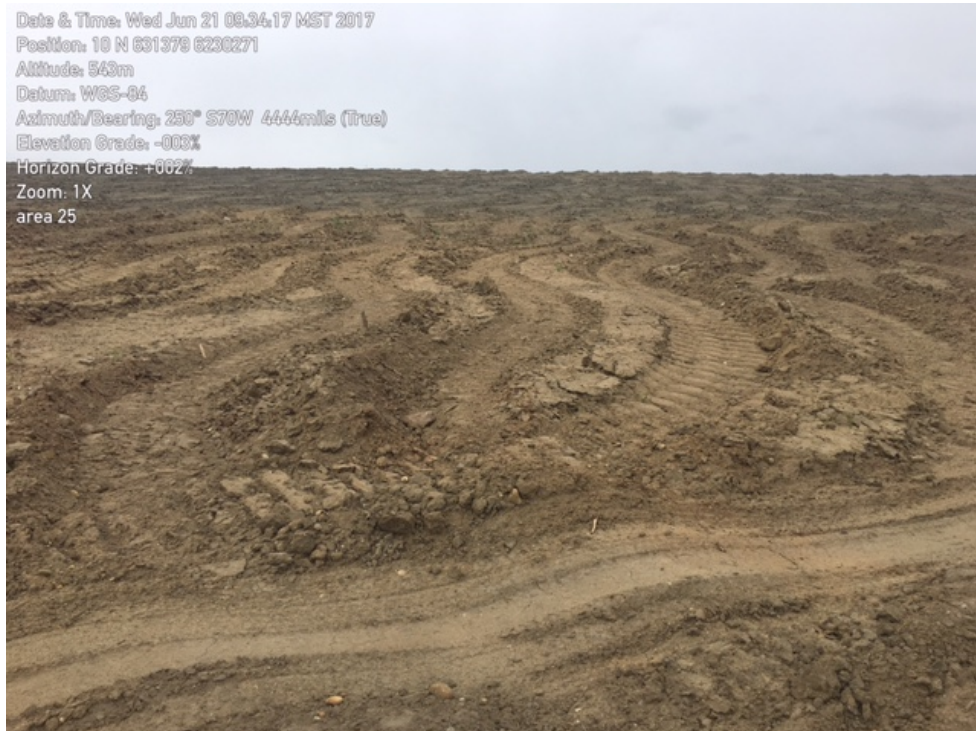
Photo 1: Example of surface roughening implemented in Area 25 and the upper L3 watershed.

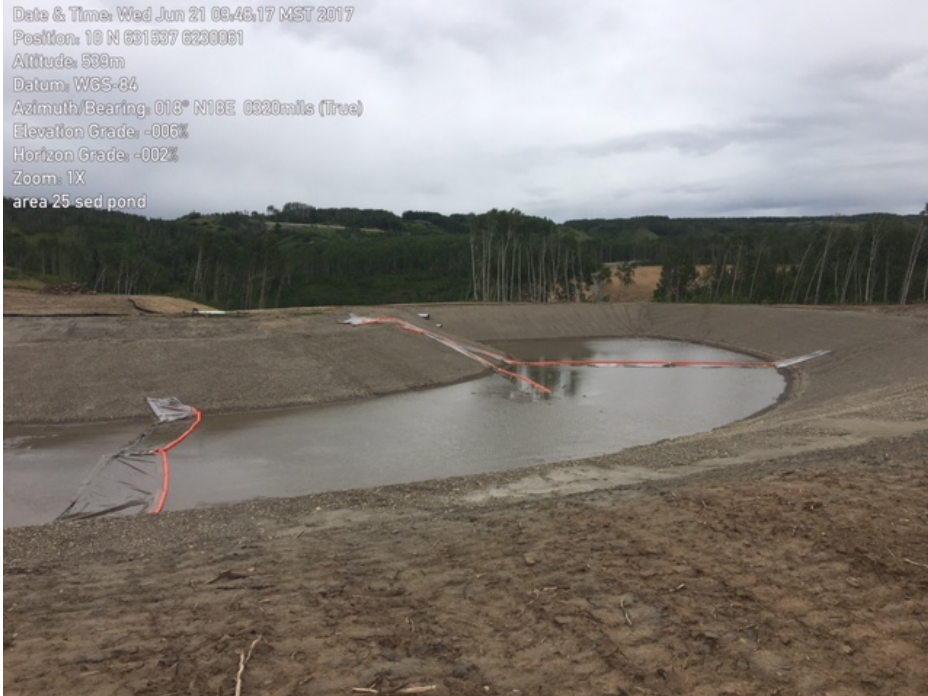
Photo 2: Area 25 sediment pond. Note sediment curtains.

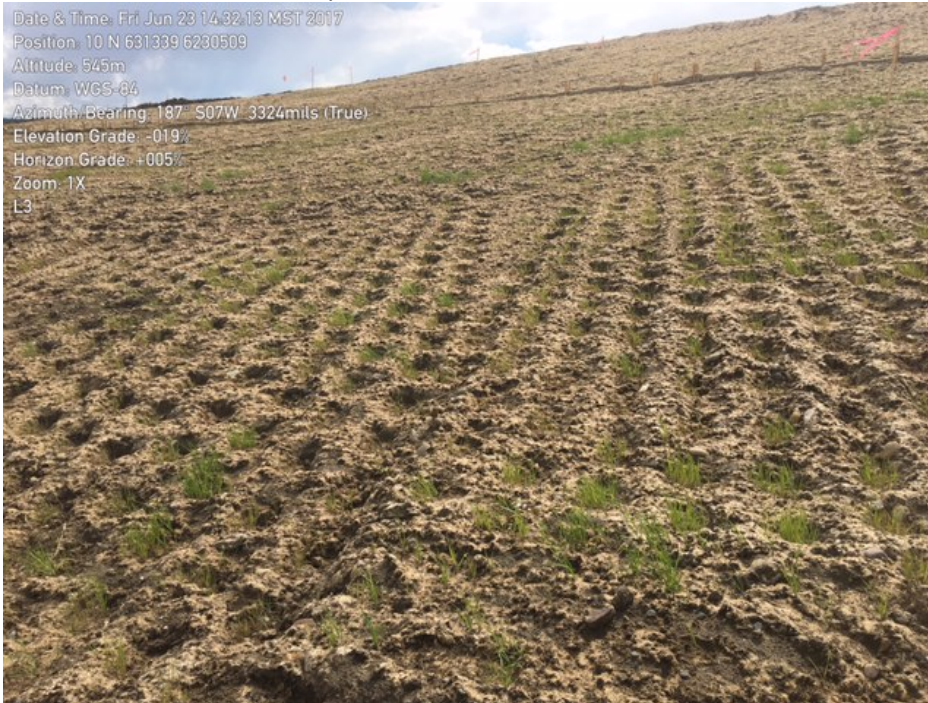
Photo 3: Hydroseeding and surface treatment implemented to reduce erosion and sediment transport, top of bank, L3 ravine.

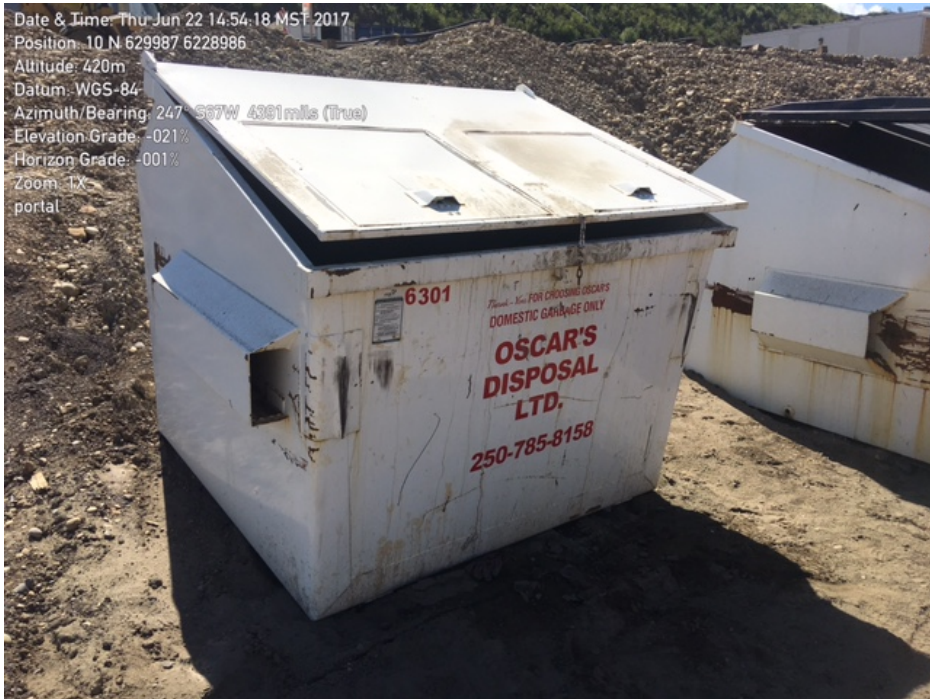
</div> <p>Photo 6: Waste receptacle with damaged lid preventing proper closure to prevent wildlife access.</p>

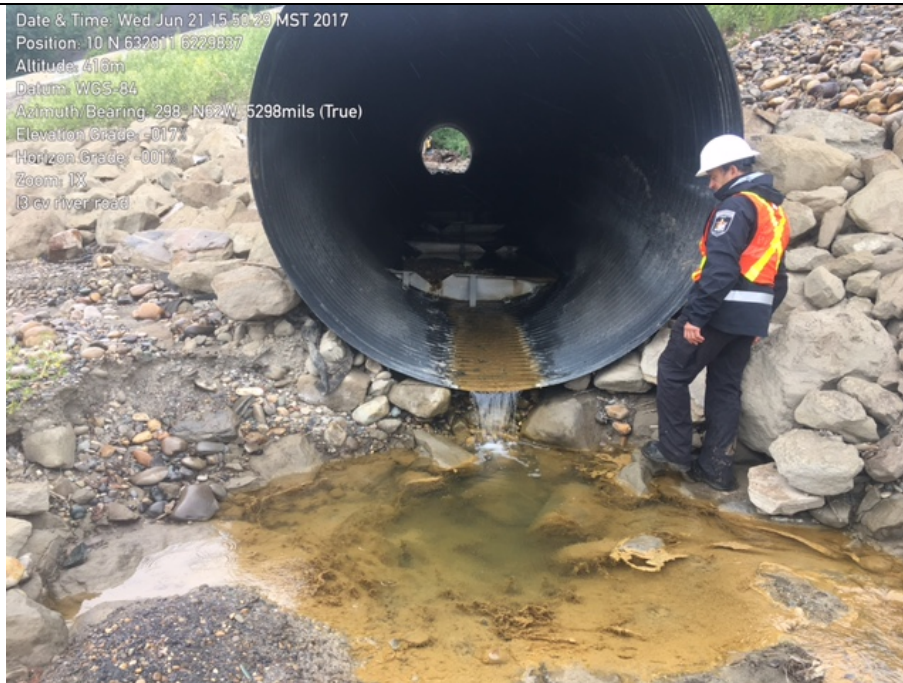
Construction
Requirement Description:	<p>Condition 69 CEMP, section 4.5, Fisheries and Aquatic Habitat Management.</p> <p>Section 4.5 requires that, unless otherwise authorized in a permit or approval, stream crossings be installed in accordance with design and construct watercourse crossings in accordance with referenced documents, including the Fish-stream Crossing Guidebook (Ministry of Forests, Lands and Natural Resource Operations et al, 2012) (Appendix H).</p>
Findings:	<p>C&E Parks observed that the culvert installed under River Road at the L3 watercourse is a closed-bottom, unembedded culvert and that the crossing may pose a barrier to upstream fish passage. The L3 watercourse is classified as an S3 fish-bearing stream. Potential concerns are that the lower end of the culvert is perched by approximately 30 centimetres; that the pool below the culvert may not be of sufficient depth to allow fish to access the perched culvert; and that baffles within the culvert meant to facilitate fish passage have filled with coarse sediment. See photos 7 and 8.</p> <p>The Fish-stream Crossing Guidebook identifies a process to determine whether an open bottom (ie bridge or box culvert) or embedded closed bottom structure may be installed, based on habitat values, gradient, and stream channel width, under the guidance of a Qualified Professional. The guidebook does not identify the type of crossing that has been installed at this location.</p> <p>August 18, 2017 Update: BC Hydro confirmed that the L3 culvert at River Road was subject to permits and approvals under the provincial Water Act and an Authorization under the federal Fisheries Act. However, the Fisheries Act Authorization states that the culvert will be set “below the creek bed”. The culvert is installed above the grade of the creek bed, and therefore appears to be not compliant with the requirements of the authorization.</p> <p>Further, note that the perched culvert is not installed in accordance with the “Fish Stream Crossing Guidebook”, which is listed as a requirement of the Water Act permit issued for this location (Appendix S).</p>

Photo 7: Culver under River Road at the L3 watercourse. Looking upstream from downstream end. Note downstream end of culvert is perched and limited plunge pool depth.

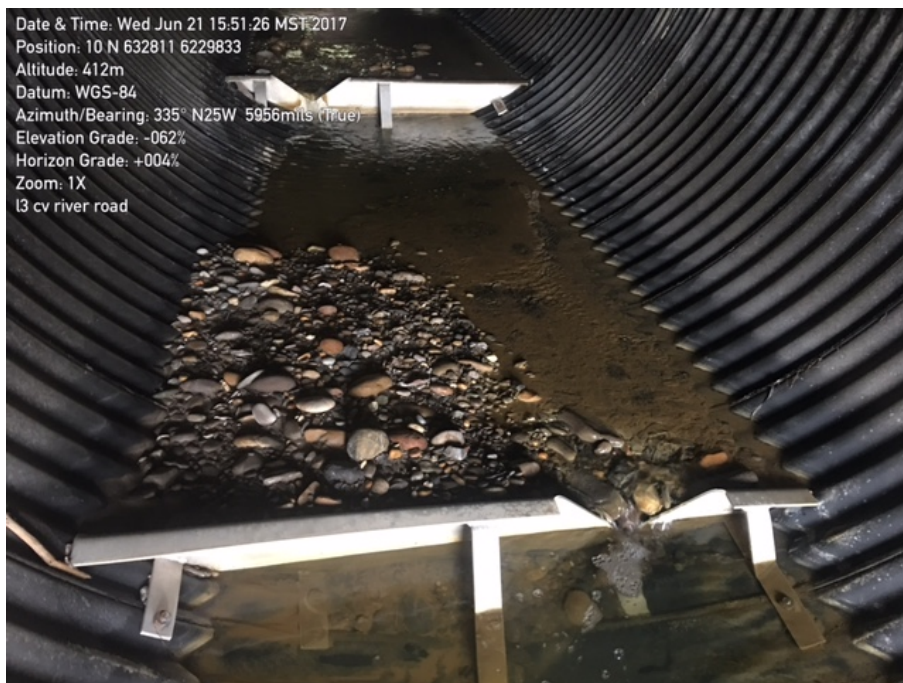
Photo 8: L3 culvert under River Road. Note culvert baffles filled with coarse sediment

creating a potential barrier to fish passage at low flows.
Compliance:	OUT - warning

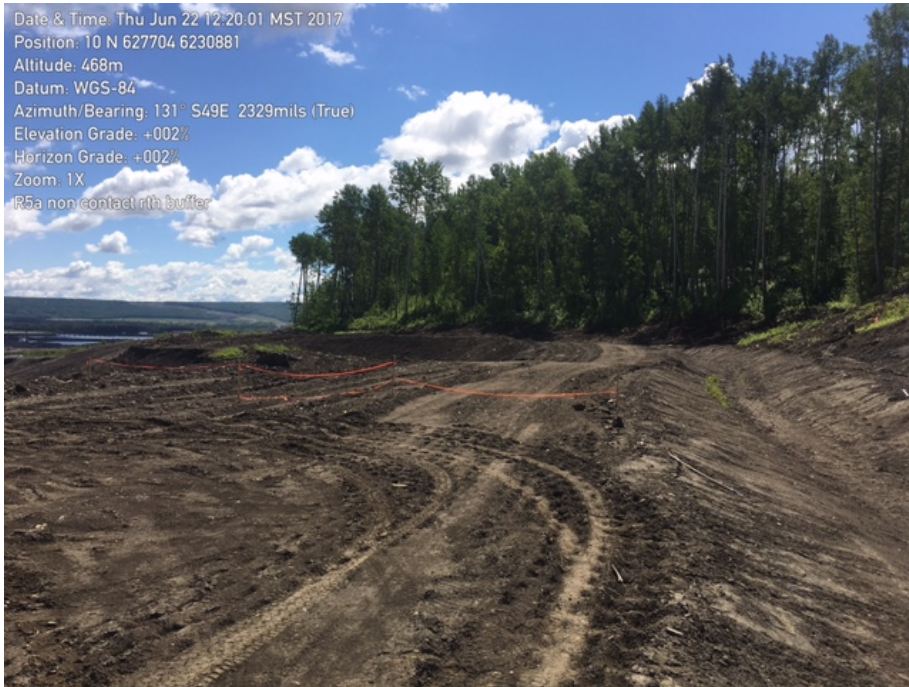
</div> <p>Photo 9: Flagging delineating red-tailed hawk buffer implemented on the RESEM R5a non-contact water ditch.</p>
