Project Name	Orca Sand and Gravel Project	Inspection Status	Final
EA Certificate #	M05-01	Inspection No.	IR2020-016
Project Status	Certified	Inspection Start	2020-04-01
Sector	Mines	UTM	9N 631270 5608405
Trigger	Planned Inspection	Inspection Type	Field and Administrative
Project Description	The Orca Sand and Gravel Project (Project) is an approximately 350 hectare sand and gravel quarry, including a conveyor transport system and a dedicated marine loading facility for bulk carrier shipping.		
Location Description	The Project is located on Johnstone Strait, approximately 4 kilometres west of Port McNeill, on Northern Vancouver Island.		
Inspection Summary	<p>On April 1, 2020, Environmental Assessment Office Compliance and Enforcement (EAO C&E) Officer Shayla Frechette conducted an administrative inspection against the requirements of EAC# M05-01 (Appendix 1).</p> <p>On April 30, 2020, EAO C&E conducted a field inspection of the ship loader.</p> <p>The Project was in Operations at the time of inspection.</p> <p>After review of observations and information obtained during the inspection, the following compliance determinations have been made:</p> <ol style="list-style-type: none"> 1.

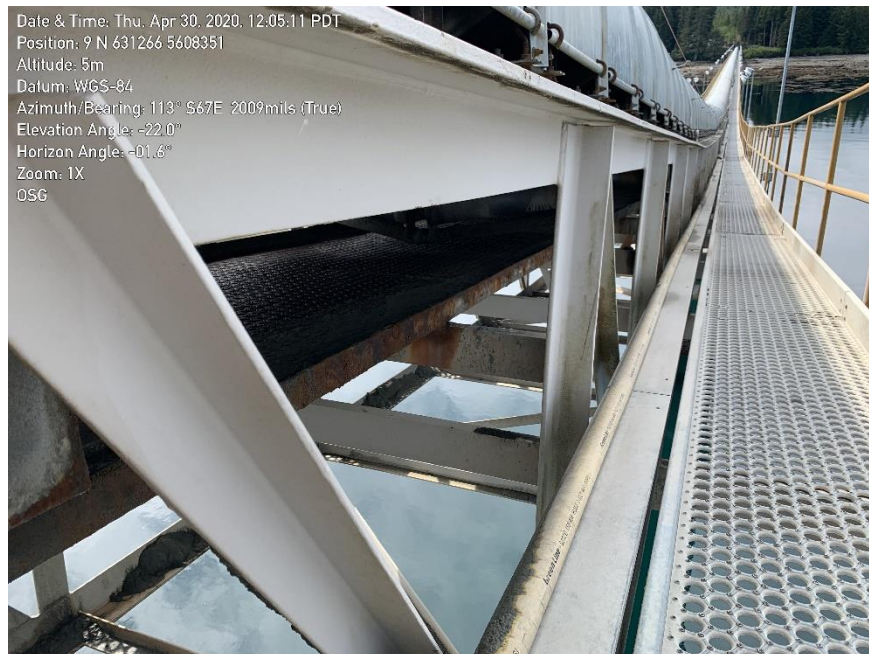
On April 30, 2020, EAO C&E conducted a field inspection of the conveyor spill tray and dust covers. EAO C&E observed the newly installed spill tray located under the conveyor belt from the shore to the boom arm (ship loader) which is approximately 537 meters long. The ship loader is a crane-like structure that slides along a semicircle rail which fills material into ship accordingly which is approximately 52 meters in length.

Photo 1: Newly constructed spill tray from shoreline to ship loader.

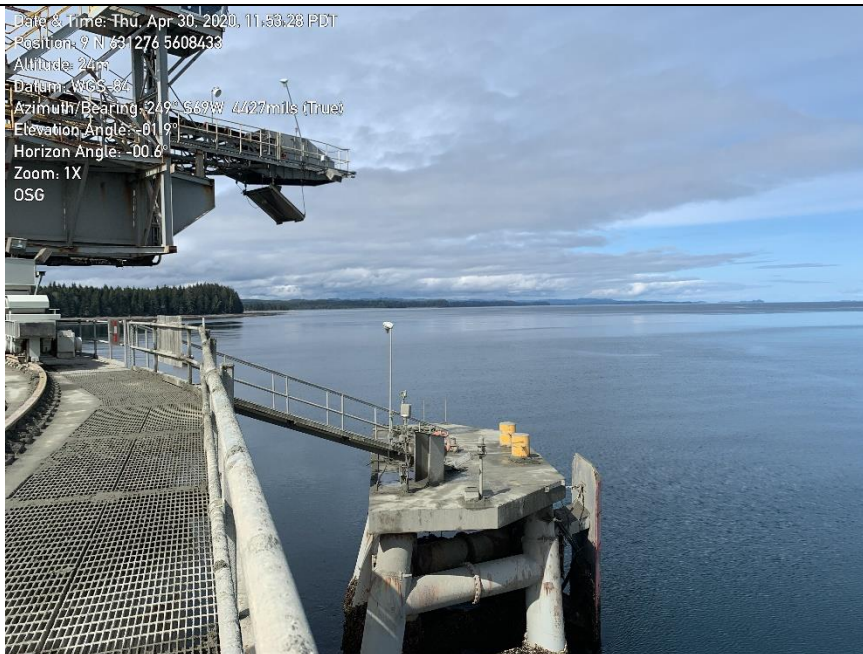
Photo 2: Ship loader with contracted extension.

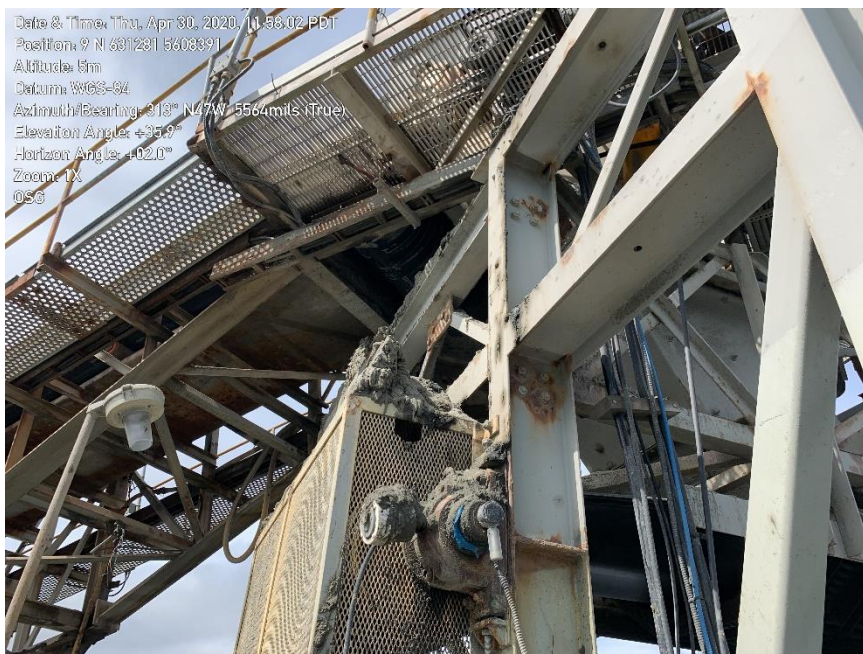
Photo 3: Start of ship loader where spill tray ends.

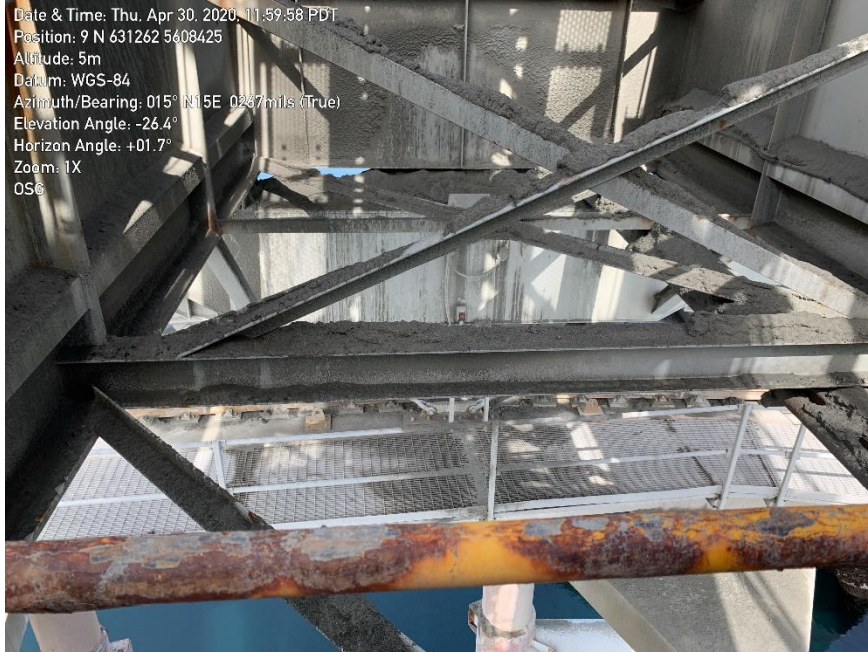
Photo 4: Piled material on cross beams under convayor belt on shiploader.

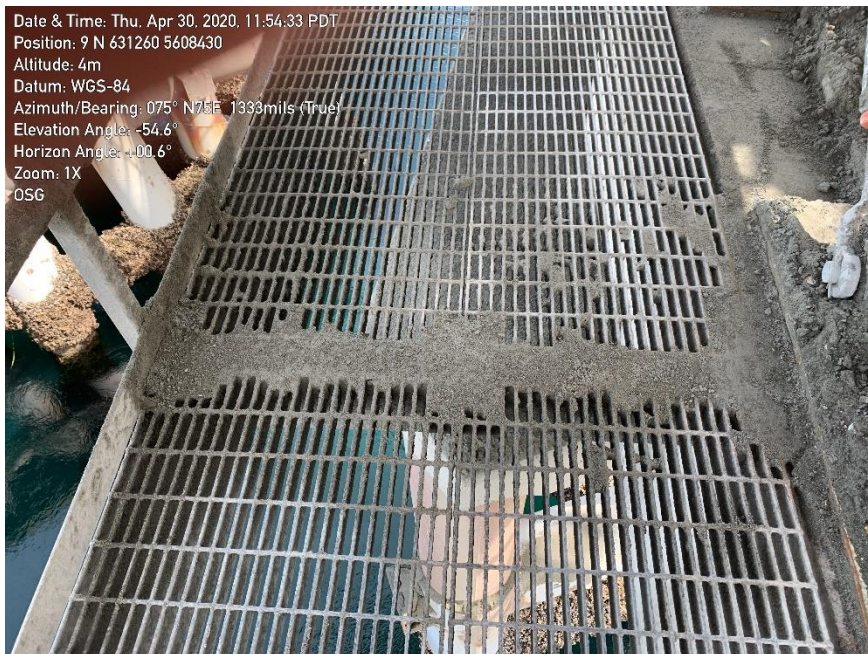
Photo 5: Grated Flooring under ship loader.
