Project Name	Coastal GasLink Pipeline Project	Inspection Status	Final
EA Certificate #	#E14-03	Inspection No.	IR2020-055
Project Status	Certified	Inspection Start	2020-10-19
Sector	Energy	UTM	10U 533697 E 6071620 N
Trigger	Planned Inspection	Inspection Type	Field
Project Description	The Coastal GasLink Pipeline Project (Project) is an approximately 650 kilometer (km) long natural gas pipeline connecting facilities in northeast British Columbia (BC) to the LNG Canada facility near Kitimat.		
Location Description	The Project is near Groundbirch (40 km west of Dawson Creek) in northeast BC to the LNG Canada facility near Kitimat. This inspection focused on work being carried out in Sections 1 through 5 of the Project.		
Inspection Summary	<p>From October 19 to 23, 2020 Environmental Assessment Office (EAO) Director of Compliance and Enforcement Chris Parks and Compliance and Enforcement Officer Clayton Smith (collectively EAO C&E) inspected the Coastal GasLink Pipeline Project (Project) against requirements of the Environmental Assessment Certificate (EAC) #E14-03 (Appendix 1). On November 2, 2020 EAO C&E conducted a follow up inspection in Section 4 of the Project near KP 244, north

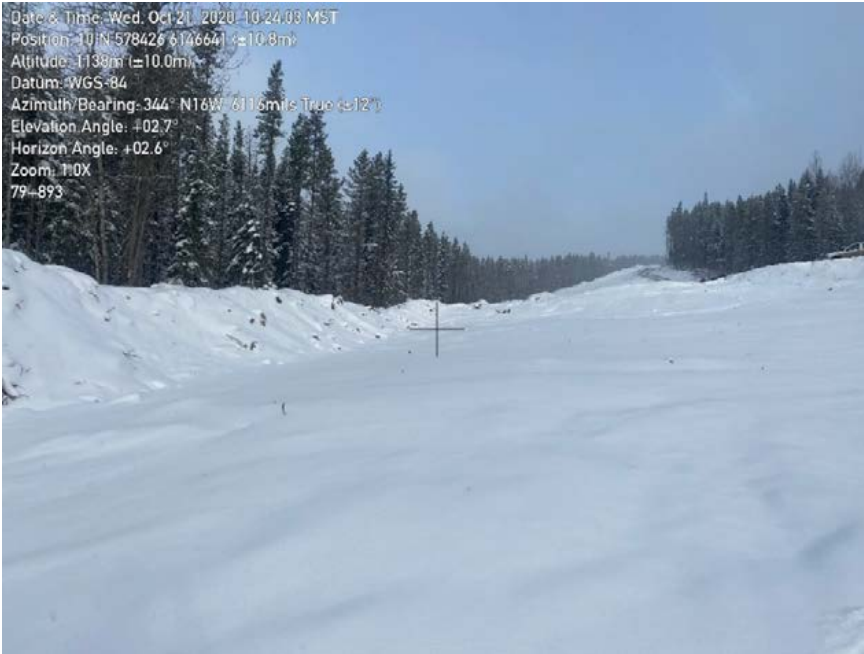
Photo 1: Example of stripped right of way near KP79. EAO C&E understands that this area of the Project will not have subsequent phases of construction until Spring 2021.

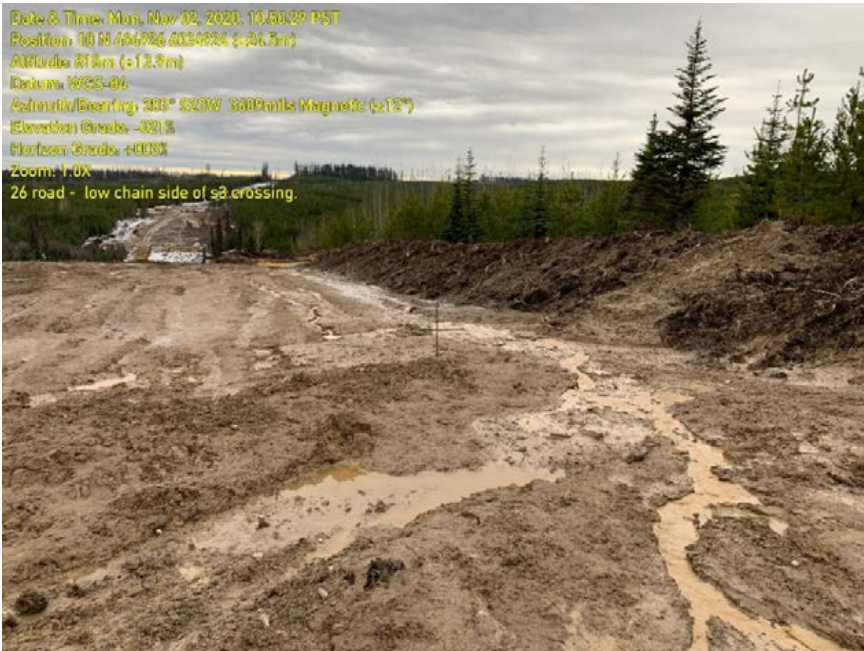
Photo 2: Exposed right of way near KP244. Lack of winterization following stripping has caused erosion on the right of way leading to impacts to a fish-bearing stream.

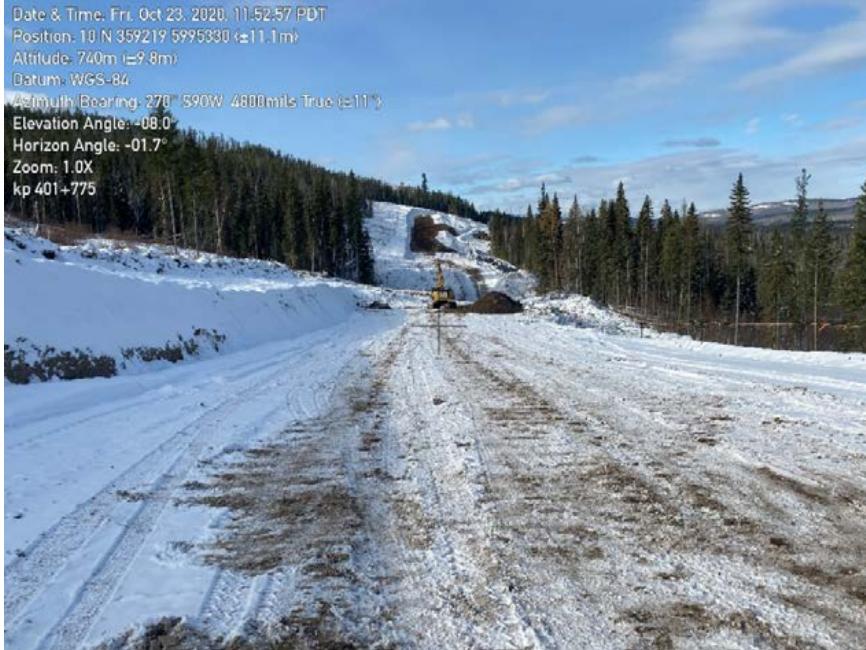
Photo 3: Exposed right of way near KP402. Lack of winterization on right of way through this portion of the Project.

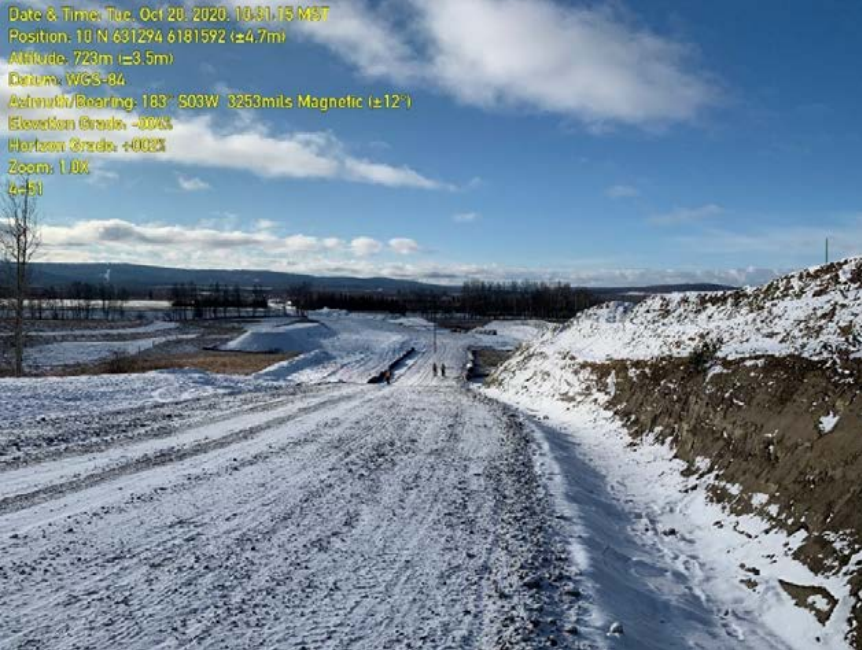
Photo 4: Ditch leading to wetland ID 0065, no ESC controls.

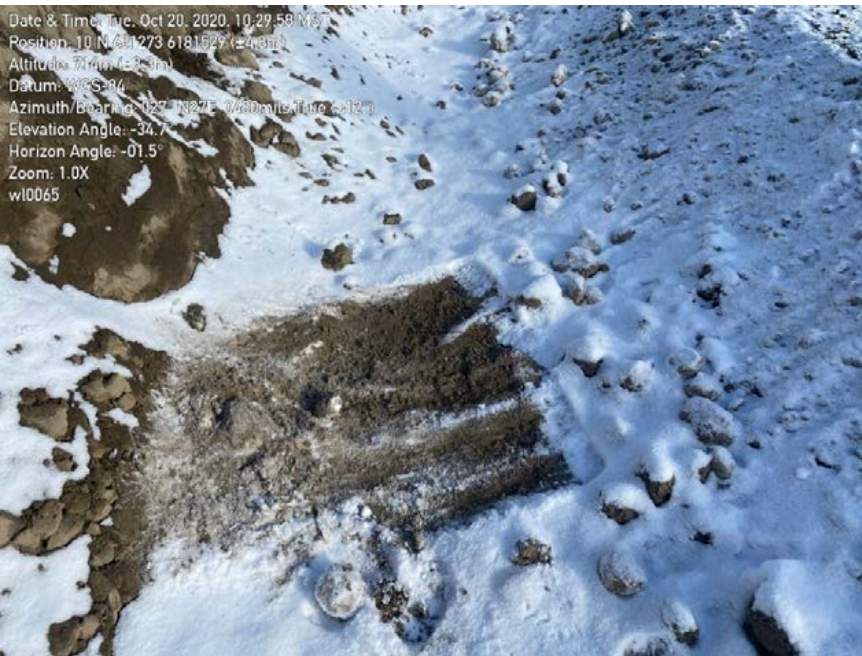
Photo 5: Fine soils in ditch line from photo above.

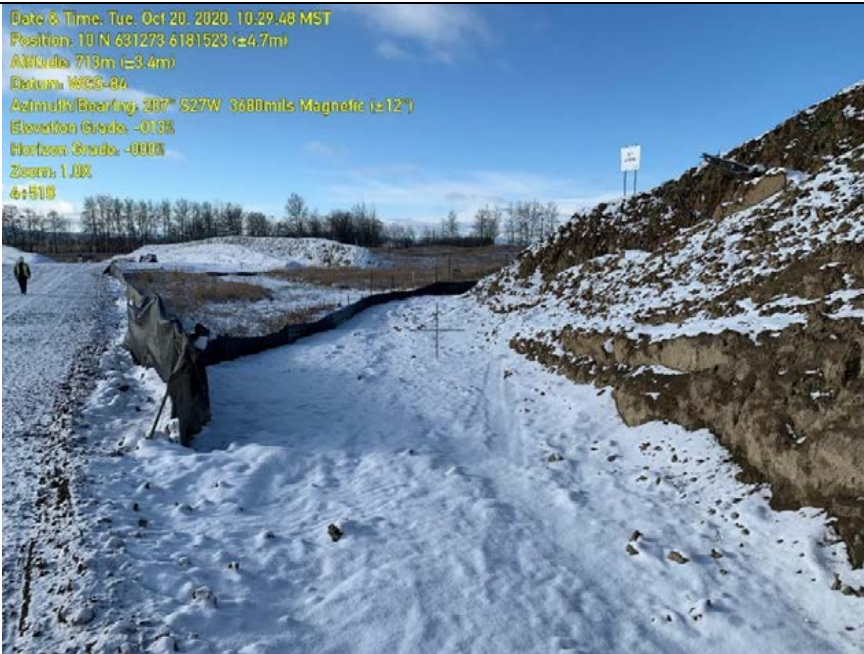
Photo 6: KP 4+518, bottom of ditch, sediment deposition adjacent to wetland ID 0065.

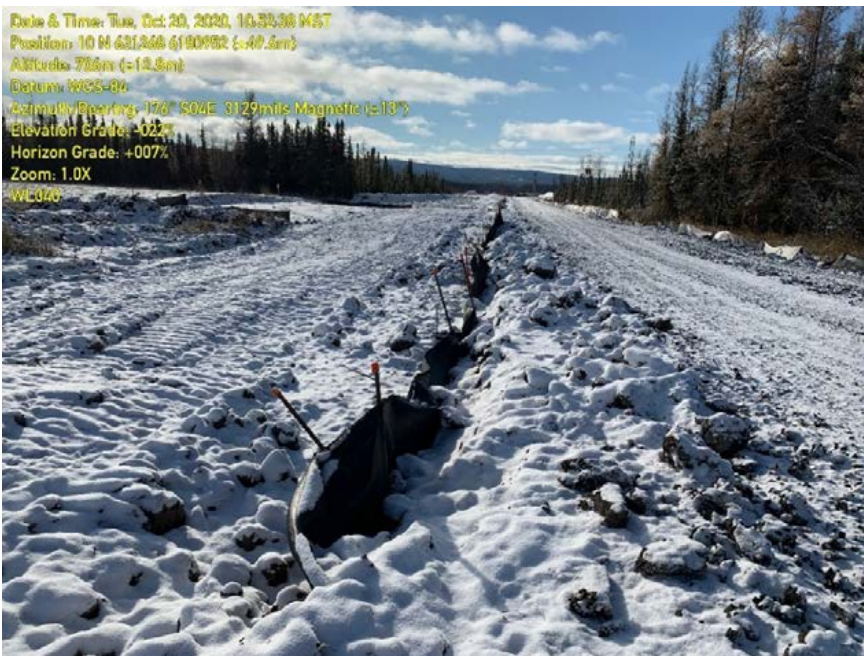
- KP_5+034_CPESC_Site-Specific ESC Plan_Rev1. Commitments in the site-specific plan to install straw wattles, repair failing sediment fencing and remove accumulated material from the fence do not appear to have been followed through. See photo 7 below;

Photo 7: Wetland ID 040, failing sediment fence.

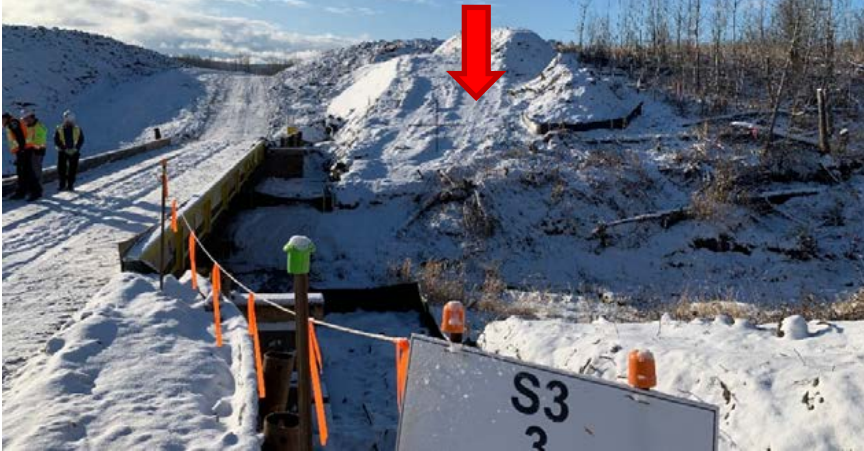
Photo 8: KP 5+607 with disturbed and exposed slopes leading to fish-bearing stream (S3).

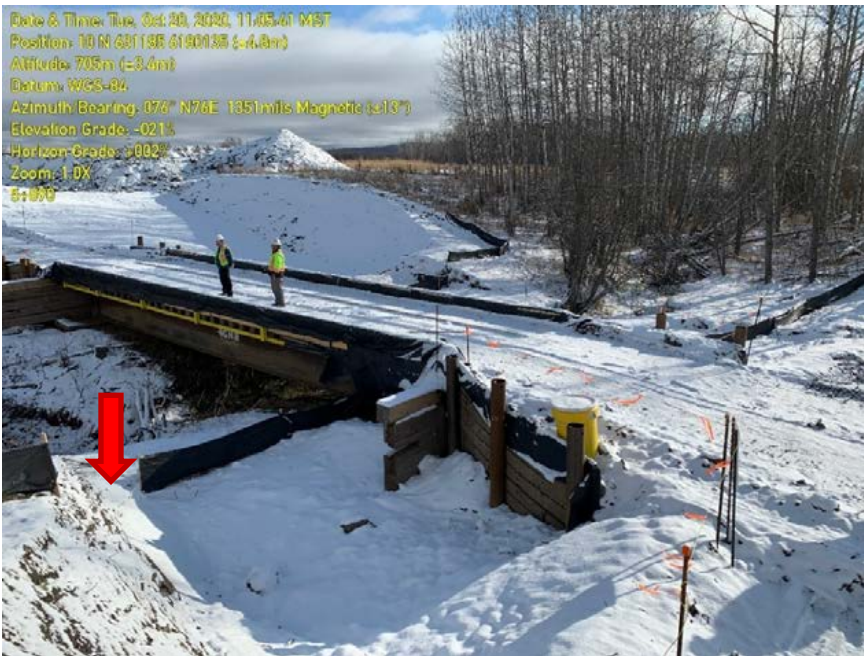
Photo 9: KP 5+890. ESC not installed to site-specific plan. Risk of sediment mobilizing to watercourse.

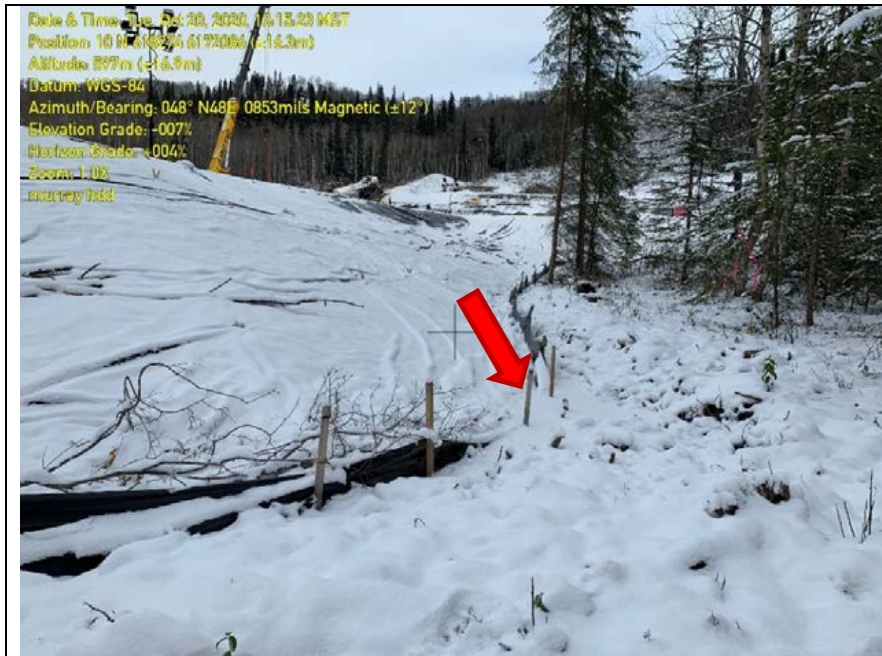
Photo 12: Red arrow indicating failed sediment fence at base of drainage ditch on left side of Murray HDD pad.

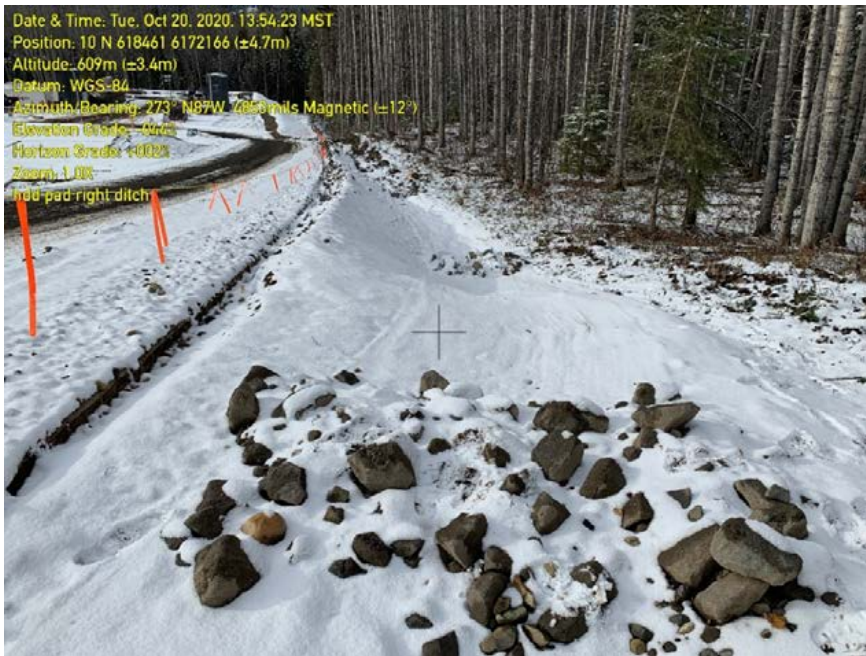
Photo 13: Drainage ditch on right side of Murray HDD pad. Check dams discontinuous and not installed to specification. Note coarse material.

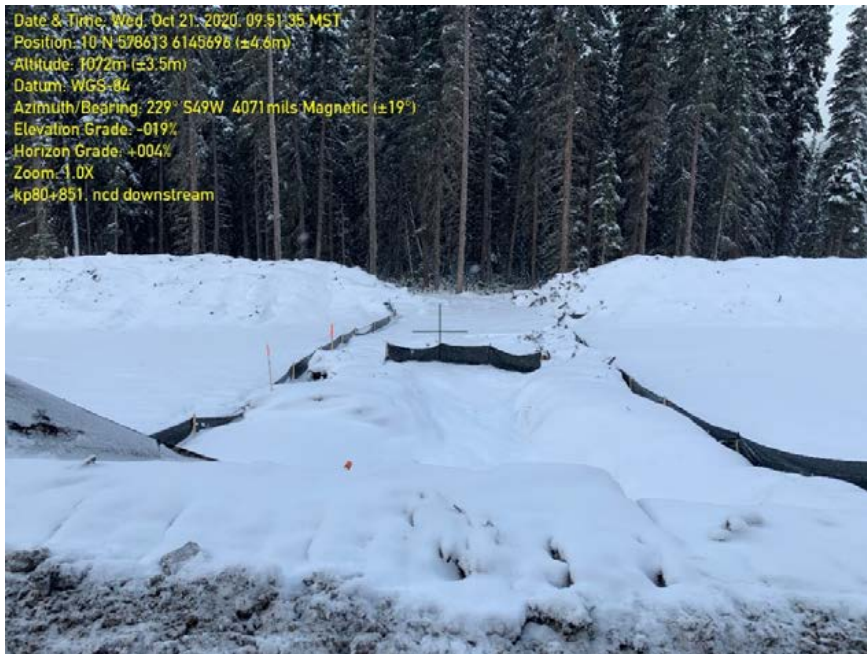
- Sediment fencing installed across riparian features or drainage channel (Photos 14 & 15);
- Failing and/or not maintained sediment fencing (Photos 16 and 17);
- Sediment fence installed in a way that allows water to escape around the edge, in some cases potentially causing erosion and sediment transport (Photo 18);
- Sediment fencing installed in locations not supported by the BMPs (Photos 19 and 20); and,
- Discontinuous sediment fence which allowed for potential sediment mobilization towards watercourses (Photo 21).

Photo 14: Sediment fence installed across an NCD feature at KP80+851.

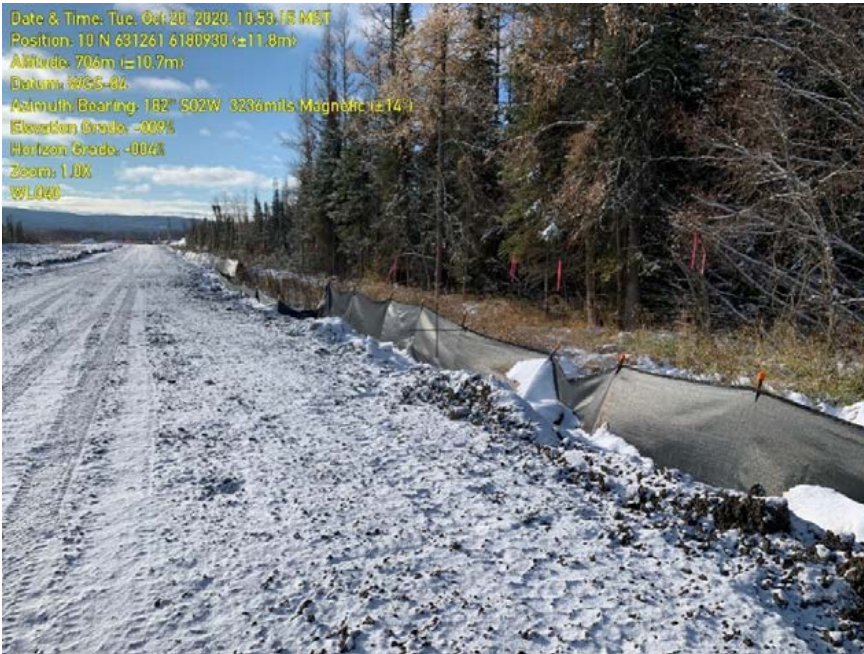
Photo 16: Wetland ID 040, failing sediment fence.

- Repair undercut fences and repair or replace split, torn, slumping or weathered fabric immediately.

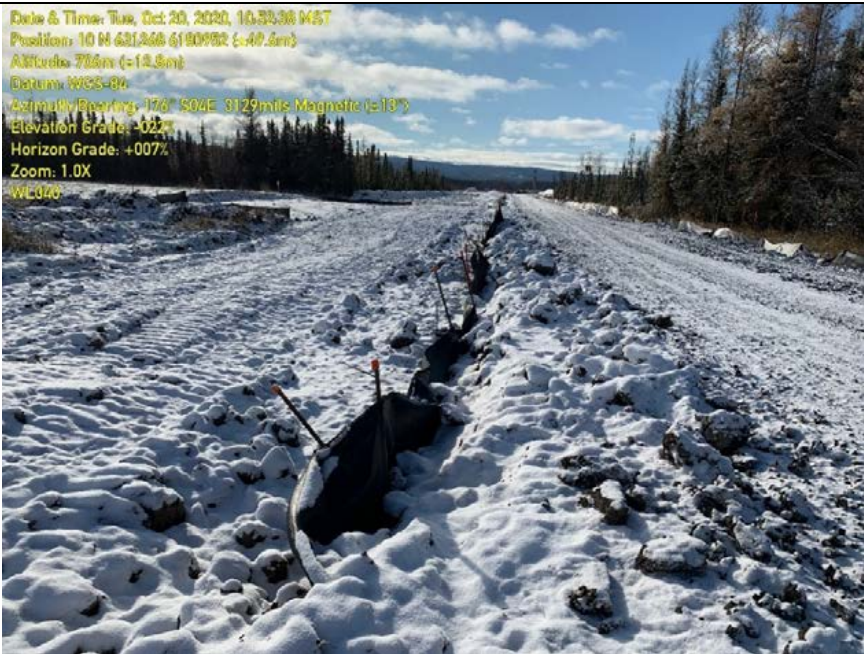
Photo 17: Wetland ID 040, failing sediment fence.

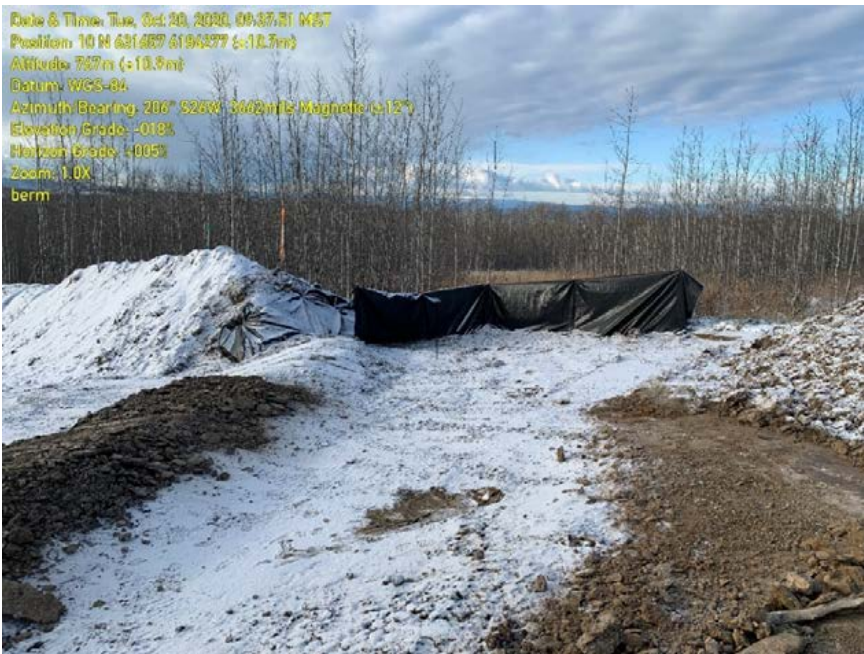
Photo 18: Sediment fence at end of berm, near KP 1+800. Potential for water to pool and escape around the edges of the sediment fence and cause erosion.

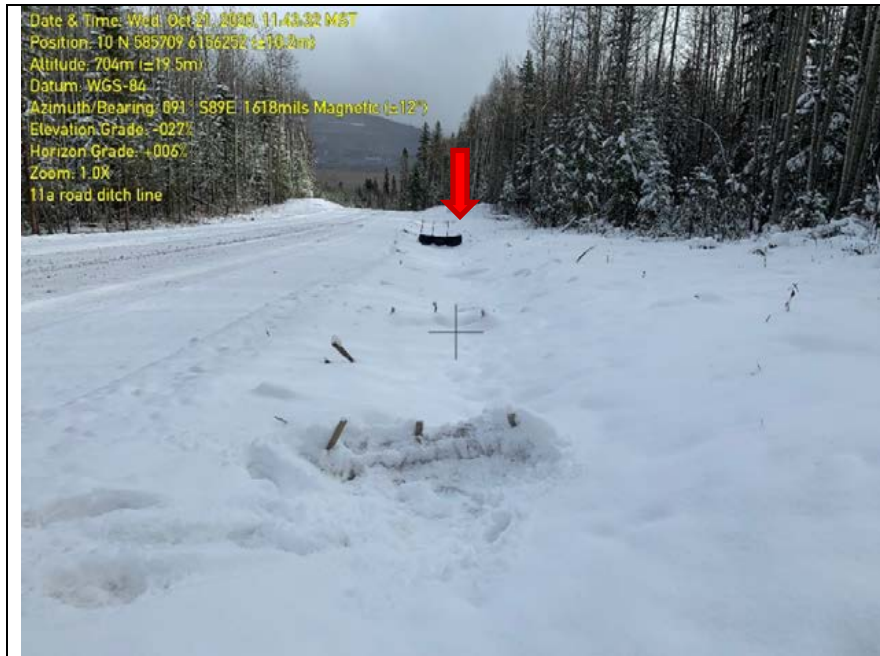
Photo 19: 11a road ditch line, example of sediment fencing installed in ditch line. Not a recommended use for sediment fencing; will increase erosion in ditch.

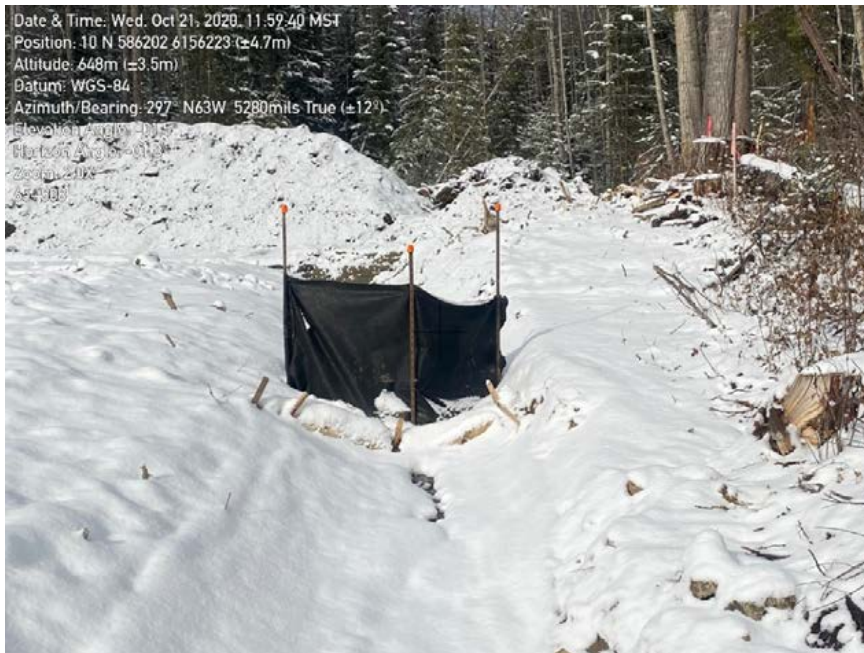
Photo 20: Example of sediment fence installed across a ditch.

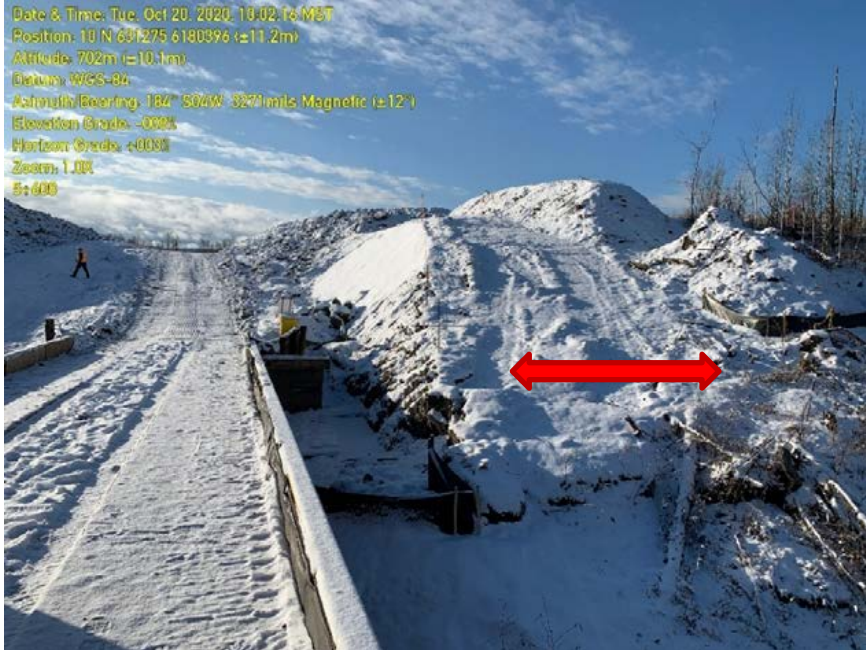
Photo 21: Discontinuous sediment fencing adjacent to fish-bearing stream feature.

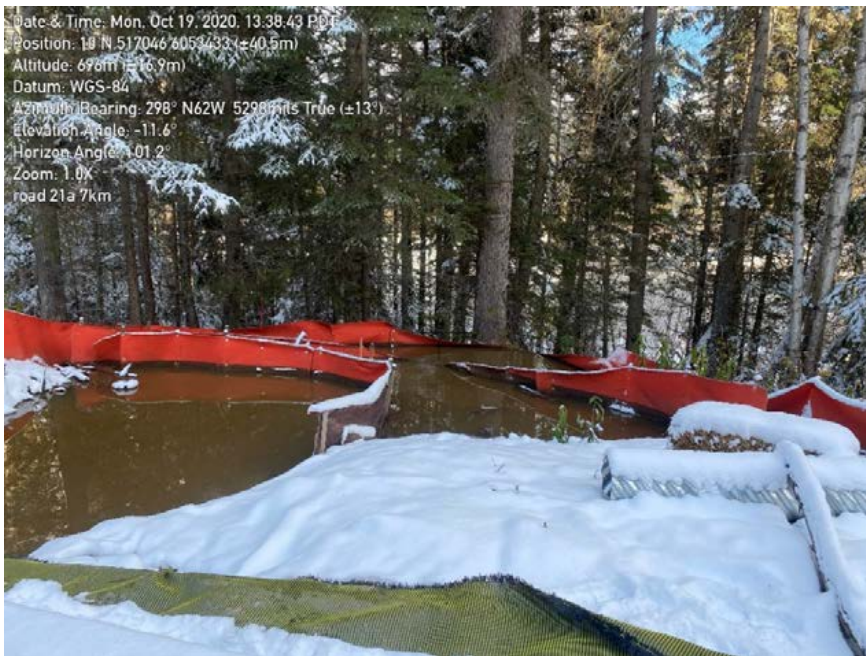
Photo 22: Sediment fence installed across a channel downstream of culvert outlet at 7 km on 21a road. Crooked River in background downslope of this location.

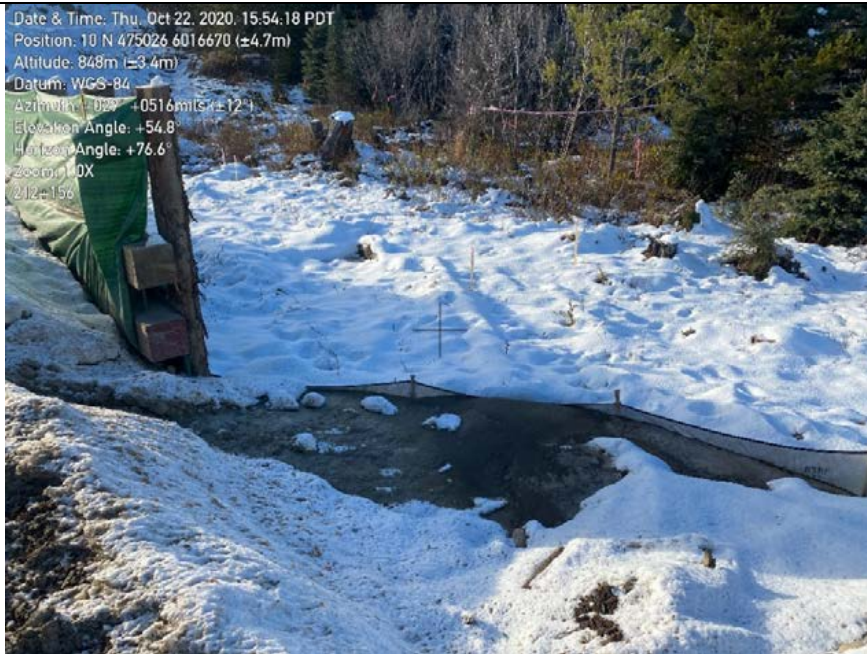
Photo 25: KP272+156. Sediment fence beside S3 watercourse overwhelmed, at risk of failing and with water passing over top of the fence.

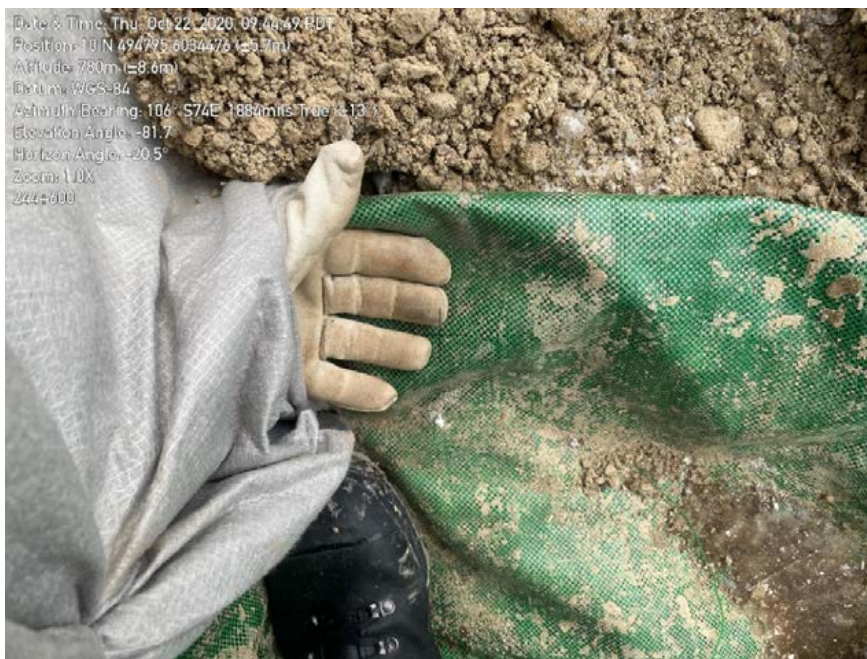
Photo 26: Sediment fence adjacent to watercourse not fastened correctly to another length of sediment fence. Large gap allows water to flow beneath.

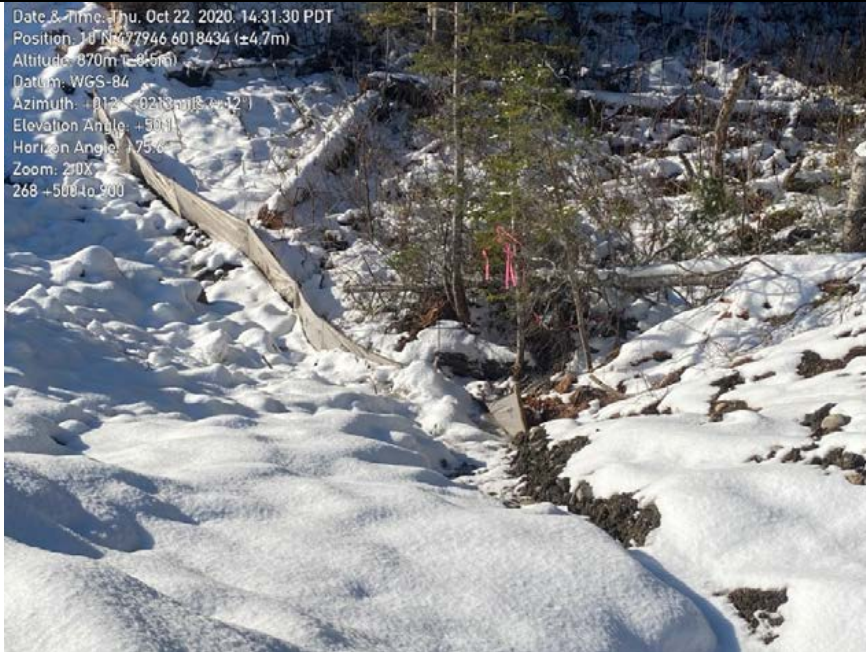
Photo 27: Sediment fence overwhelmed and at risk of failing, signs of gully erosion can be seen leading toward this section of the fence. NCD at base of slope.

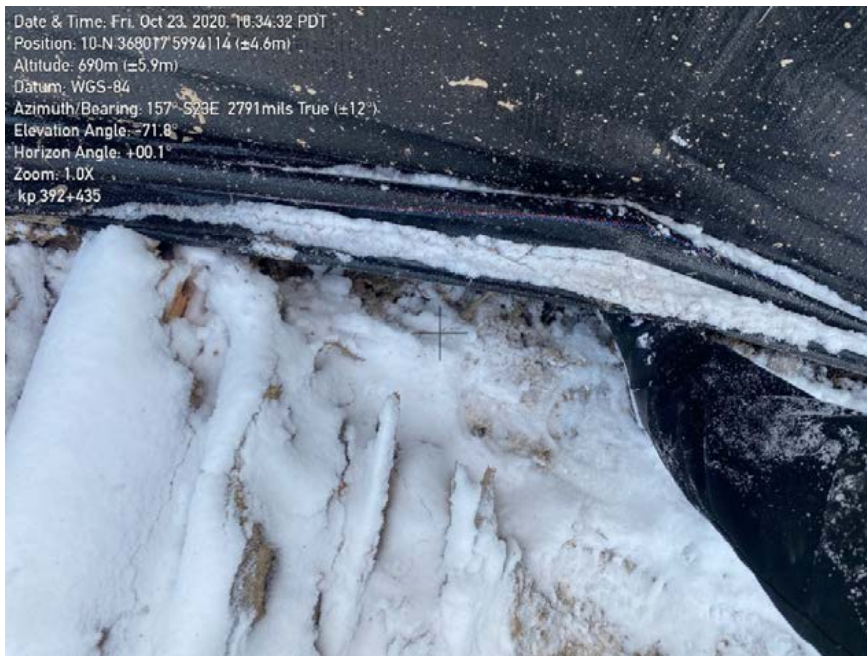
Photo 28: Gap beneath sediment fence at watercourse crossing, making ESC measure ineffective.

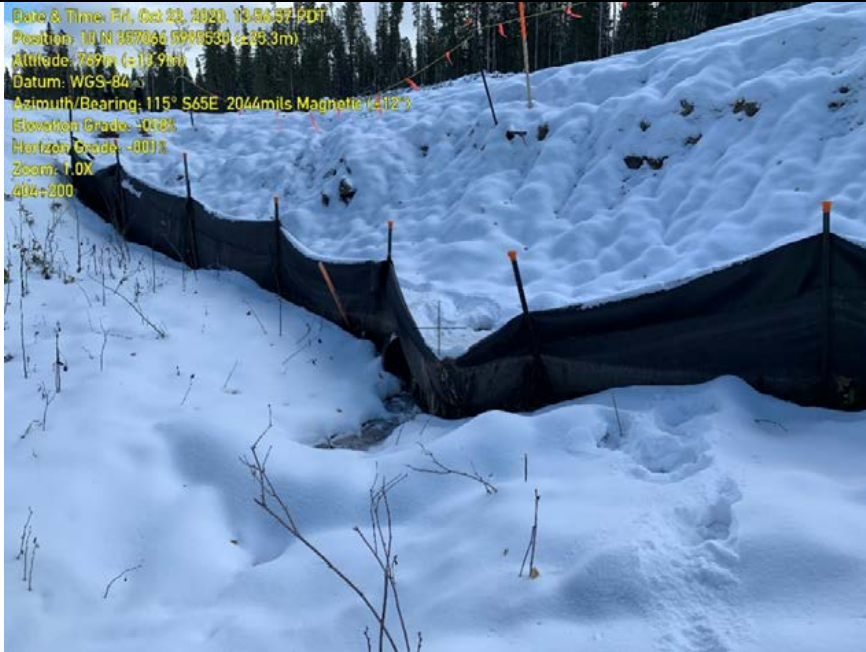
Photo 29: Material from bridge approach overwhelming sediment fence. Fence at risk of failing. Wetland (W2) at this location.

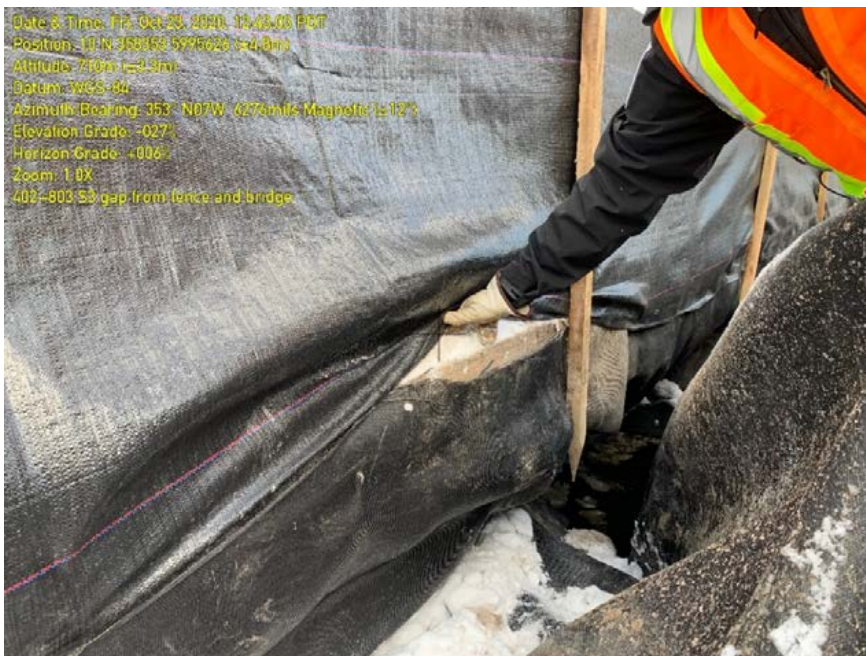
Photo 30: Sediment fence stapled to bridge over S3 stream. Ineffective installation.

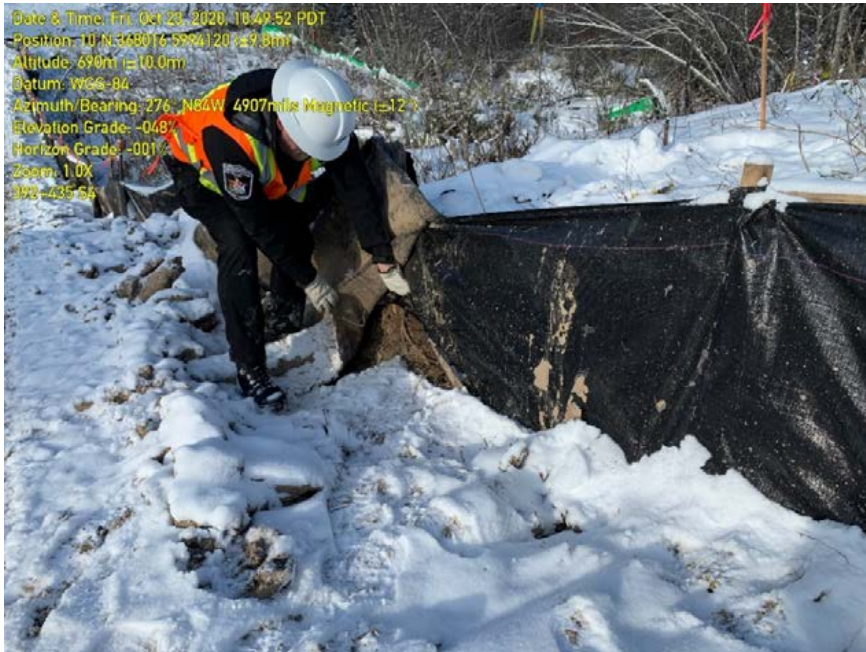
Photo 32: Sediment fence not attached to geotextile, large gap. S4 in background.

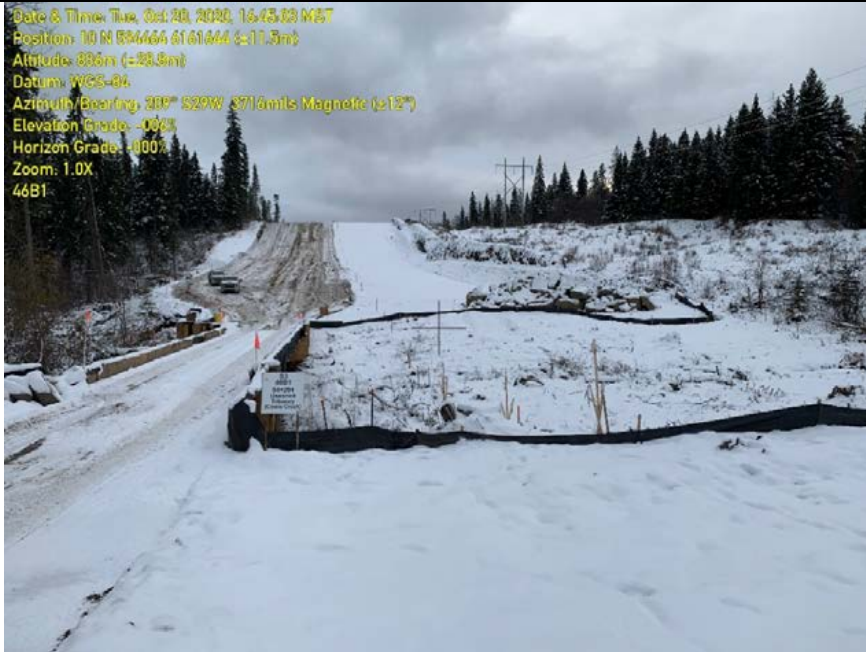
Photo 33: Work package 1, KP54+204. Exposed right of way drains to single row of sediment fence adjacent to S3 stream.

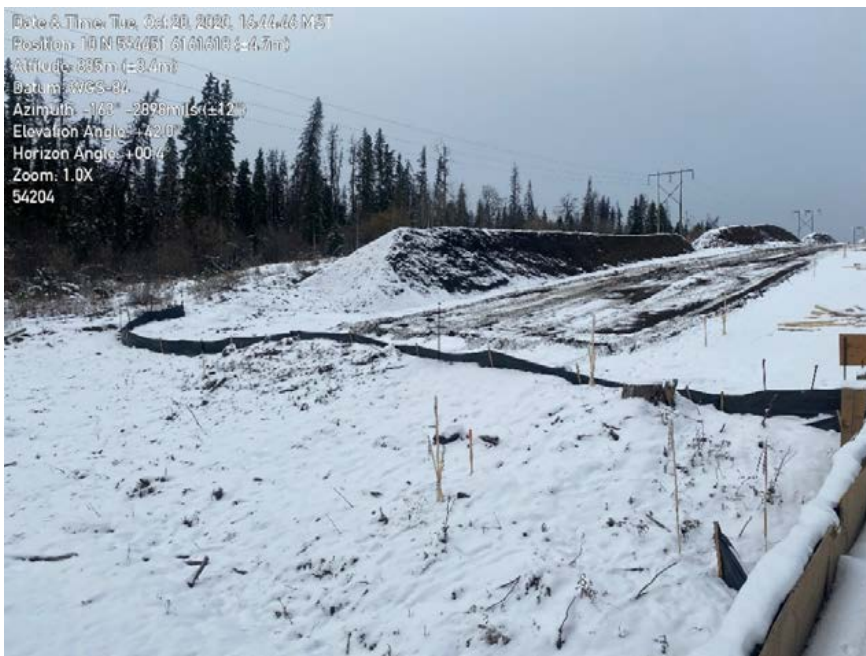
Photo 34: Work package 1, KP54+204. Right bank approach to S3 stream is roughly 170 m long of exposed material. Single row of sediment fence at the base of the slope as ESC measure.

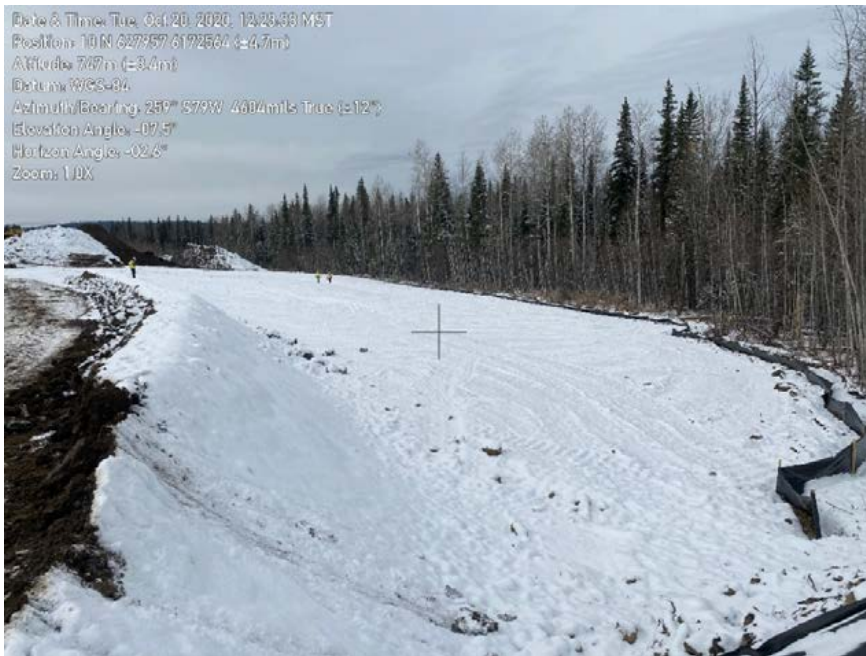
Photo 38: Work package 1, Timber Deck Area 1. Exposed material sloping towards single row of sediment fence.

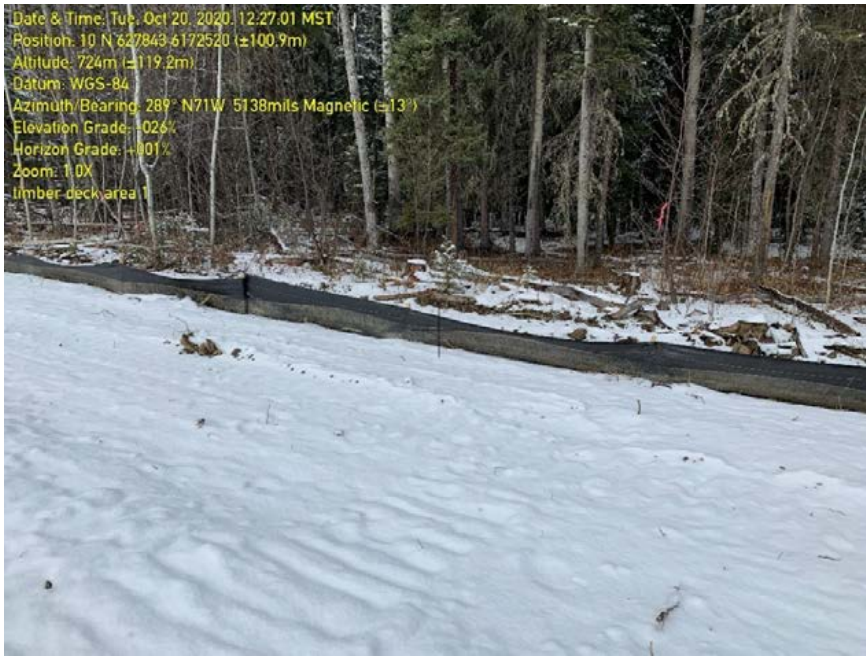
Photo 39: Work package 1. Low point along sediment fence in Timber Deck Area 1. Staining on sediment fence showing how high sediment build up in this area has been previously.

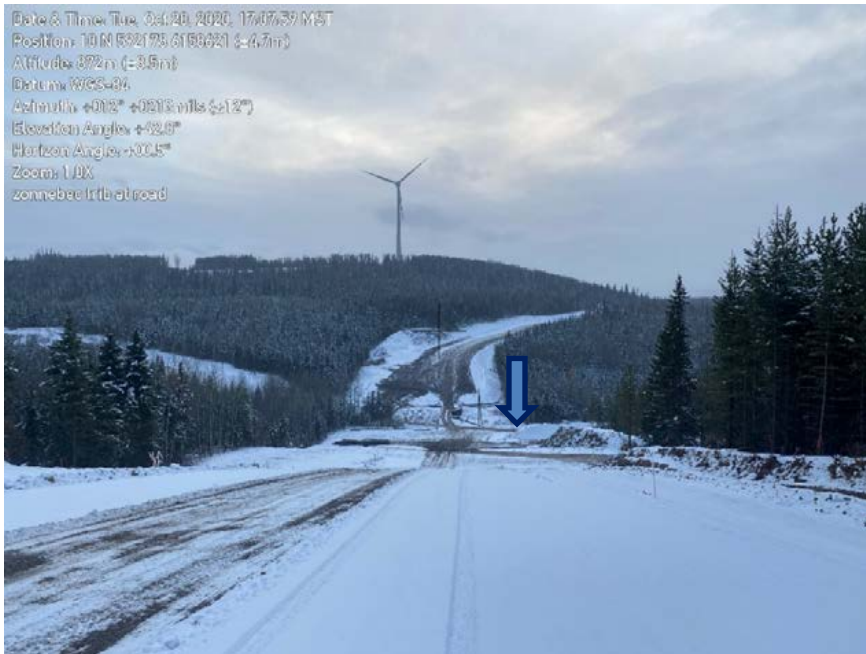
Photo 40: Work pack 1, exposed soils from right of way draining down slope towards S6 stream feature. Blue arrow roughly indicating location of stream.

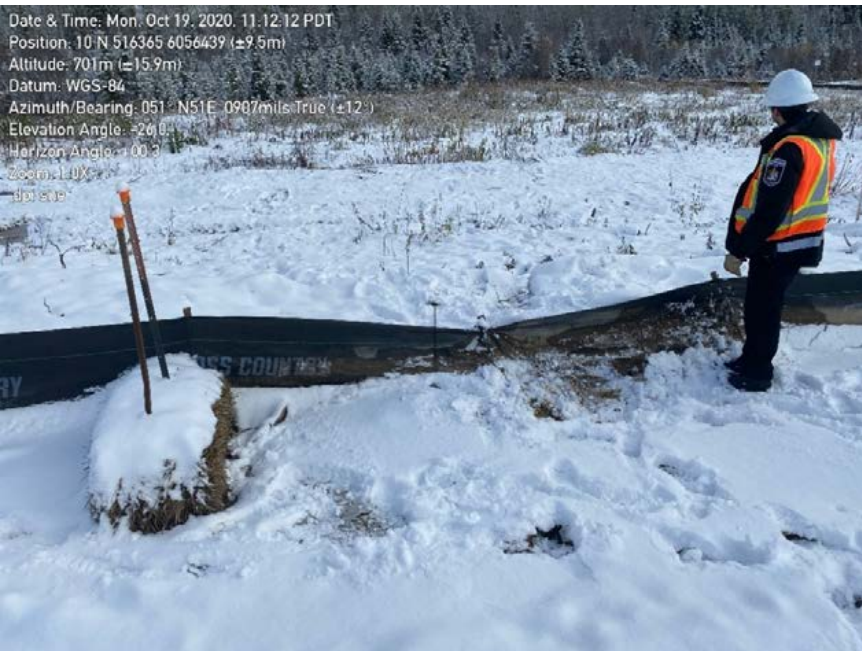
Photo 44: Work package 2. High chain looking towards low chain at Crooked River DPI. Large exposed area and soil stockpile all flows to this section of sediment fence. Fence overwhelmed and had previously failed.

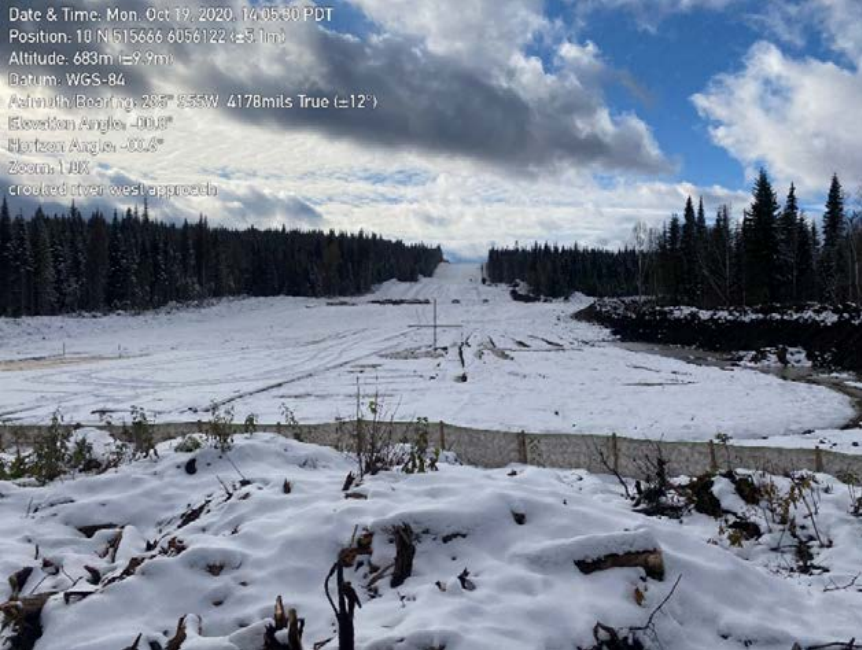
Photo 45: Work package 2. Right bank side of Crooked River. Exposed right of way with limited erosion and sediment controls in place. Approach is roughly 600 m long x 80 m wide with the cleared laydown measuring approximately 130 m long x 125 m wide. Both upslope areas report to the base of the slope adjacent to the Crooked River. See photo below for different perspective of where this location drains to.

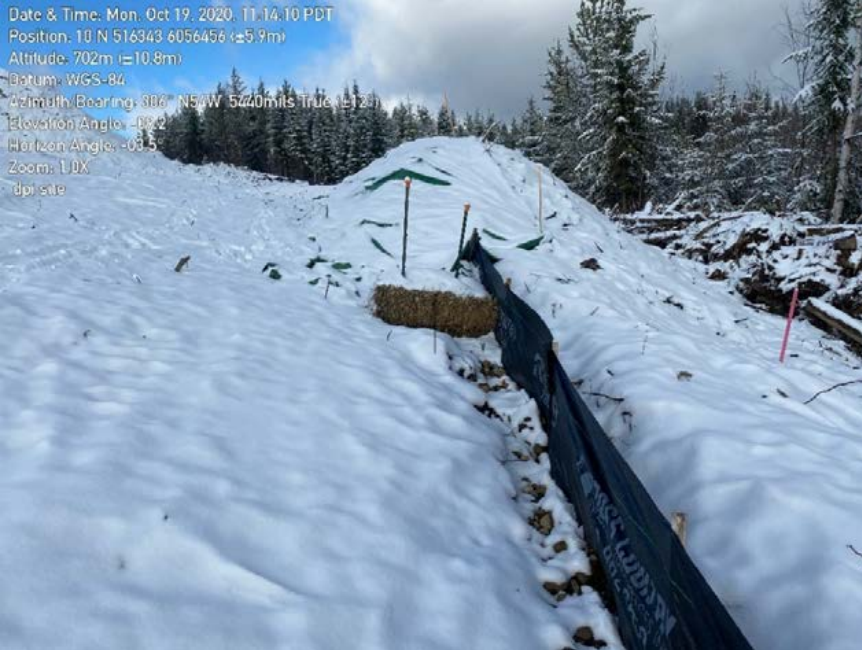
Photo 49: Ineffective straw bail not installed as required at Crooked River DPI site. Bail was not keyed into place. Water has eroded beneath the bail.

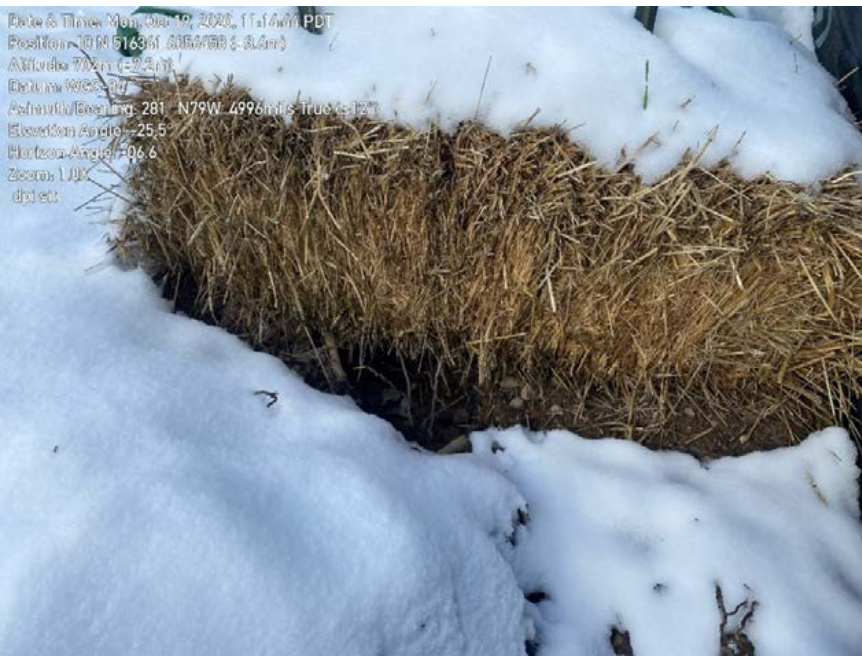
Photo 50: Close up of gap beneath straw bail at Crooked River DPI site.

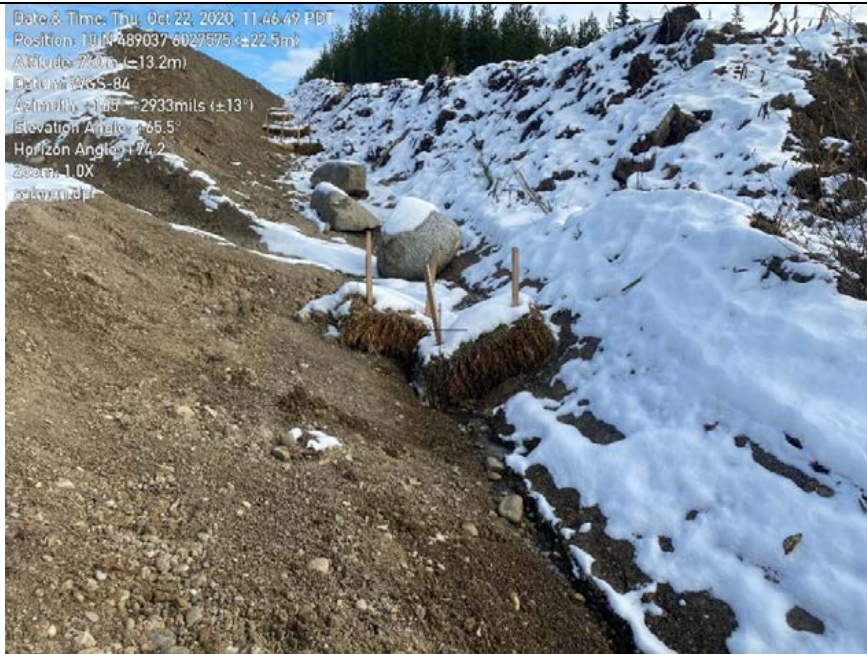
Photo 51: Incorrectly installed straw bails at the Salmon River DPI site. Bails not keyed in place and erosion has taken place beneath. Note the rocks installed upslope which are not acting as an effective ESC measure.

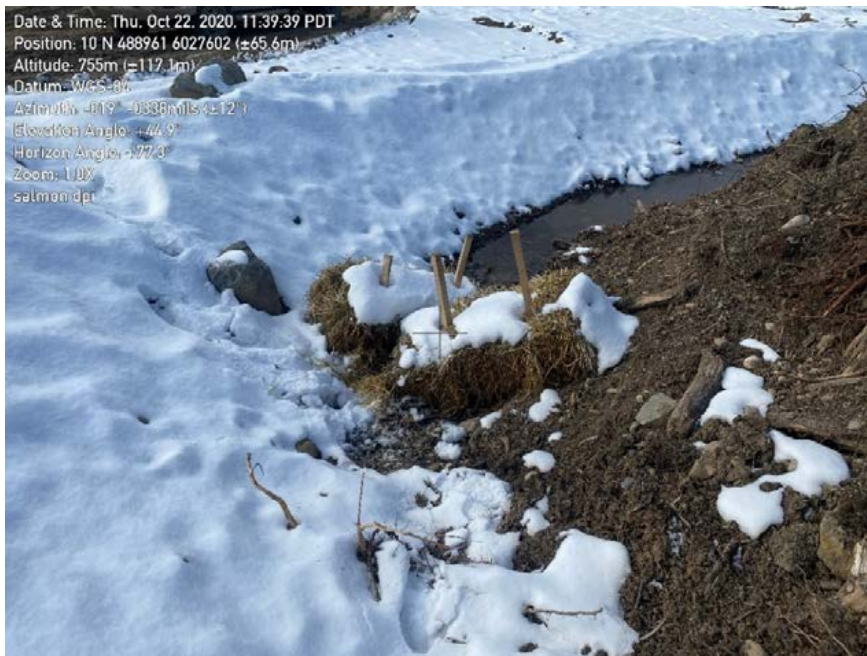
Photo 52: Incorrectly installed straw bails at the Salmon River DPI site. Water has eroded beneath the structures.
