Project Name	Coastal GasLink Pipeline Project	Inspection Status	Final
EA Certificate #	#E14-03	Inspection No.	IR2020-055
Project Status	Certified	Inspection Start	2020-10-19
Sector	Energy	UTM	10U 533697 E 6071620 N
Trigger	Planned Inspection	Inspection Type	Field
Project Description	The Coastal GasLink Pipeline Project (Project) is an approximately 650 kilometer (km) long natural gas pipeline connecting facilities in northeast British Columbia (BC) to the LNG Canada facility near Kitimat.		
Location Description	The Project is near Groundbirch (40 km west of Dawson Creek) in northeast BC to the LNG Canada facility near Kitimat. This inspection focused on work being carried out in Sections 1 through 5 of the Project.		
Inspection Summary	<p>From October 19 to 23, 2020 Environmental Assessment Office (EAO) Director of Compliance and Enforcement Chris Parks and Compliance and Enforcement Officer Clayton Smith (collectively EAO C&E) inspected the Coastal GasLink Pipeline Project (Project) against requirements of the Environmental Assessment Certificate (EAC) #E14-03 (Appendix 1). On November 2, 2020 EAO C&E conducted a follow up inspection in Section 4 of the Project near KP 244, north

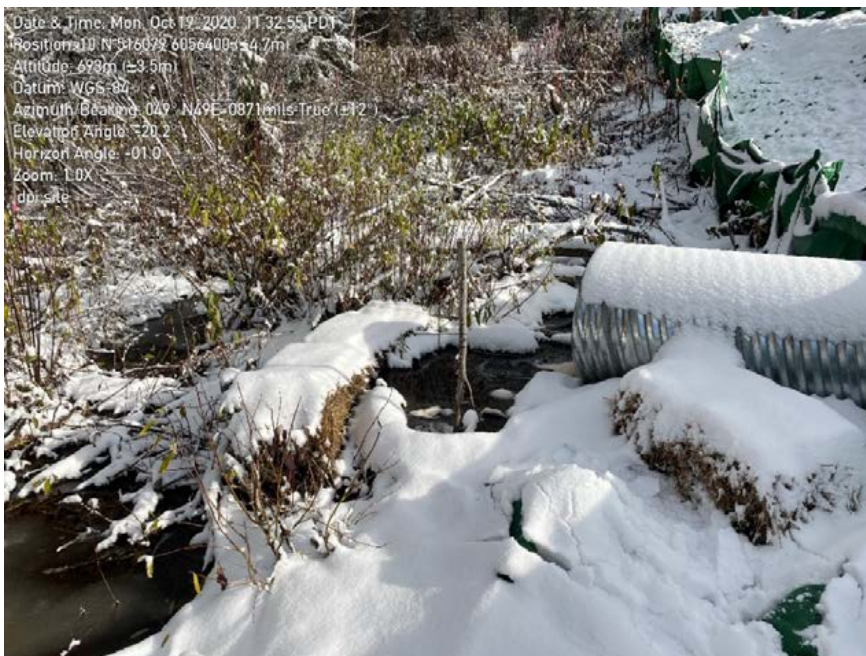
Photo 54: Incorrect installation of straw bails at Crooked River DPI. Not intended to be used within a channel at inlet or outlet of culvert.

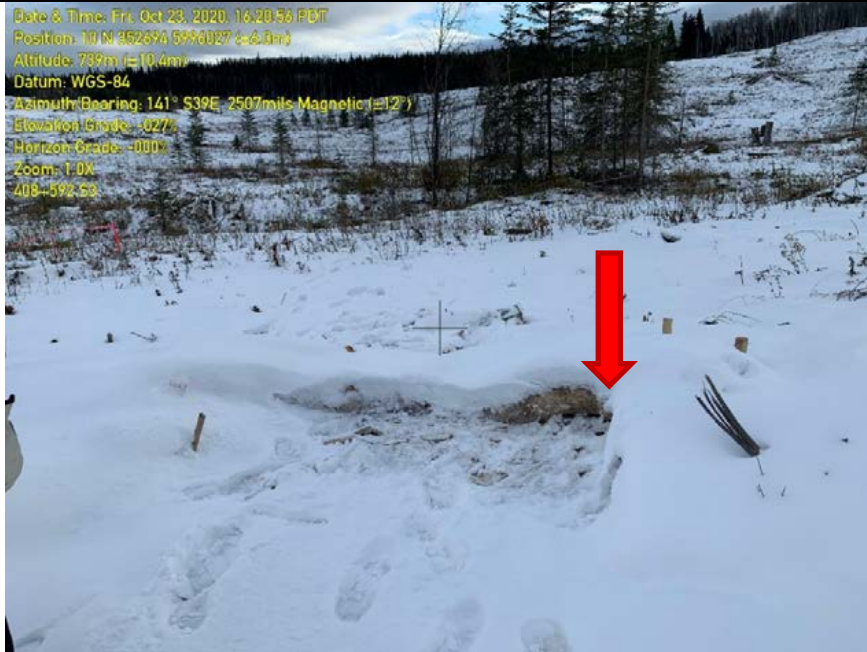
Photo 55: Work package 3. Straw rolls not keyed into place correctly. Gap beneath roll allowing water to flow beneath measure.

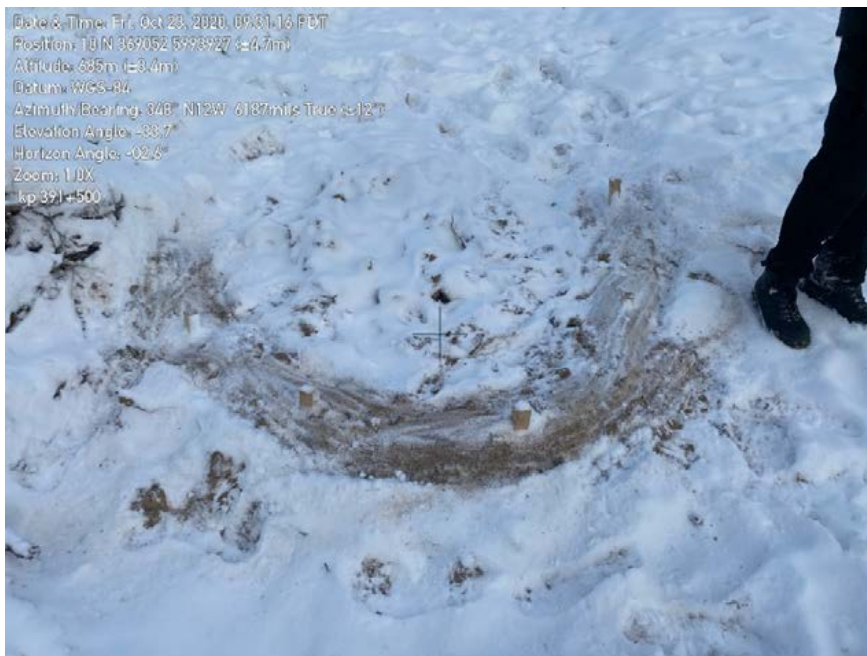
Photo 56: Work package 3. Straw roll keyed in too deep, limited catchment area as a result.

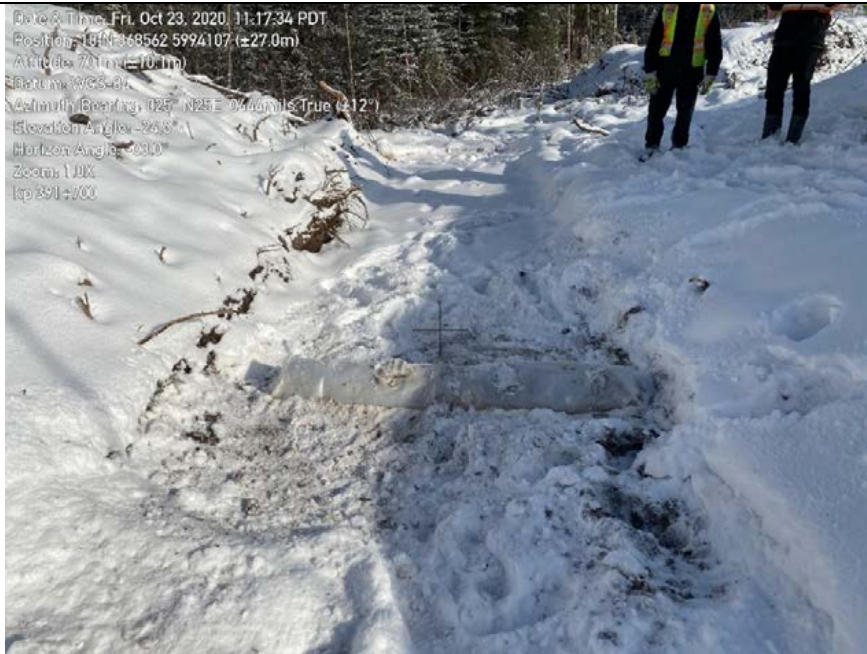
Photo 57: Work package 3. Check dam of sandbags covered with poly installed in ditch. Measure does not extend across ditch; flow can escape around the structure. Not effective. Exposed area seen in Photo 47 above is designed to drain to this ditch and then into the vegetated area beyond the right of way.

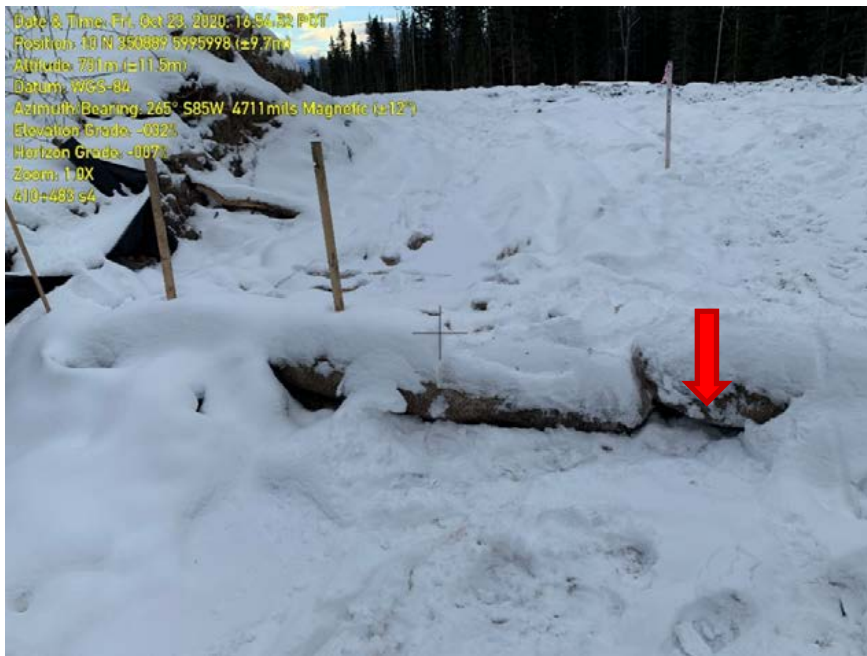
Photo 58: Work package 3. Straw rolls not keyed into place; arrow indicating gap beneath the straw roll.

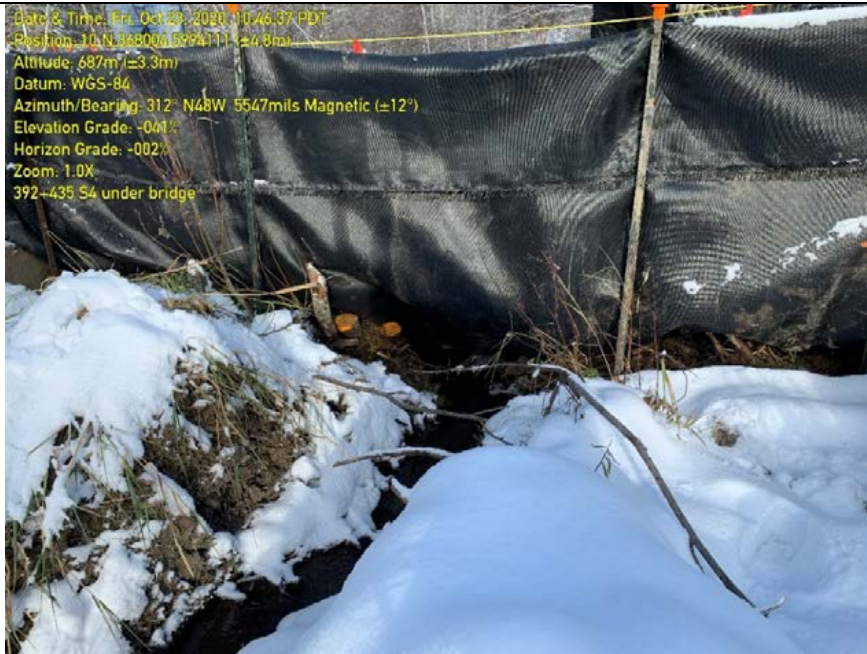
During inspection in work package 3 (Section 5) on October 23, 2020 EAO C&E observed geotextile fabric, which was installed beneath three bridges, sagging into the flowing channel below. The fabric had been previously wrapped beneath the bridges and had captured sediment, snow and water from above. The fabric was sagging low enough to be within the actively flowing channel of two separate fish-bearing streams and a third stream that is classified as non fish-bearing. Material being held within the fabric (sediment) was slowly being released into the channel as water from the flowing channel was passing through the fabric. This finding was observed at KP392+435 (S4), KP401+971 (S6), and 402+800 (S3).

Photo 59: Geotextile from bridge over S4 stream at KP392+435 sagging into channel.

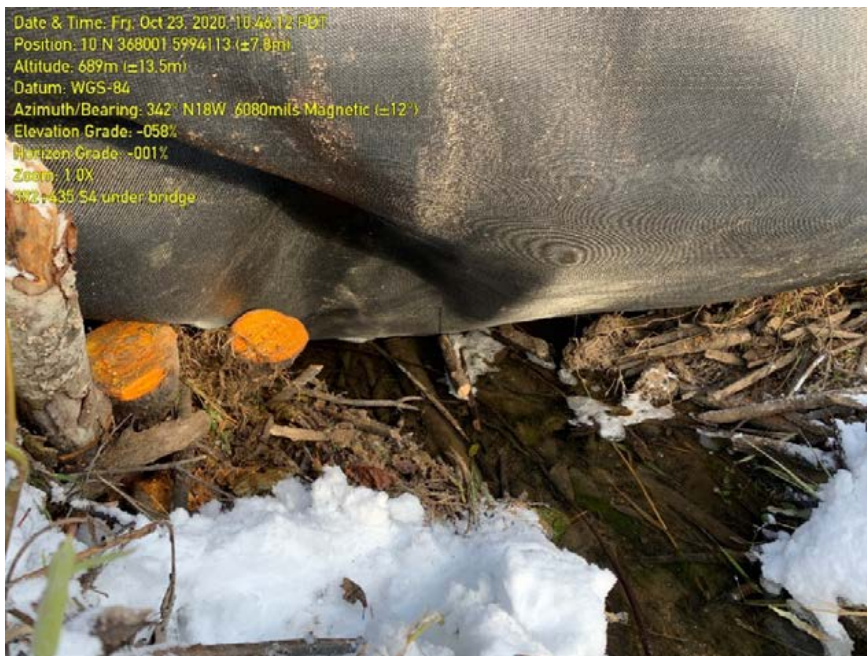
Photo 60: Close up of geotextile from bridge over S4 stream at KP392+435 sagging into channel.

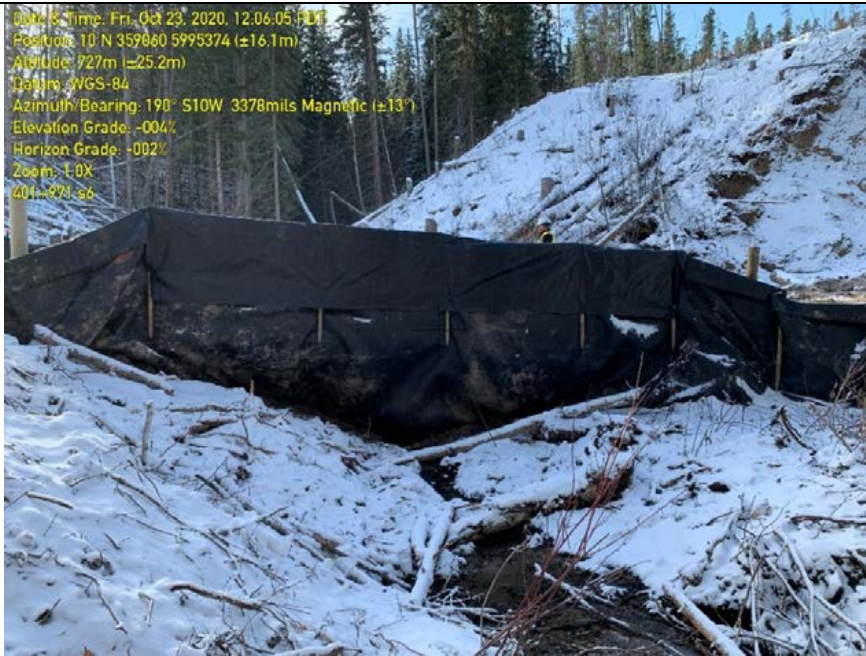
Photo 61: Work package 3. Geotextile fabric from bridge crossing sagging into watercourse.

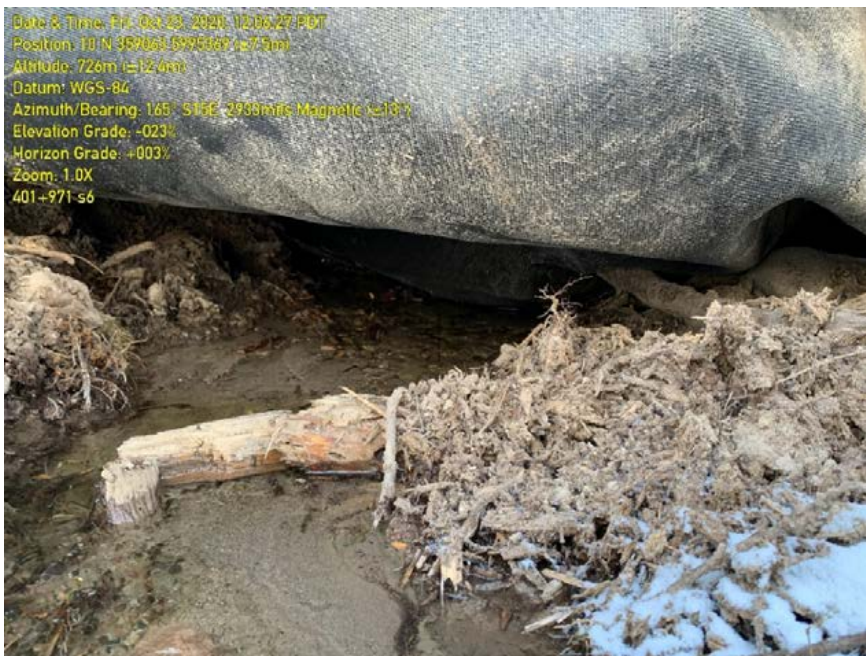
Photo 62: Geotextile containing sediment; sagging within the channel of S6 watercourse.

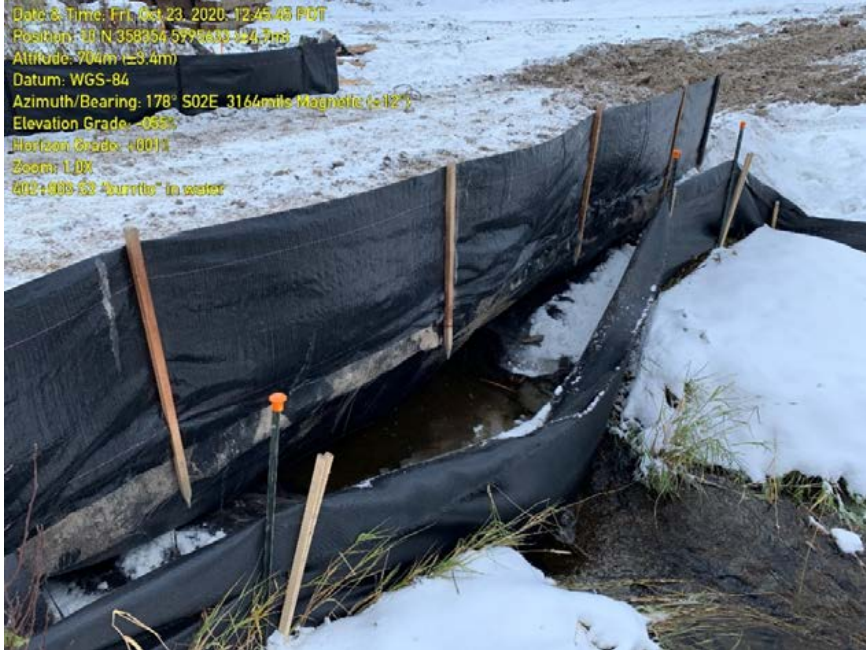
Photo 65: Geotextile within S3 channel.

Having the geotextile from the bridges sagging and reaching the watercourse has the potential to introduce deleterious substances into the watercourse, as observed at KP401+971, and may impact stream flows. The observations above provide evidence that installation of geotextile at the three above noted watercourse crossings have not contained material to the bridge deck, have not directed stormwater from the bridge deck away from the watercourse and have not been repaired when warranted.

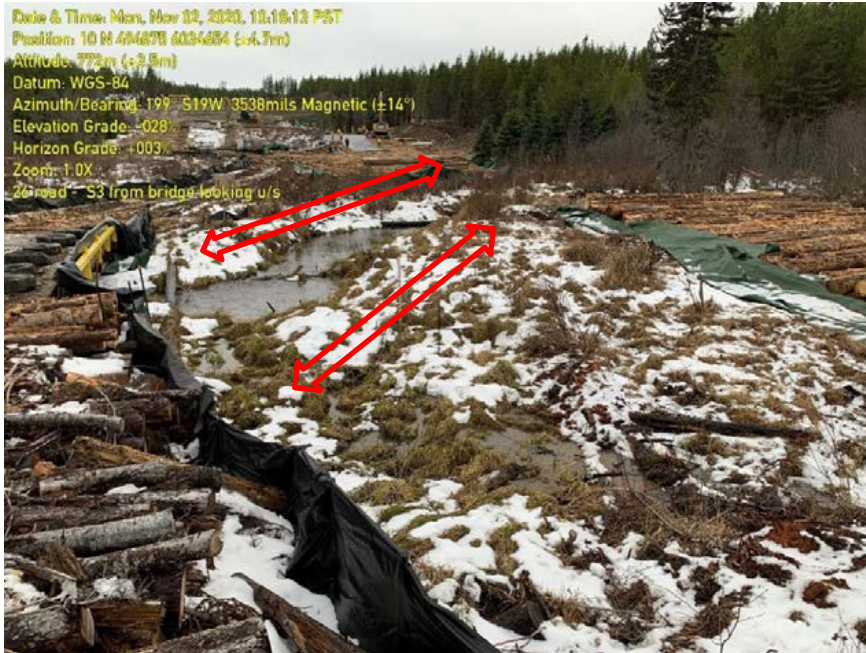
Photo 66: KP 244+510, low chain looking towards high chain. No ESC measures along banks of S3.

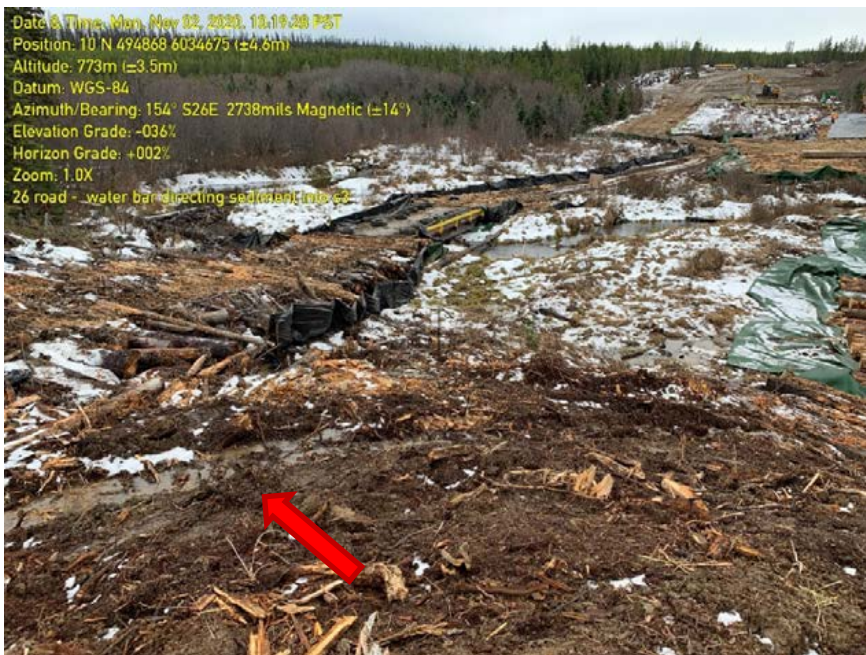
Photo 67: WC272, Low chain looking towards high chain. ESC measures along banks of stream are limited to incorrectly installed and unmaintained sediment fence, increasing risk of sediment transport to fish-bearing watercourse. Red arrow showing erosion and sediment transport towards and into fish-bearing stream.

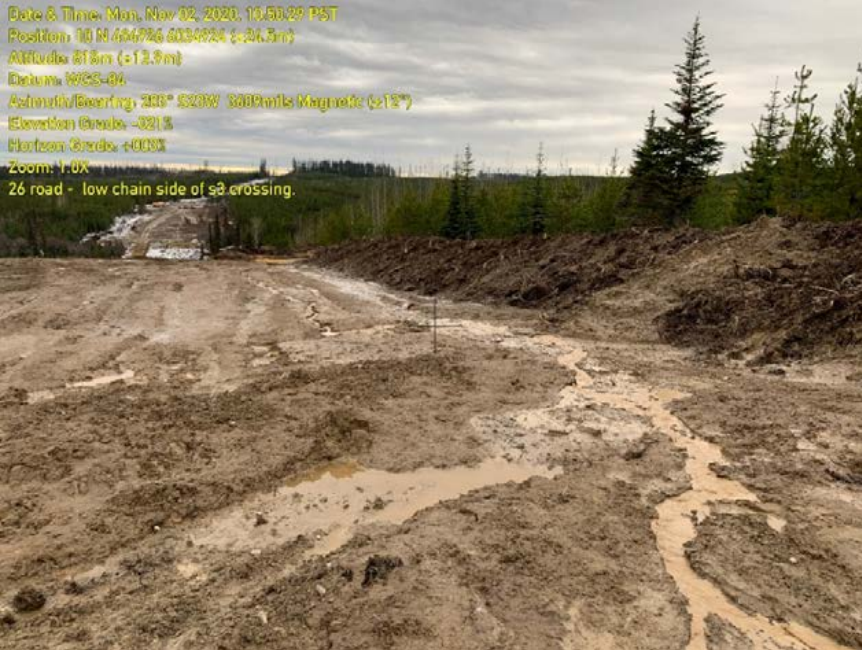
Photo 69: Exposed surface materials from stripping of right of way, active erosion. Sediment mobilizing towards watercourse #WC272.

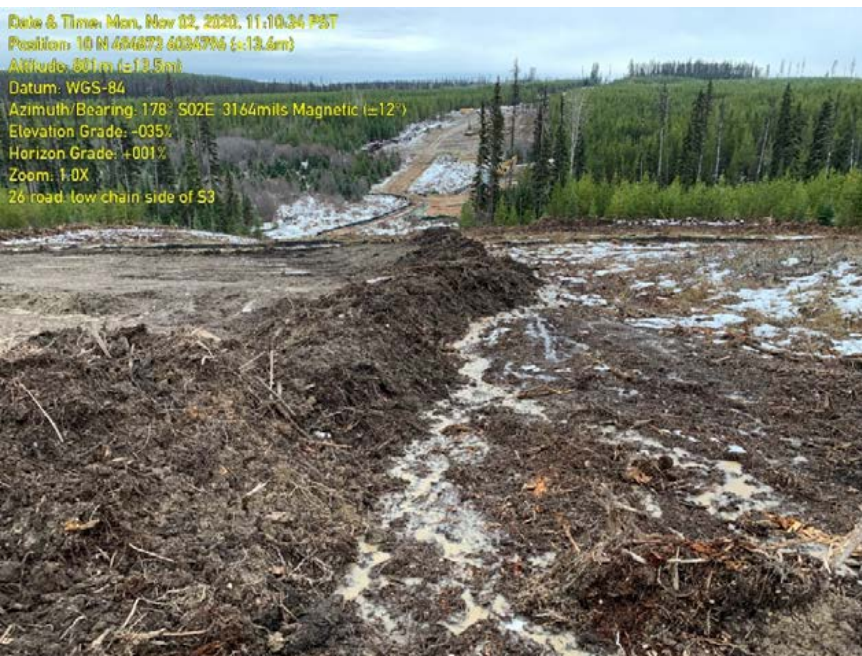
Photo 70. Water from water bar directed to back side of berm and flowing towards watercourse. Erosion taking place and sediment mobilizing towards watercourse #WC272.

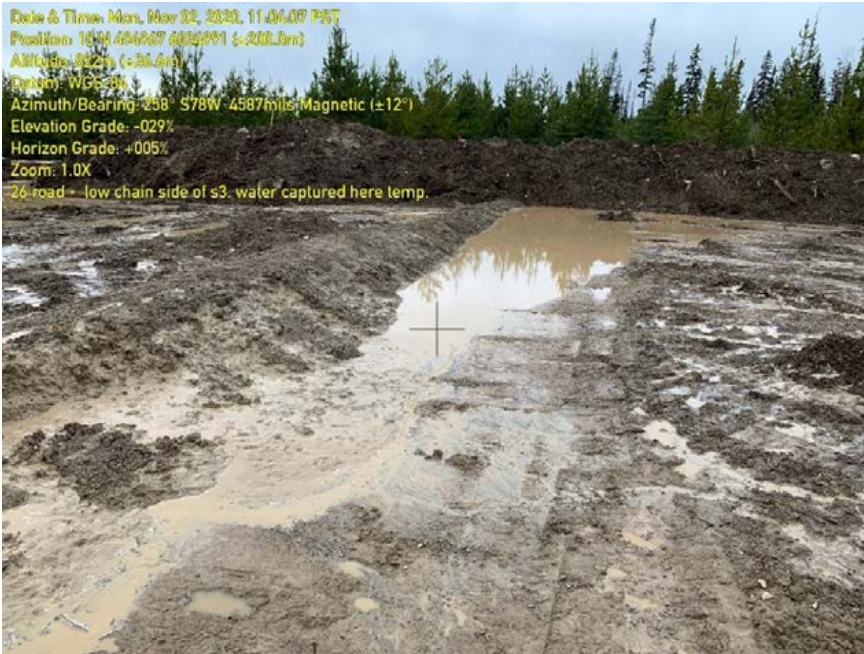
Photo 72: Berm used to direct water from ROW to low point.

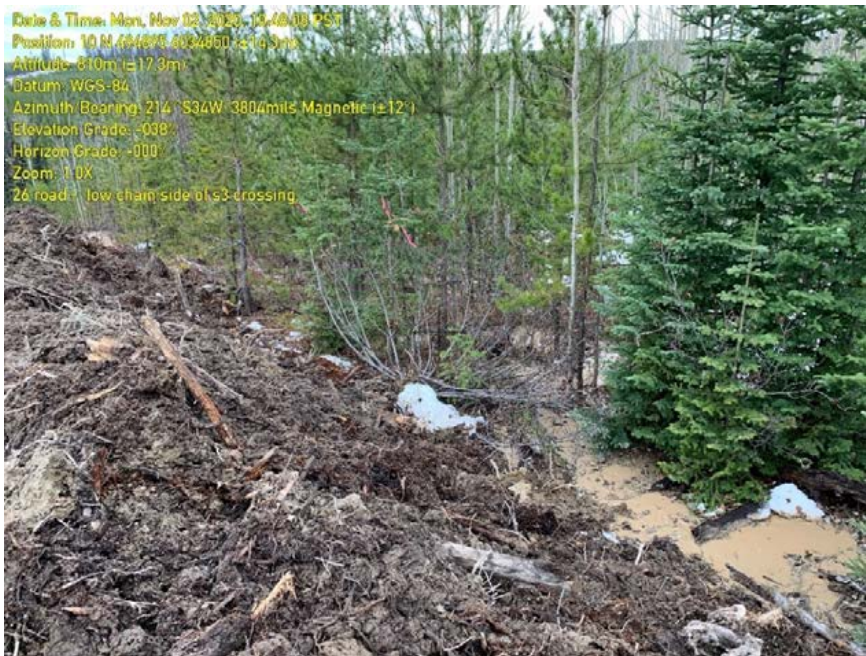
Photo 78: Opposite side of sediment fence. Sediment laden water now flowing down slope on opposite side of topsoil windrow.

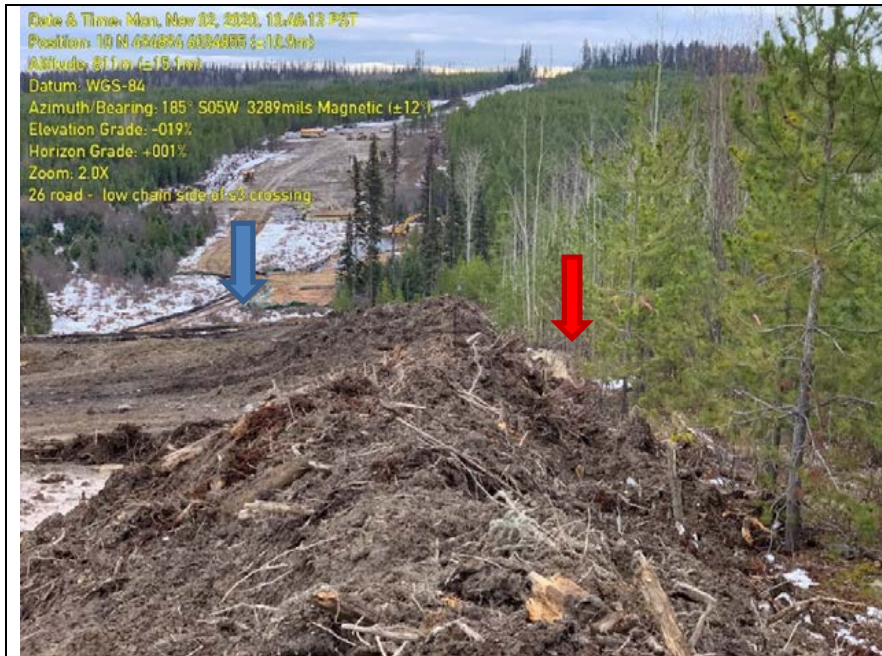
Photo 79: Red arrow indicating sediment laden water on back side of windrow continuing to flow down slope. Blue arrow indicates fish-bearing stream at base of slope.

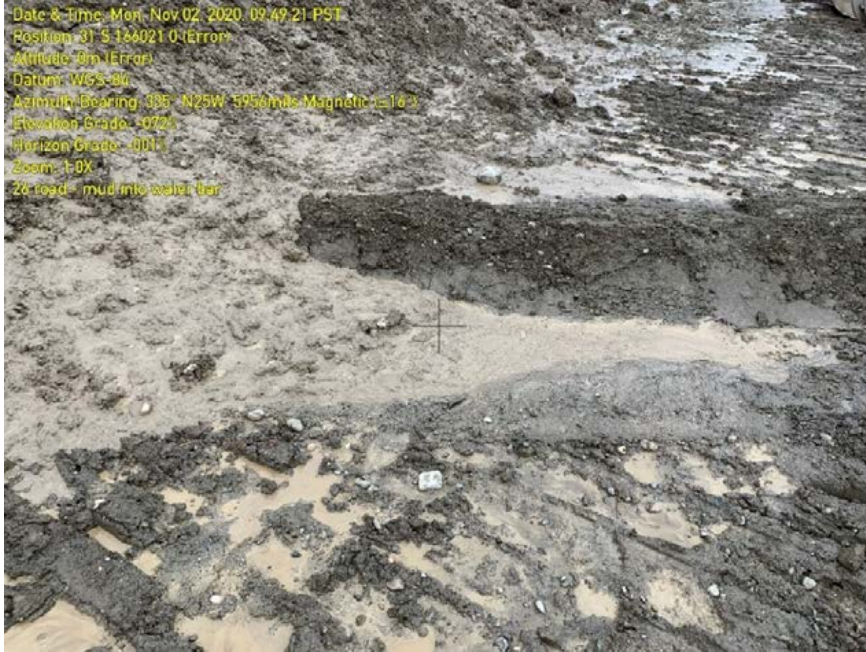
Photo 80: Soil stockpile material sloughing into water bar.

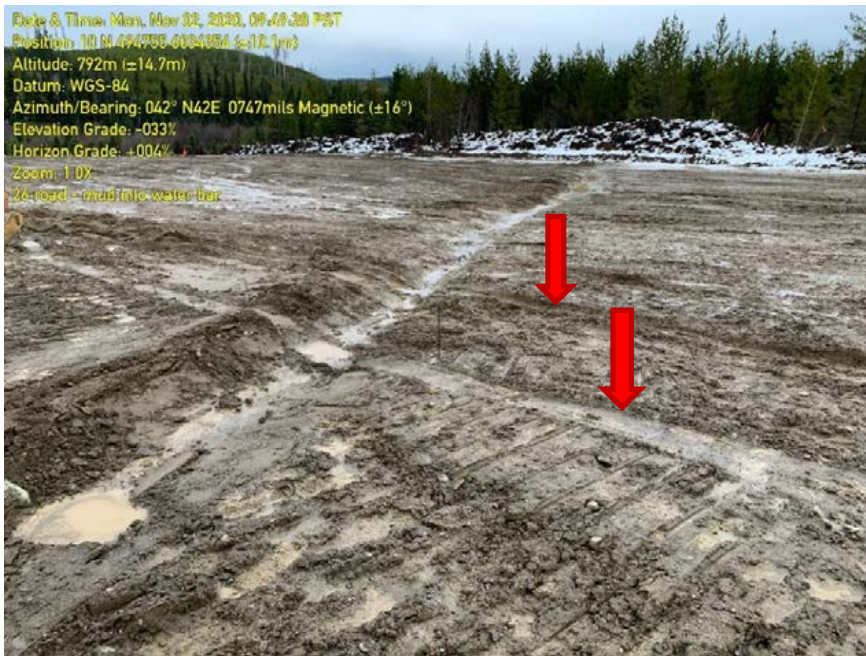
Photo 81: Upper water bar looking north, red arrow indicates tracks through water bar.

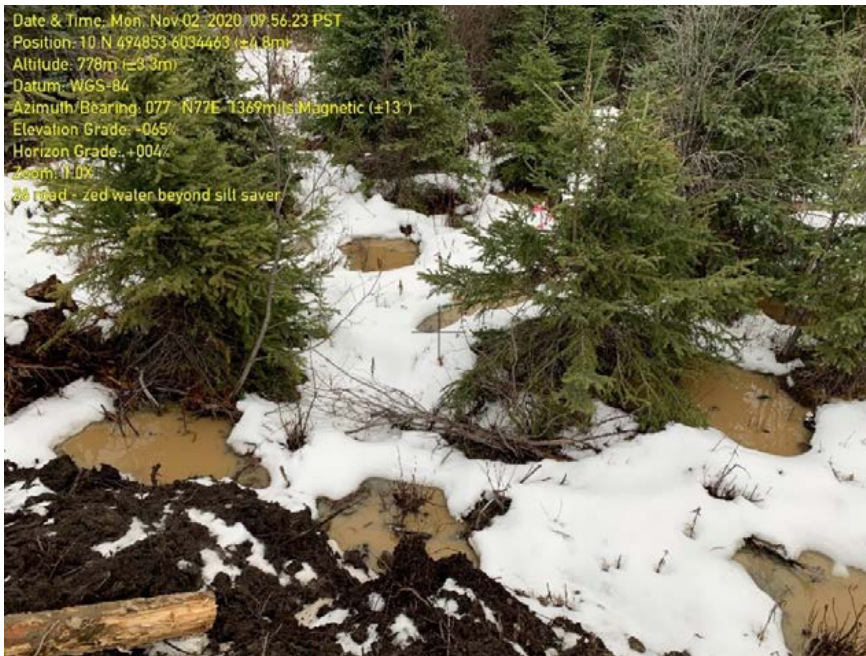
Photo 85: Sediment laden water in vegetation beyond water bar discharge location. Risk of this material reaching S4 feature.

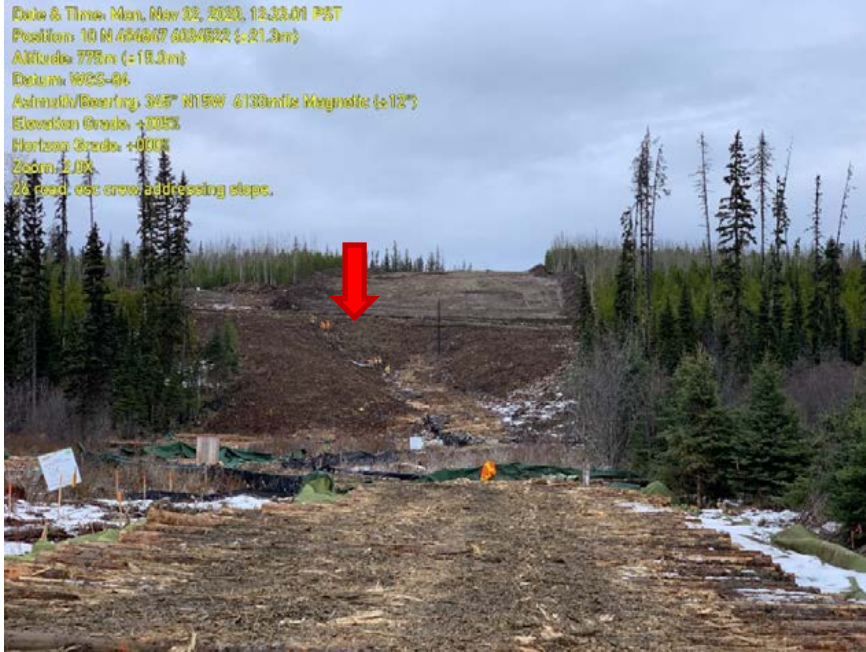
Photo 86: Arrow indicating crew members installing ESC measures on slope to S3 stream.

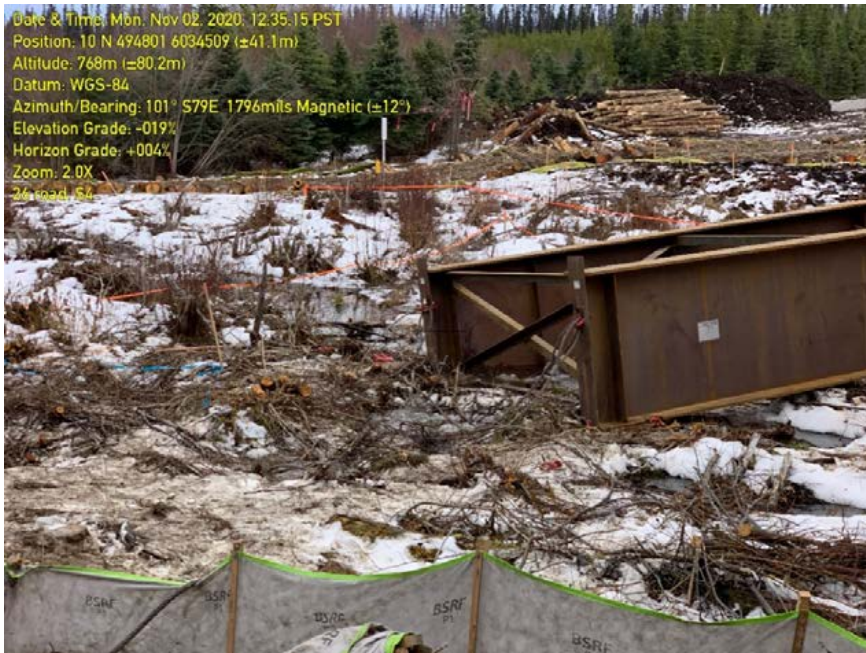
Photo 87: Steel girder dropped into S4 channel. Upstream looking downstream.

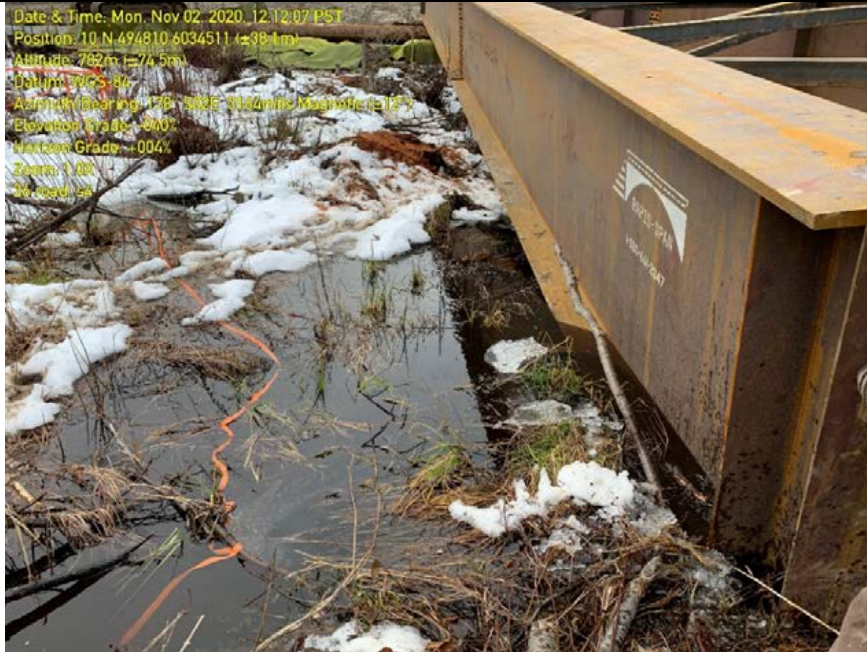
Photo 88: Steel girder in S4 channel. Left bank facing right bank.

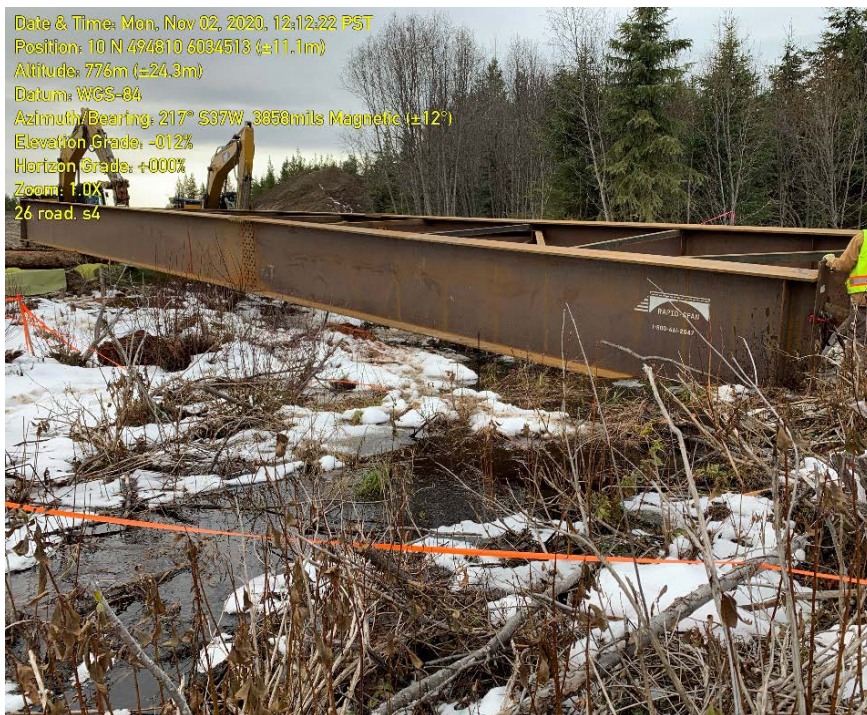
Photo 89: Steel girder in S4 channel. Downstream facing upstream.

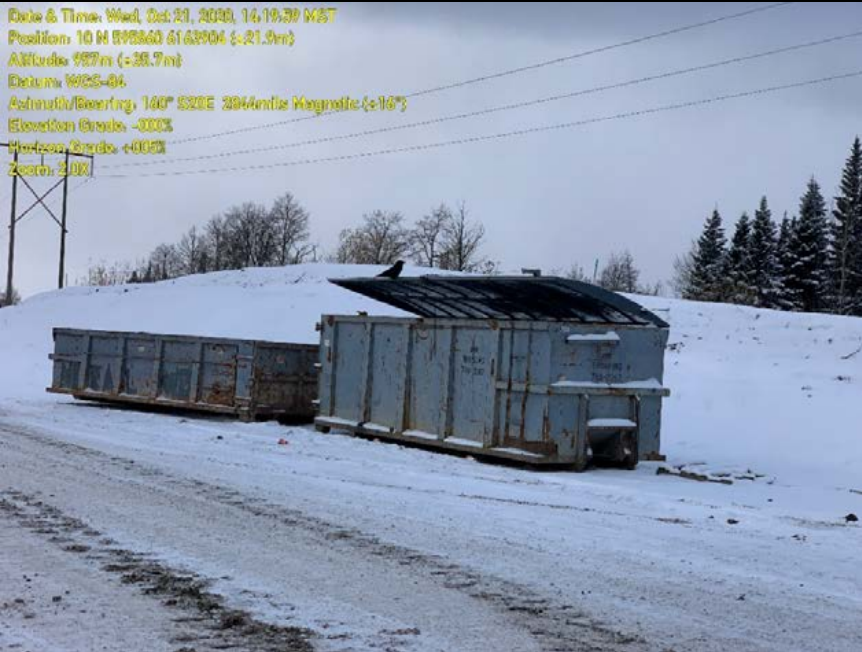
Photo 90: Raven observed scavenging from waste bin.

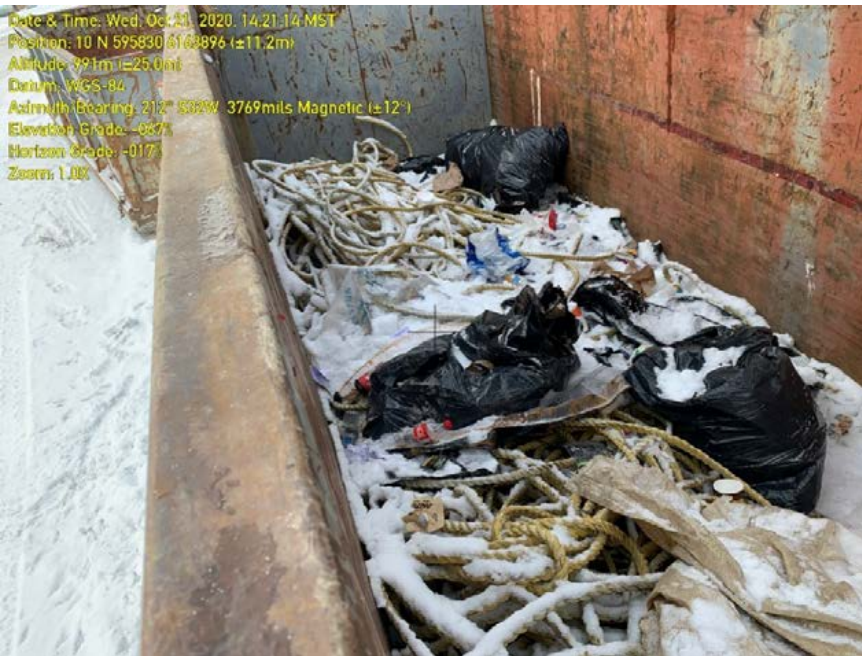
Photo 91: Contents of bin above.

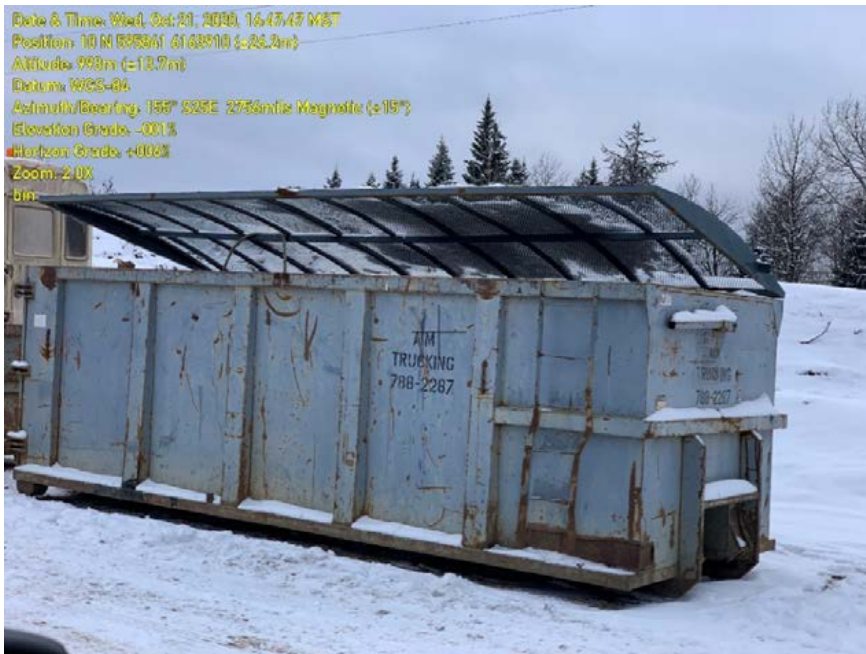
Photo 93: Bin as seen at 16:47 hours.

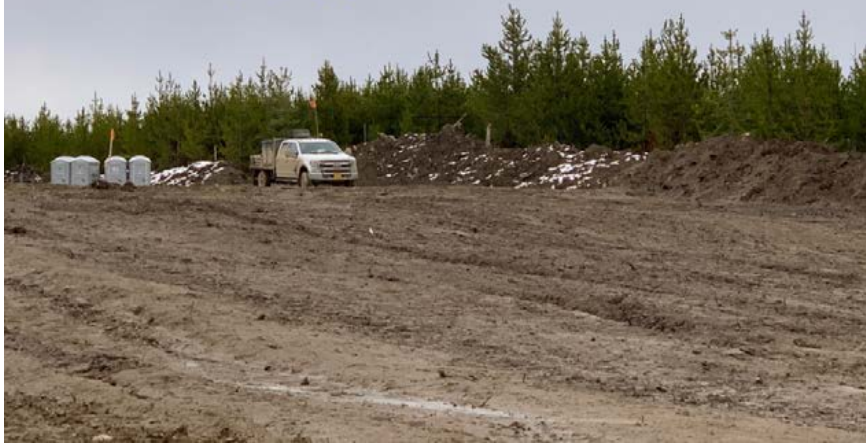
Photo 94: Vehicle observed to be unattended and idling for at least 1 hour and 40 minutes. Temperature ranged from 5 to 8 degrees Celsius while on site.
