Project Name	Coastal GasLink Pipeline Project	Inspection Status	Final
EA Certificate #	E14-03	Inspection No.	IR2022-054
Project Status	Certified	Inspection Start	2022-11-02
Sector	Energy	UTM	10N 533609 6071561
Trigger	Planned Inspection	Inspection Type	Field
Project Description	The Coastal GasLink Pipeline Project (Project) is an approximately 650 kilometer (km) long natural gas pipeline connecting facilities in northeast British Columbia (BC) to the LNG Canada facility near Kitimat.		
Location Description	The Project is near Groundbirch (40 km west of Dawson Creek) in northeast BC to the LNG Canada facility near Kitimat. This inspection covered work being carried out in Sections 3 and 4. The UTM referenced above is approximately in the center of the sections of where the inspection took place.		
Inspection Summary	<p>On November 2 to 4, 2022, Environmental Assessment Office (EAO) Senior Compliance and Enforcement Officer Shayla Frechette and Compliance and Enforcement Specialist Sarah Ellis inspected the Project against requirements of the Environmental Assessment Certificate (EAC) #E14-03 (Appendix 1-4).</p> <p>The Project was in Construction at the time of inspection.</p> <p>Pro

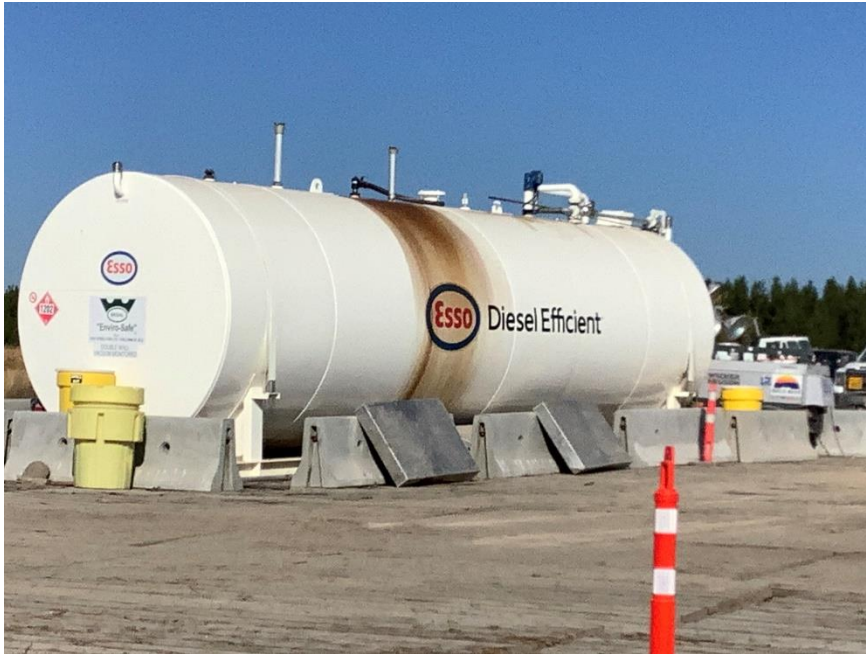
On November 3, 2022, Officers Frechette and Ellis were accompanied by local Construction Monitoring Community Liaisons (CMCLs) who indicated that they first observed a spill on a fuel tank at the 10A Laydown on October 6, 2022. The CMCLs provided a copy of the photograph to Officer Frechette (Photo 1). During the inspection Officer Frechette noted the fuel tank, which appeared to have previously overflowed and dripped fuel down the sides and onto the ground (Photo 2). The tank appeared to be cleaned but still contained residue on the top and bottom of the tank (Photo 3). On November 4, 2022, Officer Frechette requested a copy of the spill report for this location. On November 22, Manager, CGL Regulatory Services stated the following: *"Coastal GasLink understands that a spill was reported to EAO independently by the CMCLs. However, neither Coastal GasLink, nor the Prime [contractor] have a record of a spill at this location and I'm not aware of a spill report being filed by the CMCLs. Coastal GasLink personnel who participated in the inspection also reported that no evidence of a spill was observed during the inspection. If EAO has specific information related to a spill at this location, Coastal GasLink would appreciate EAO sharing that information so we can conduct an investigation."*

Coastal GasLink understands that a minor incident occurred in early October where a small amount of fuel was splashed during fueling, however the errant fuel was contained, no fuel made contact with the ground, and therefore this would not qualify as a reportable spill under the OGC spill reporting guidelines."

Photo 1: Photo taken on October 6, 2022, of fuel tank at 10A laydown provided by CMCL representative.

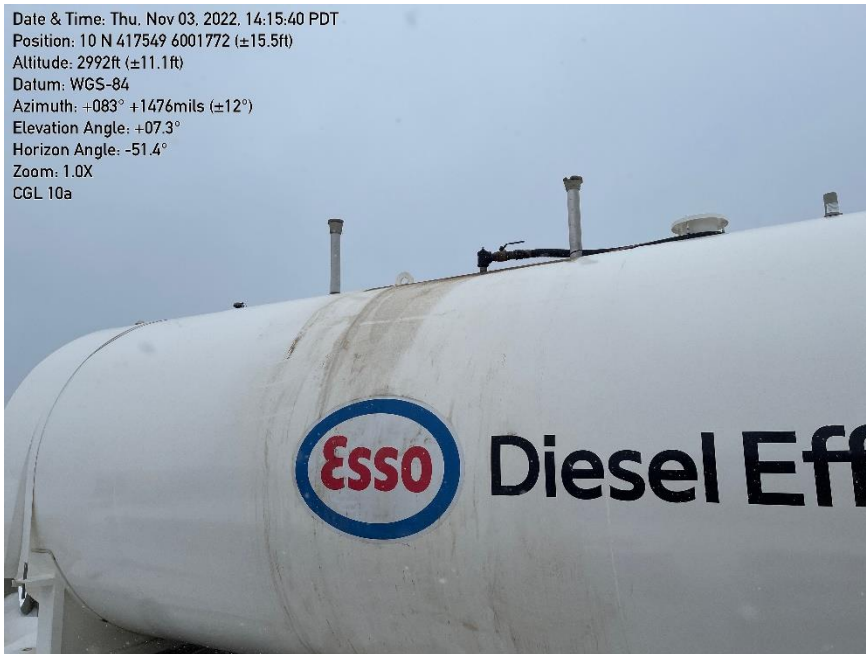
Photo 2: Spill residue on fuel tank at 10A laydown.

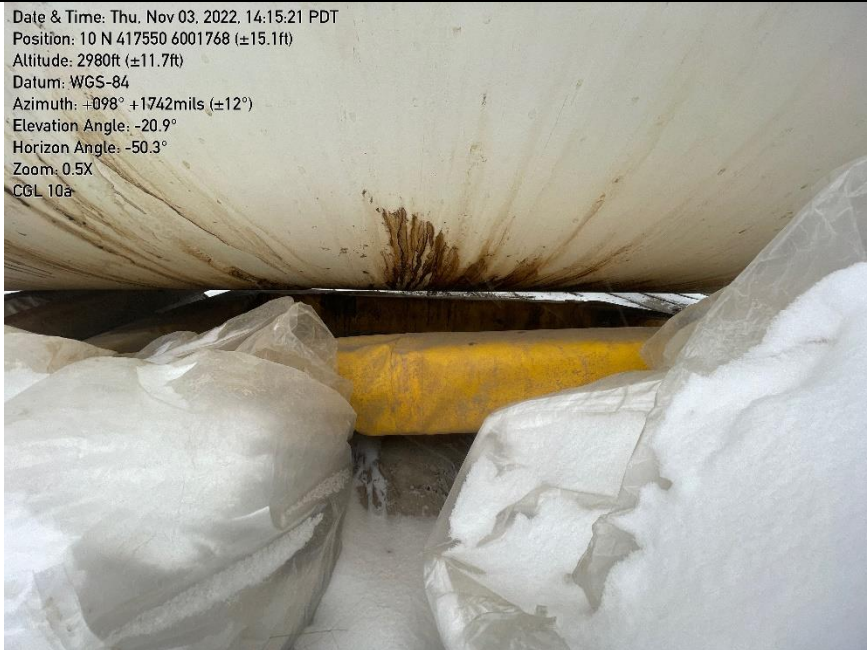
Photo 3: Spill residue on fuel tank at 10A laydown.

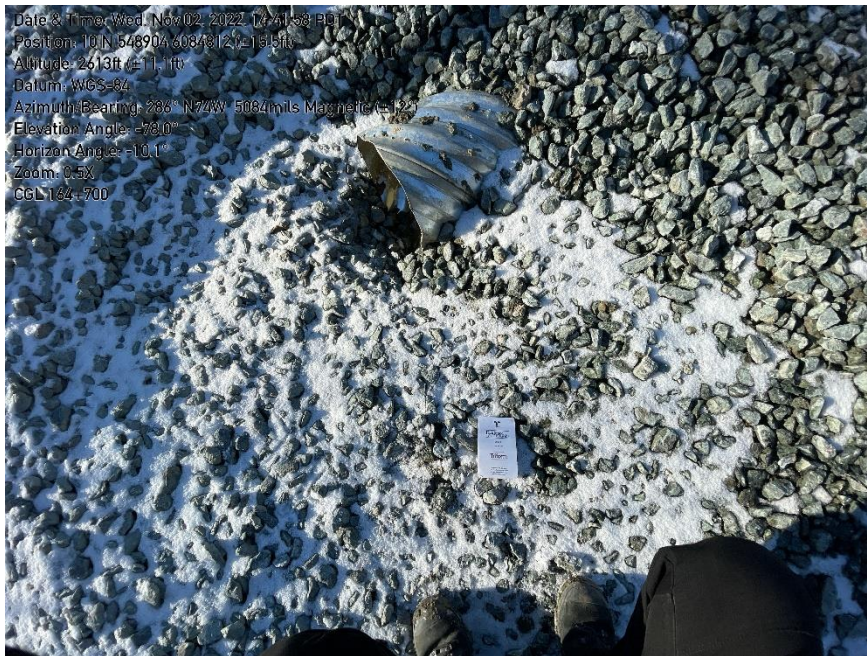
- KP164+720 - Lack of energy dissipater at the end of a rock lined perimeter ditch with respect to material size used as specified by the SSESCPs (Photo 4); and,
- KP164+311 - Lack of sediment fence behind stockpile as specified by the SSESCPs. It was noted by the Environmental Construction Coordinator on November 3, 2022, that the sediment fence had since been installed. However, Officer Frechette could not confirm if it was installed as per specification (Photo 5).

Photo 4: KP164+720 - Lack of energy dissipater at end of perimeter ditch and entrance to culvert.

The observations noted at the time of the inspection provide evidence of non-compliance with respect to the implementation of the WEP and EN2022-028.

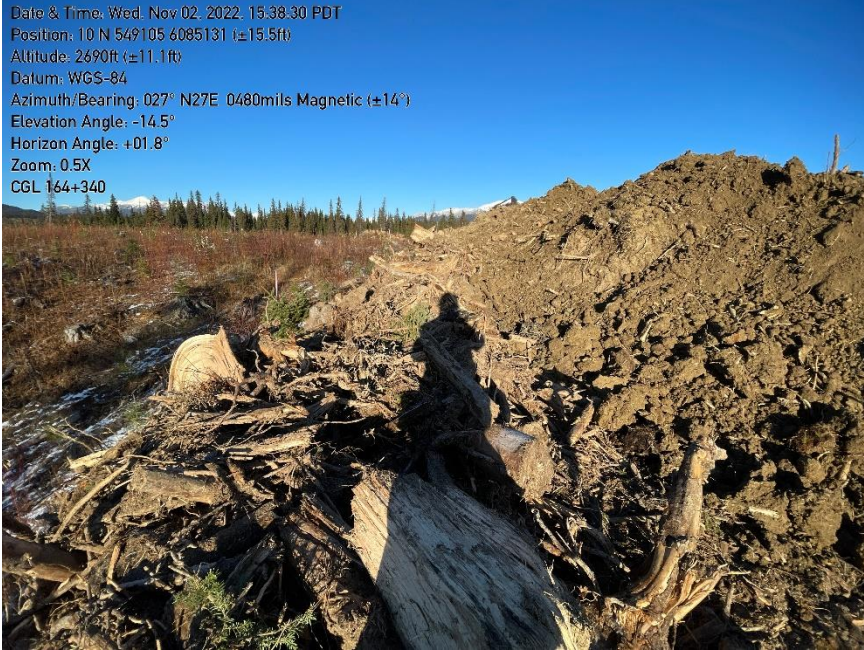
Photo 5: KP164+311 - Lack of sediment fence located behind stockpile.

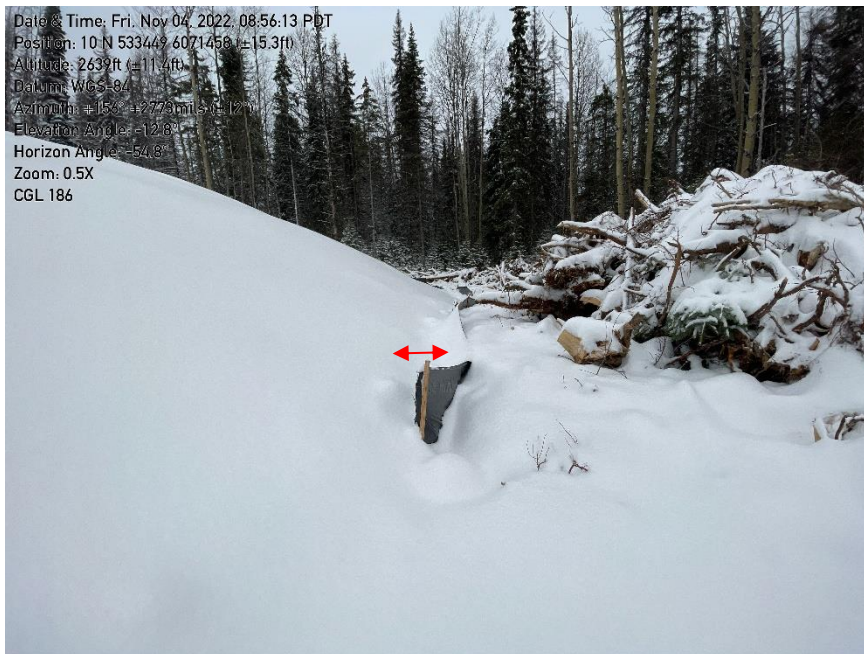
- KP186+720 - Sediment fence installed protecting stockpile on north-east side of ROW not to specification with respect to spacing between stockpile and sediment fence as specified by the SSESCPs (Photo 7);
- KP186+740 - Sediment fence installed protecting stockpile on south-west side of ROW not to specification with respect to spacing between stockpile and sediment fence as specified by the SSESCP (Photo 8); and,
- KP186+740 - Lack of perimeter ditch behind stockpile on south-west side of ROW as specified by the SSESCP (Photo 8).

Photo 6: KP186+720 - Sediment fence installed protecting stockpile not to specification.

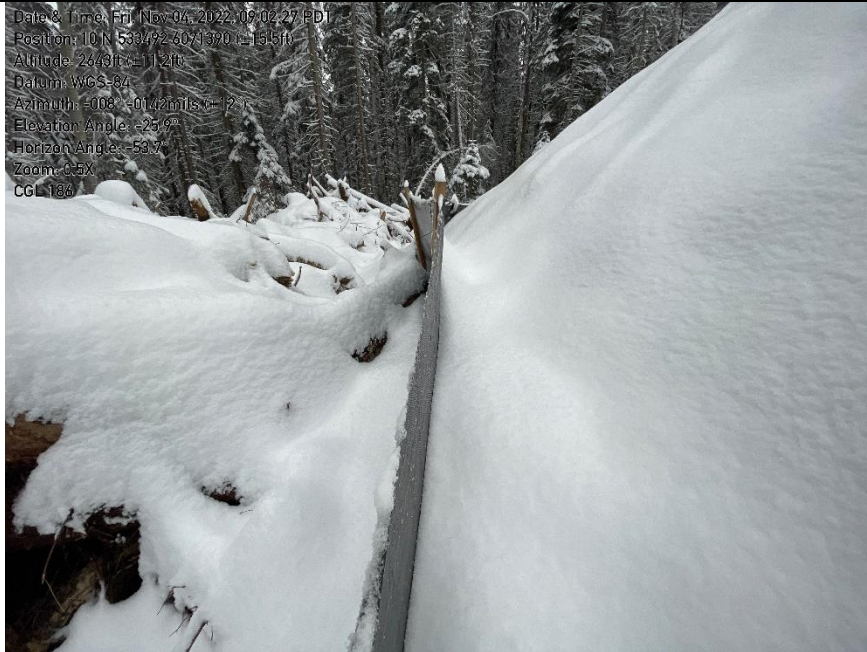
Photo 7: KP186+740 - Sediment fence installed protecting stockpile not to specification.

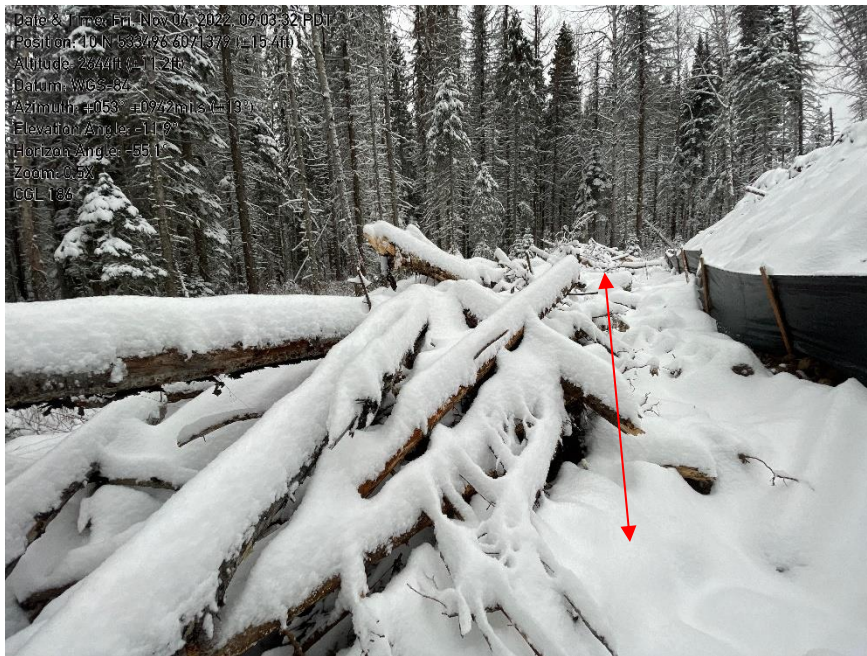
Photo 8: KP186+740 - Lack of perimeter ditch behind stockpile.

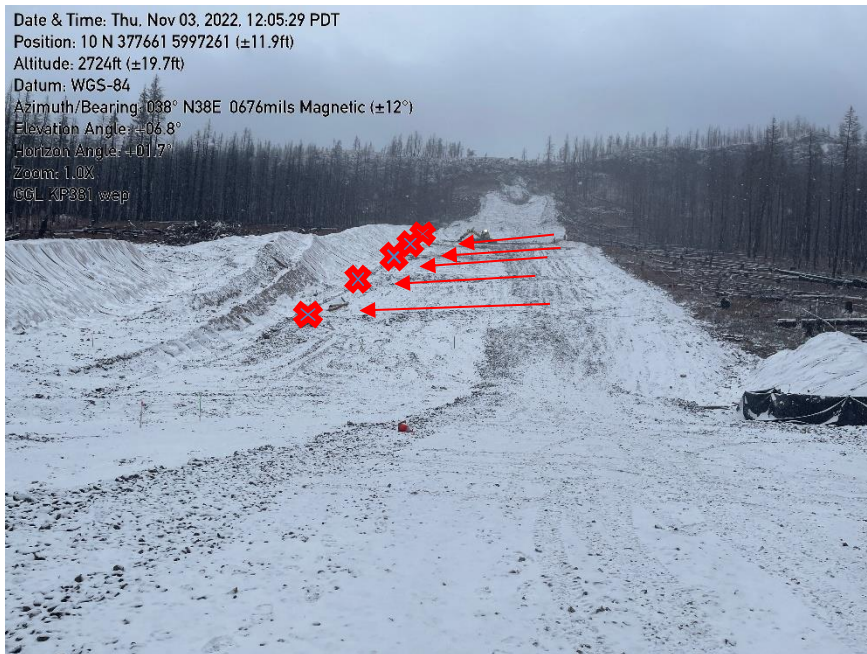
- KP381+440 to 381+575 - Missing five correctly installed straw wattles on north-east side of ROW as specified by the SSECP (Photo 9);
- KP381+440 to 381+575 - Missing five sediment fences on north-east side of ROW as specified by the SSECP (Photo 9);
- KP381+440 to 381+575 - Five water bars located along slope not constructed to specification with respect to size as specified by the SSECP (Photo 9 & 10);
- KP381+520 to 381+575 - Lack of rock lined feature on south-east side of ROW as specified by the SSECP (Photo 11);
- KP381+520 to 381+575 - Lack of two straw wattles on south-east side of ROW as specified by the SSECP (Photo 11);
- KP381+520 to 381+575 - Lack of two sediment fences on south-east side of ROW as specified by the SSECP (Photo 11);

Photo 9: KP381+440 to 381+575 - Missing five correctly installed straw wattles and sediment fences.

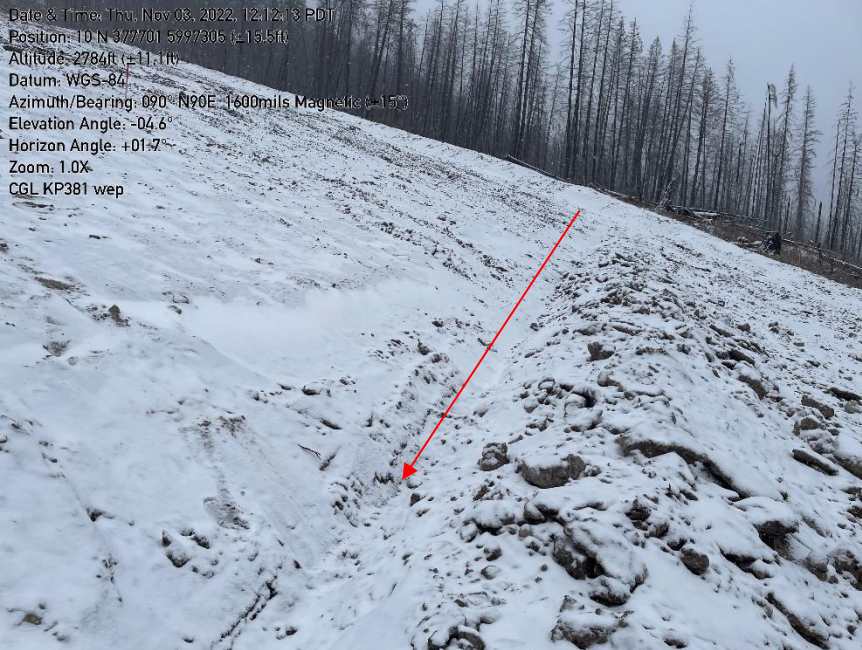
Photo 10: KP381+440 to 381+575 - Five water bars located along slope not constructed to specification.

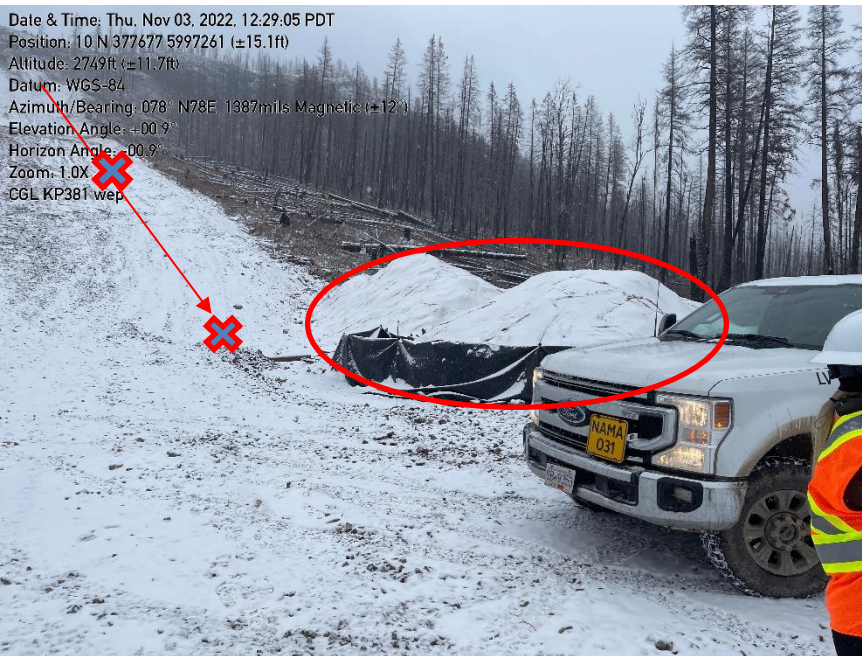
- KP381+570 - Unapproved stockpiles located on the southeast base of the slope not specified by the SSECP (Photo 11);
- KP381+575 - Unapproved discharge located behind unapproved stockpiles located on the south-east base of the slope not specified by the SSECP (Photo 12). Project staff indicate that dewatering occurs when required at this location;

Photo 11: KP381+520 to 381+575 - Lack of rock lined feature (indicated by red arrows), straw wattles, sediment fences (indicated by red x's) and unapproved stockpiles (indicated in red circle).

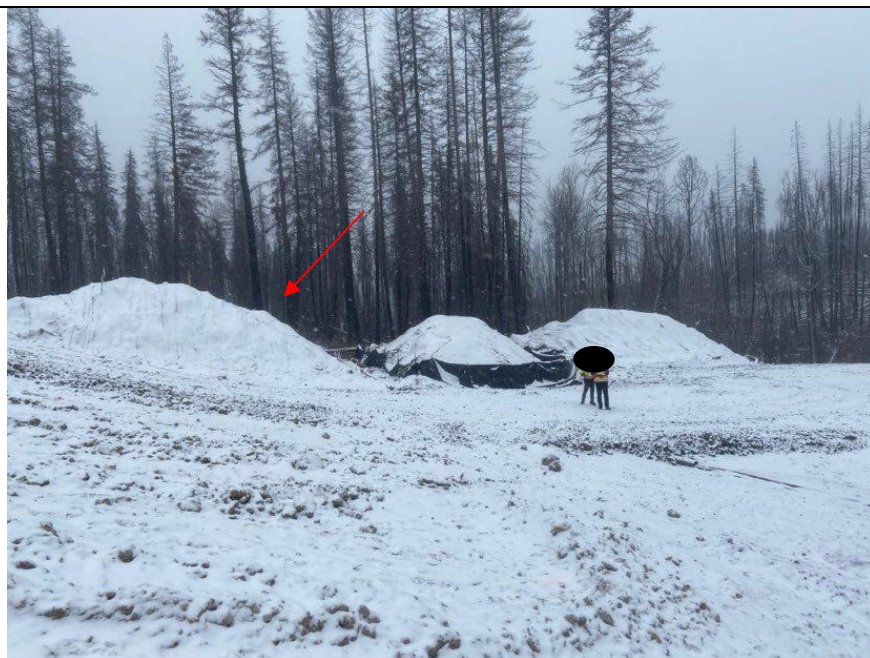
Photo 12: KP381+575 - Unapproved discharge located behind unapproved stockpiles.

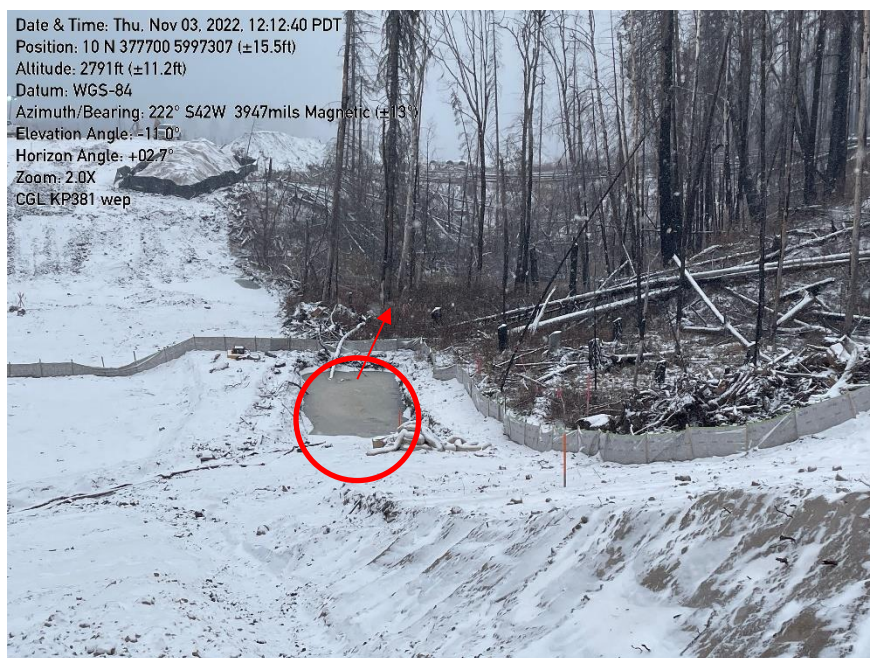
- KP381+580 - Unapproved pumping from sump located on the north-west side of the ROW not specified by the SSECP (Photo 13). Project staff indicate that the sump is dewatered into near by vegetation when required;

Photo 13: KP381+580 - Unapproved pumping from sump.

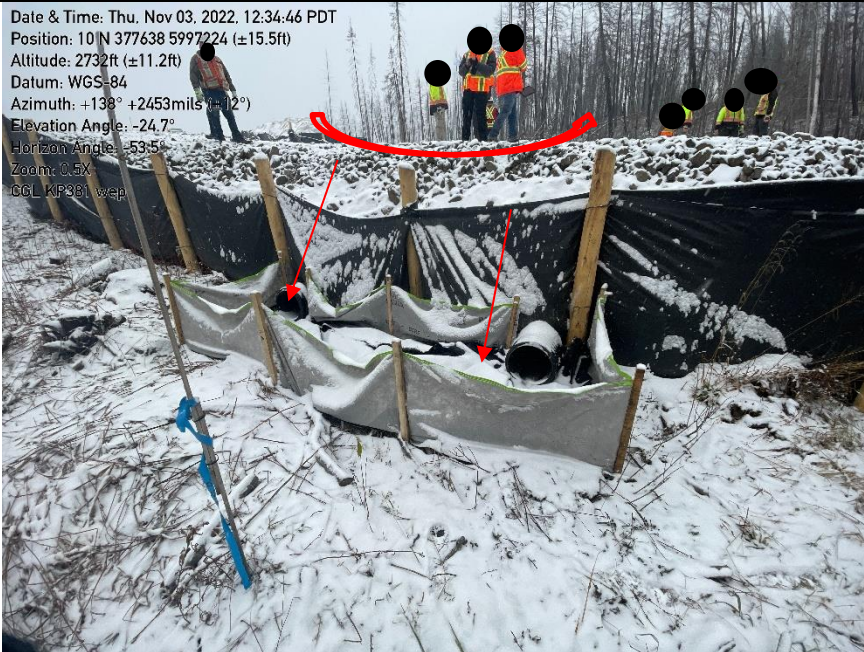
- KP381+600 - Culvert flume outlet crossing non-classified drainage 62C1, lacking straw wattles inside sediment fence as specified by the SSECP (Photo 14);

- KP381+600 - Vehicle crossing over culvert not constructed with respect to crowning of crossing as specified by SSECP (Photo 14); and,
- KP381+625 - Unapproved stockpile located on slope on high chain, north-west side of non-classified drainage 62C1 (Photo 15).

Photo 14: KP381+600 - Culvert flume outlet lacking straw wattles.

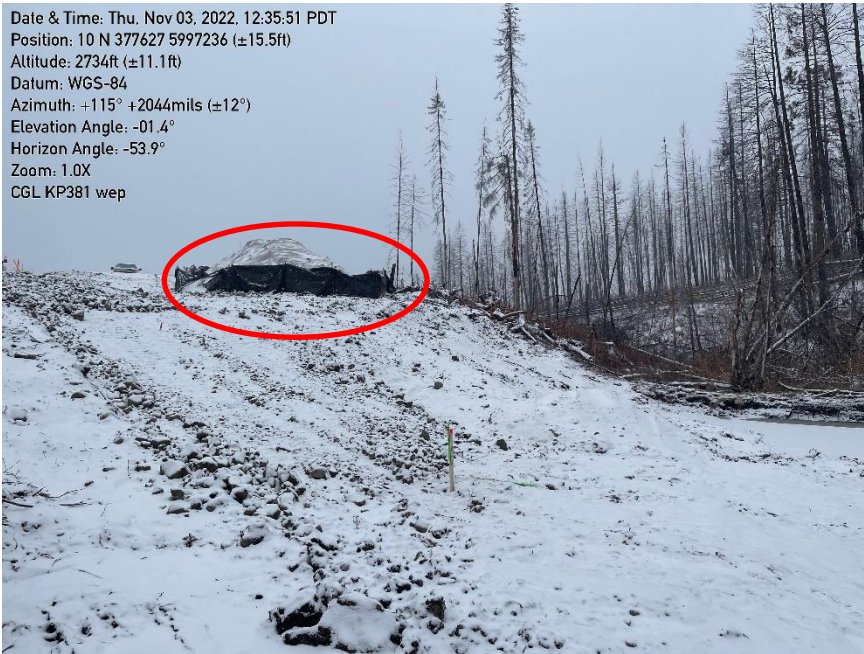
Photo 15: KP381+625 - Unapproved stockpile located on slope
