<b>Project Name</b>	LNG Canada Export Terminal Project (LNGC)	<b>Inspection Status</b>	Final
<b>EA Certificate #</b>	E15-01	<b>Inspection No.</b>	20230012_IR001
<b>Project Status</b>	Certified	<b>Inspection Start</b>	2023-03-21
<b>Sector</b>	Energy	<b>UTM</b>	9U 520432 E 5986829 N
<b>Trigger</b>	Planned Inspection	<b>Inspection Type</b>	Field and Administrative
<b>Project Description</b>	The LNG Canada Export Terminal Project (Project) consists of the construction and operation of a liquefied natural gas (LNG) plant and associated marine terminal facilities.		
<b>Location Description</b>	The Project is located in the District of Kitimat.		
<b>Inspection Summary</b>	<p>On March 21, 2023, Environmental Assessment Office (EAO) Compliance and Enforcement Officer Shayla Frechette inspected the LNG Canada Export Terminal Project (Project) against the requirements of the Environmental Assessment Certificate (EAC) E15-01, Schedule B (Appendix 1).</p> <p>The Project was in Construction at the time of inspection.</p> <p>Officer Frechette inspected the Cedar Valley Lodge, laydowns, stockpile, water storage ponds and discharge locations. The inspection included a debrief of observations with P

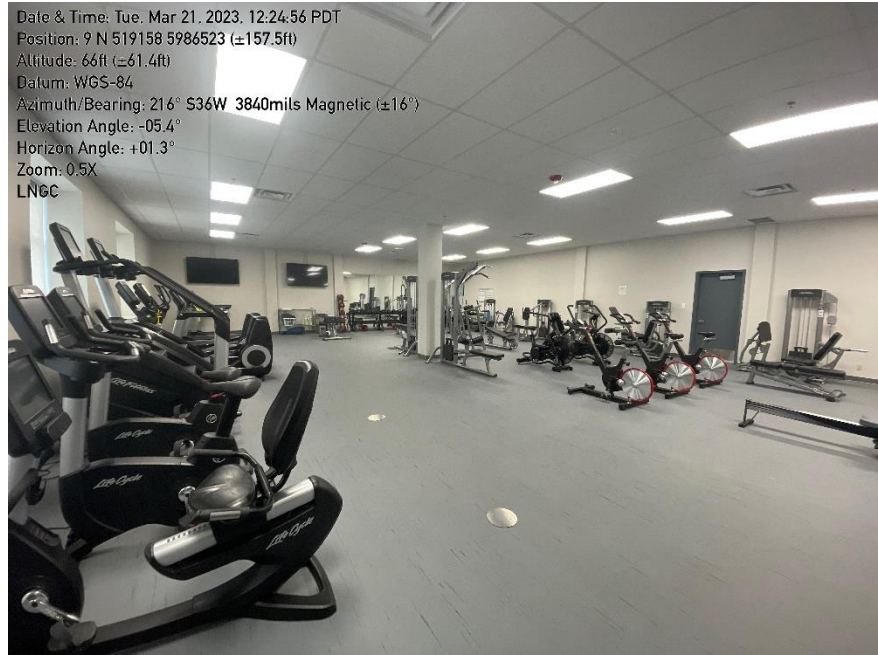
On March 21, 2023, Officer Frechette and Ellis inspected the workforce accommodation center, also known as Cedar Valley Lodge (CVL), for recreational facilities. Officers observed a gymnasium, walking track, four squash courts, two rock climbing walls, two weightlifting gyms, a yoga studio, golf simulator and games rooms. In addition, Officers noted posters advertising classes, activities and movies on hallway walls. LNGC Project representatives explained how CVL has an app, which all guests have access to and includes the facility services.

Photo 1: Ladies only fitness room

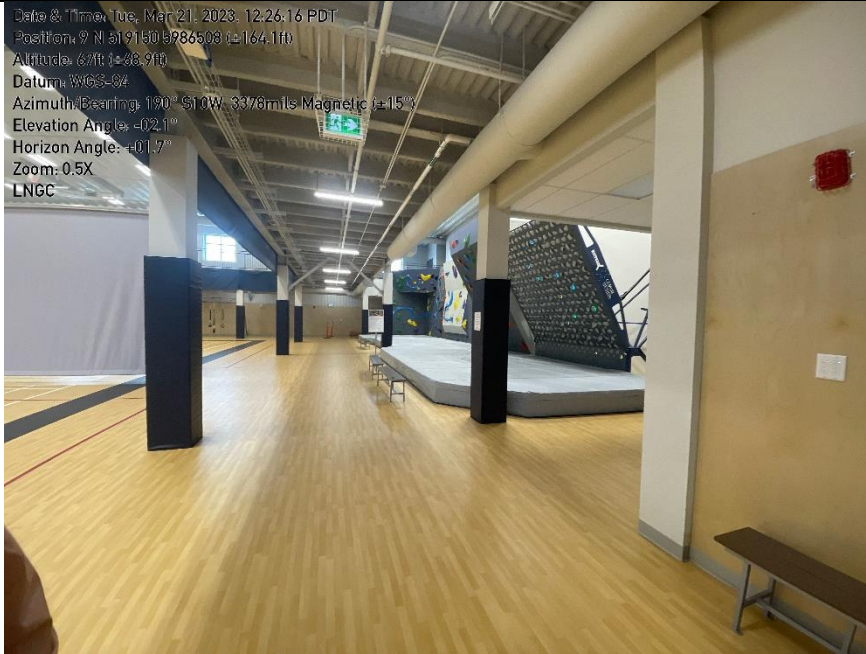
Photo 2: Gymnasium and rock-climbing wall.

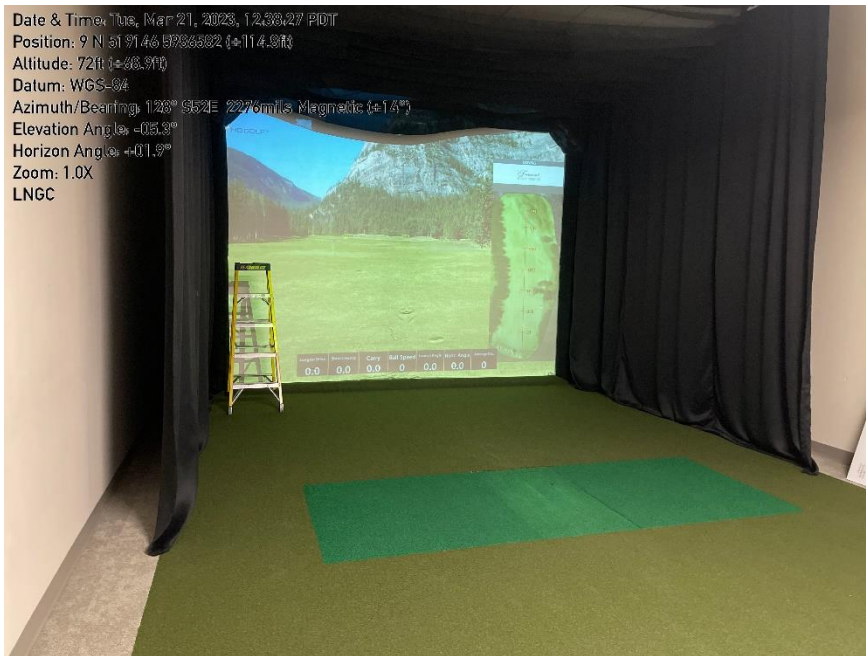
Photo 3: Golf simulator room.

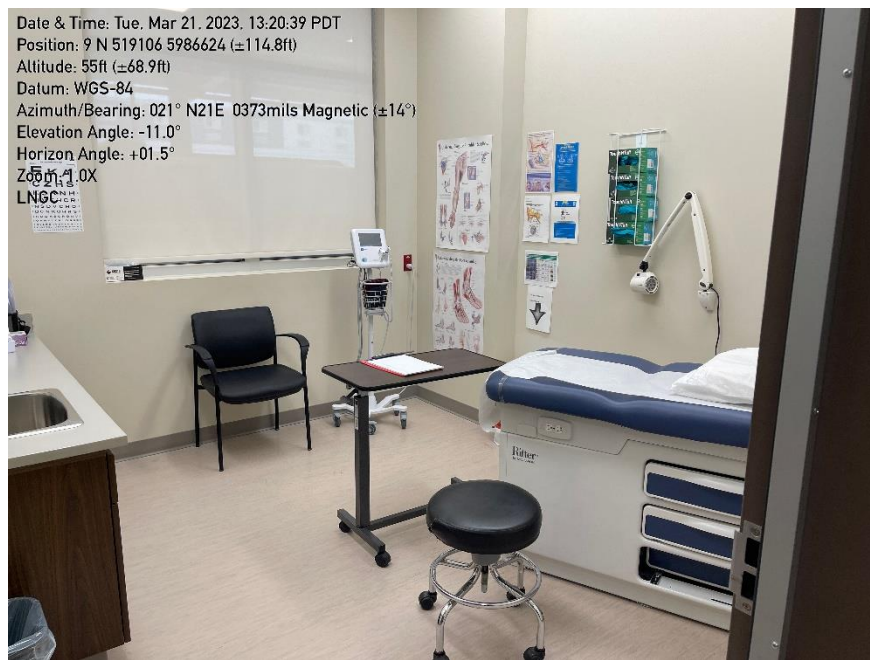
During the inspection Officers inspected the workforce accommodation centre for on-site health services. Officers noted four primary care rooms as well as one trauma centre room. Officers spoke with the onsite nurse practitioner who explained that the clinic can be accessed via drop in or by appointment, which reduces the level of impact to the public health care. For more serious injuries or illnesses, patients are transported to Kitimat or Terrace for treatment. LNGC Project representatives also noted that during the Covid 19 vaccination roll out that the clinic offered vaccines, which also reduced the level of risk and impact of the community.

Photo 4: One of four medical examination rooms located in medical facility.

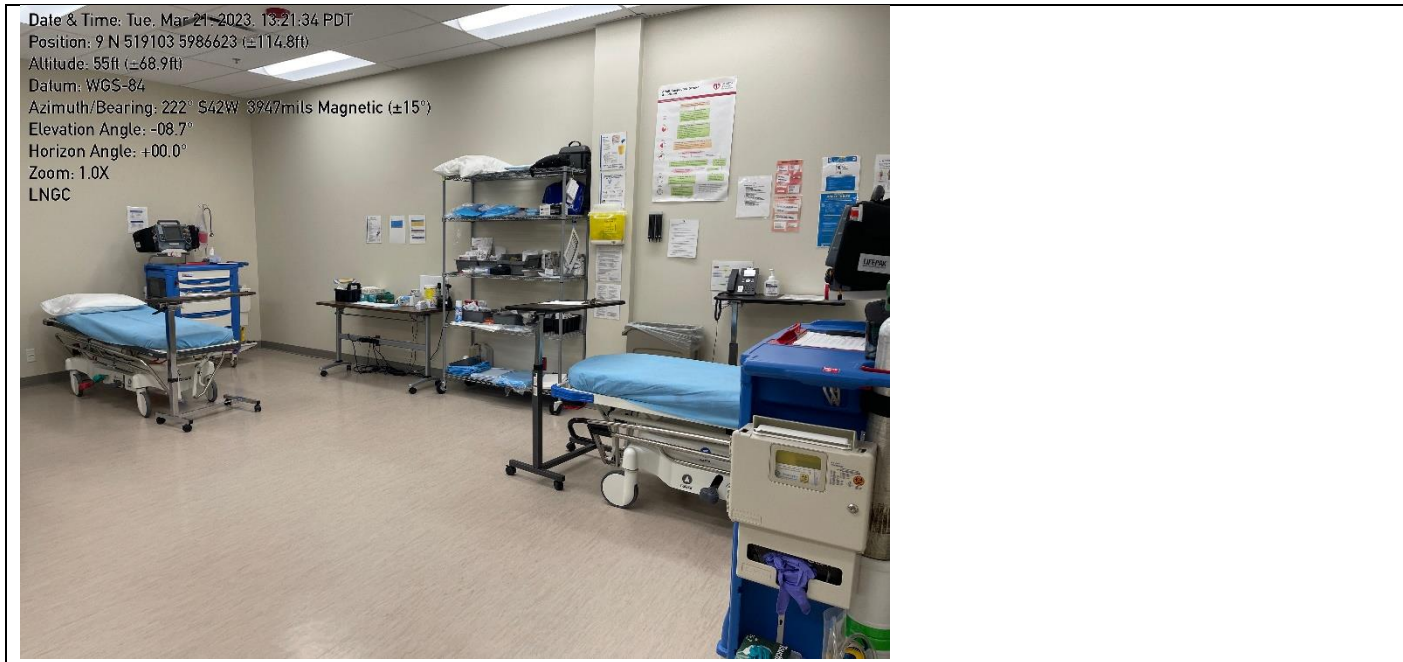
Photo 5: Trauma Room location in medical facility.

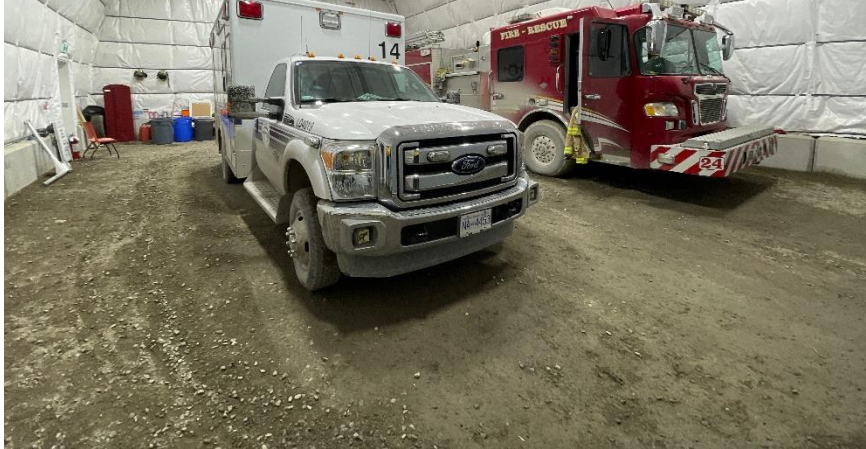
On March 21, 2023, while speaking to the nurse practitioner it was noted that the Project has one ambulance, two mobile treatment centres, two paramedics and one fire captain on site at all times. LNGC Project representatives explained that the mobile treatment centres are used at site-specific locations during construction and the ambulance and fire truck are used in emergencies. The nurse practitioner noted that most injuries and illnesses are managed onsite, but when patients require advance care they are transported via company vehicle or by the BC Ambulance service. Officer Frechette confirmed an ambulance and firetruck to be onsite between the office trailers and CVL.

Photo 6: Medical ambulance and fire truck located in building between office trailers and Cedar Valley Lodge.

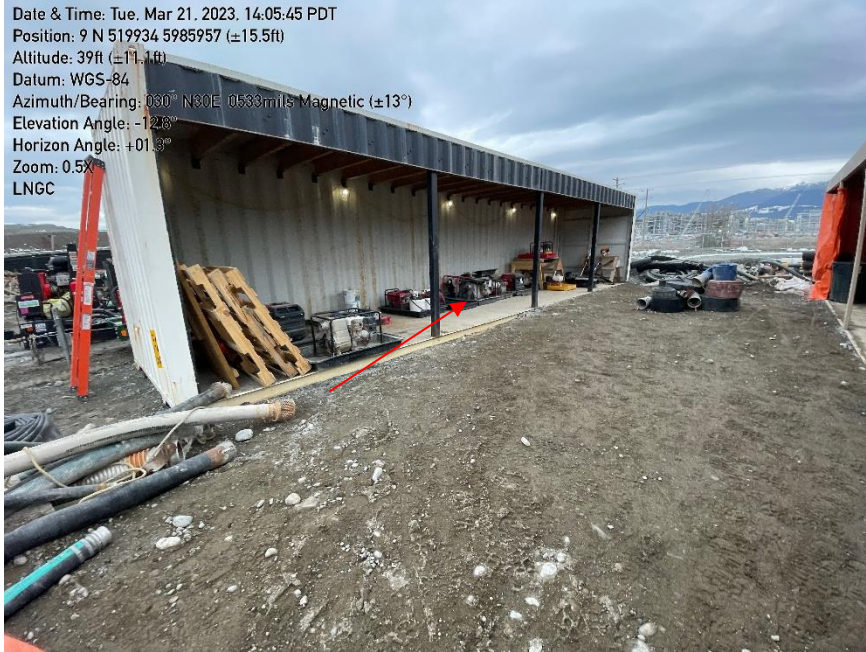
During the inspection Officers inspected laydowns for secondary containment and drip trays. Officers noted all secondary containment trays to be free of rainwater and accumulation of snow. Additionally, long term storage of equipment and hazardous liquids was managed by storing items in secondary containment under covered areas.

Photo 7: Equipment in secondary containment stored under cover.

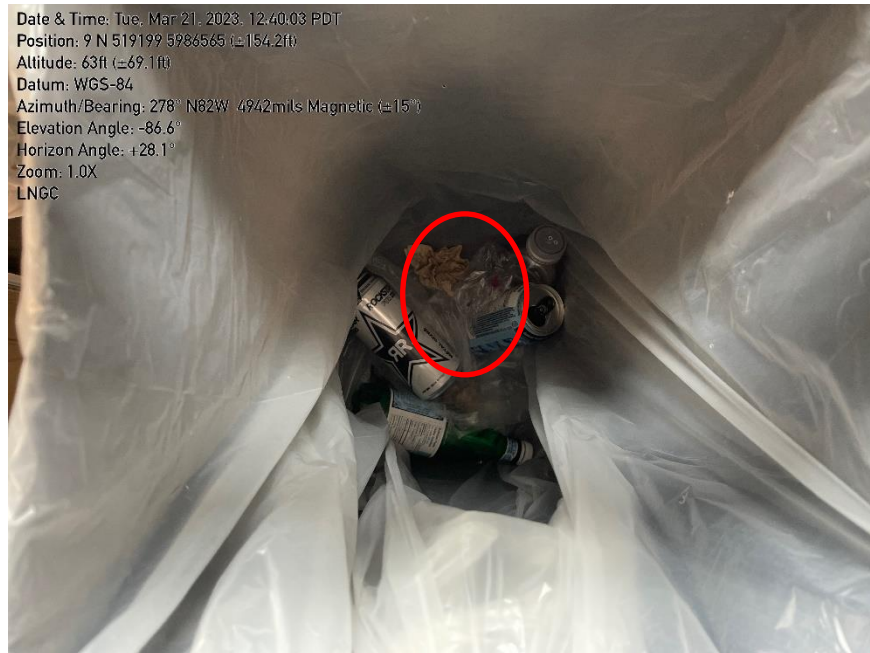
During the inspection, Officer Frechette and Ellis inspected the workforce accommodation for segregation of waste streams. Officer Frechette observed a variety of mixed waste, including recyclable materials in incorrectly labelled bins throughout the hallways, dining areas and common areas. Furthermore, Officers inspected waste storage areas outside the kitchen and outside housekeeping, which included compactors bins, recycling bins and compost bins. Officers noted recyclable materials, such as paper, cardboard, plastics and beverage containers in the general waste compactor bins and a mix of hard plastics and metals in one bin. Project representatives explained that waste bins are removed directly off site and are further sorted at landfill locations.

The observations at the time of the inspection provide evidence of non-compliance with respect to on site waste management.

Photo 8: Marked drink container recycling with bottles, cans, plastic and paper.

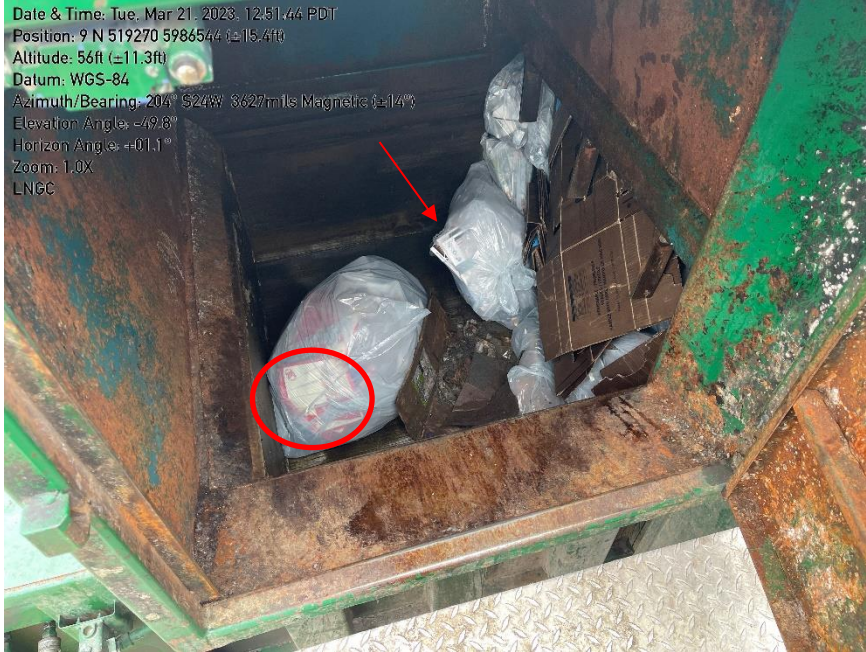
Photo 9: General waste compactor containing paper and cardboard.

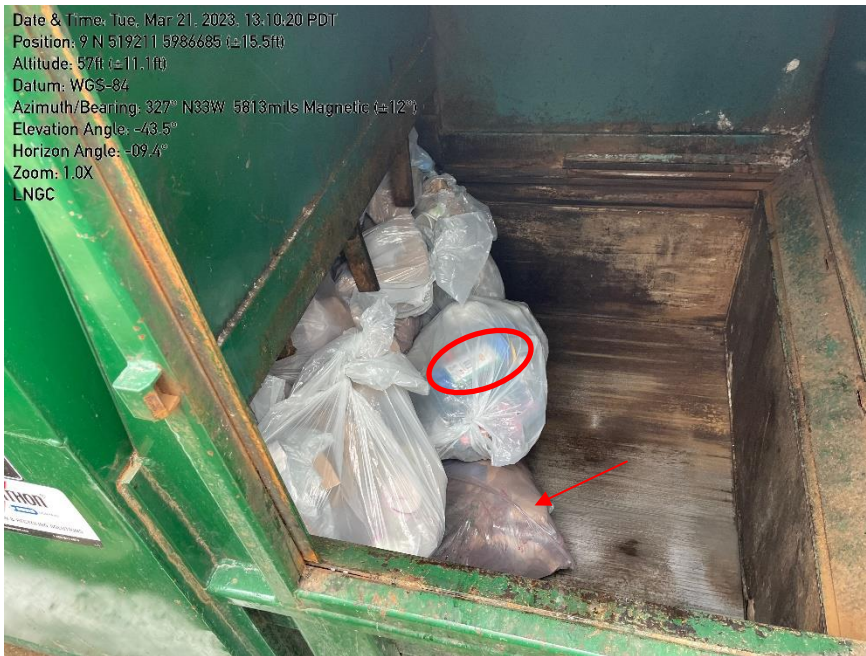
Photo 10: General waste compactor containing hard plastics, paper and drink containers.

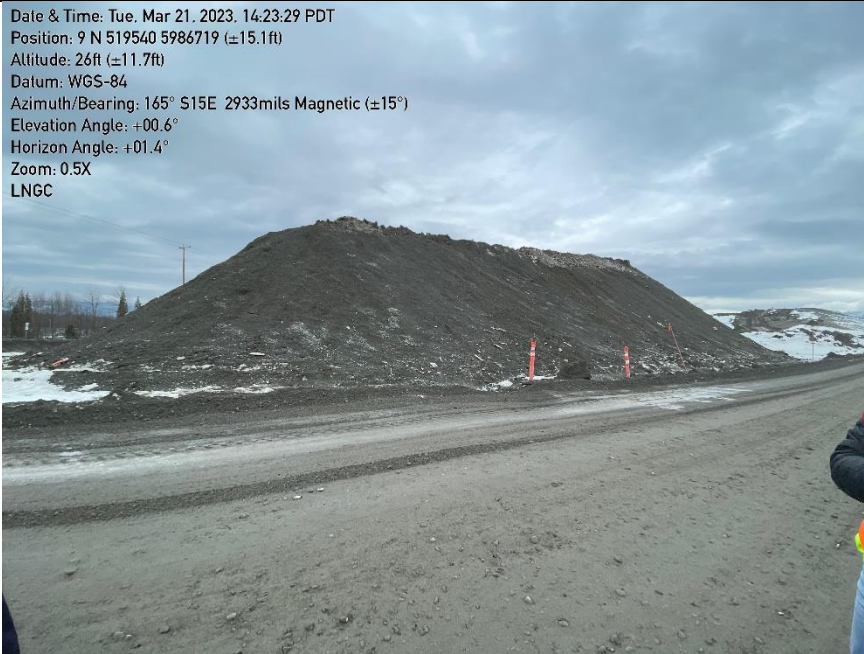
On March 22, 2023, Officer Frechette and Ellis observed two snow dump locations for the Project site. One snow dump was located at the east side of the stockpile and contained a perimeter ditch. LNGC Project representatives explained that during warmer temperatures crews will use equipment and water to melt the snow. The wastewater is pumped via hoses to the main storage water ponds and is treated prior to discharge. Officer Frechette noted an inactive pump and hose located in the perimeter ditch next to the snow pile.

Photo 11: Snow pile located beside stockpile with perimeter ditch.

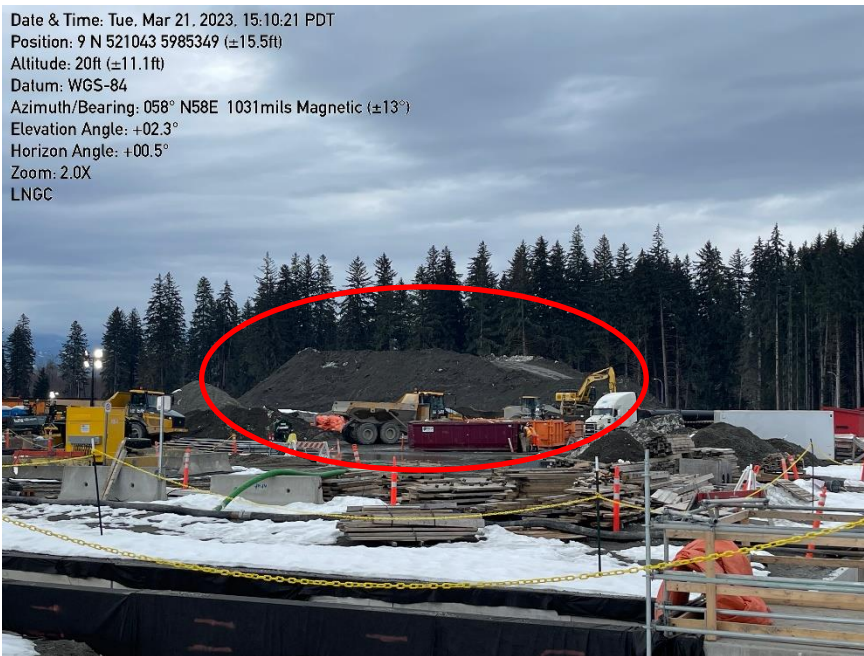
Photo 12: Snow pile located near the facility area.
