COURSIER DAM DECOMMISSIONING PROJECT

ANNUAL REPORT 2008

Report No. E737
September 2009

Report No. E737
September 2009
WPR-2728

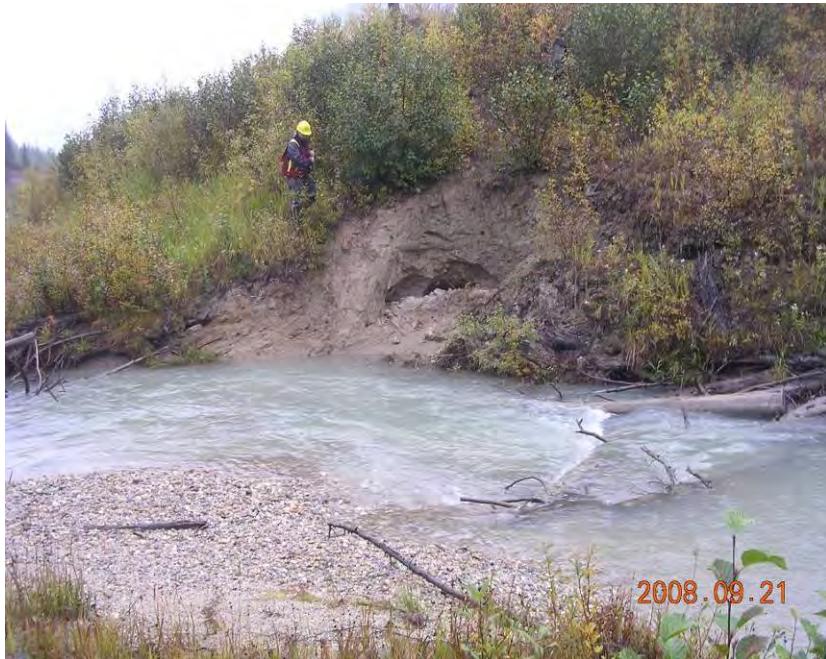
Photograph 2: Active erosion at a previously recorded (in 2006) right bank erosion site in Upper South Cranberry Creek (USCC) Segment 4 just upstream of Segment 3. The photo was taken facing downstream.

The 2003 assessment, compared with 2008 observations, indicates that there are relatively minor morphological changes to date. Therefore, no physical interventions are recommended at this time.

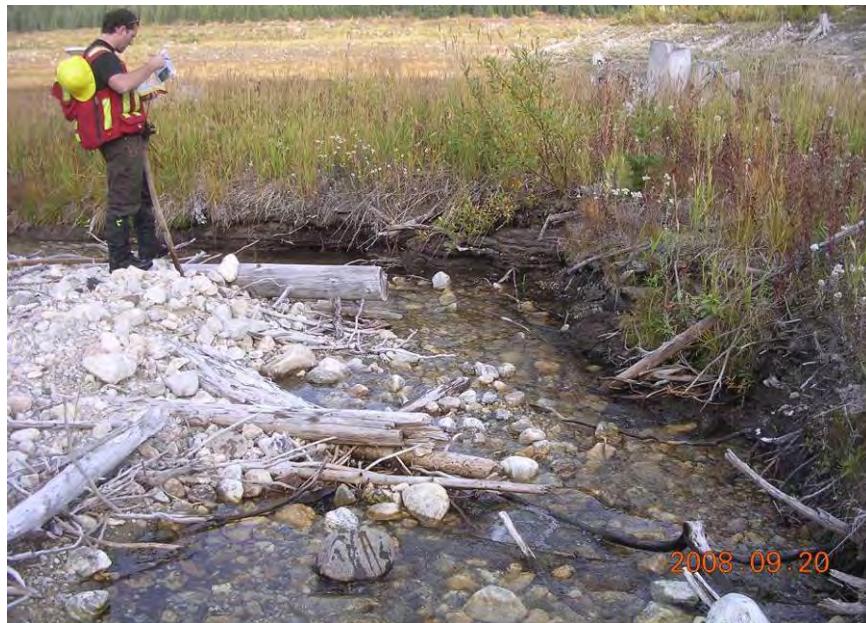
Photograph 3: Westside Creek Segment 2 facing downstream. Notice the natural and recently planted riparian vegetation.

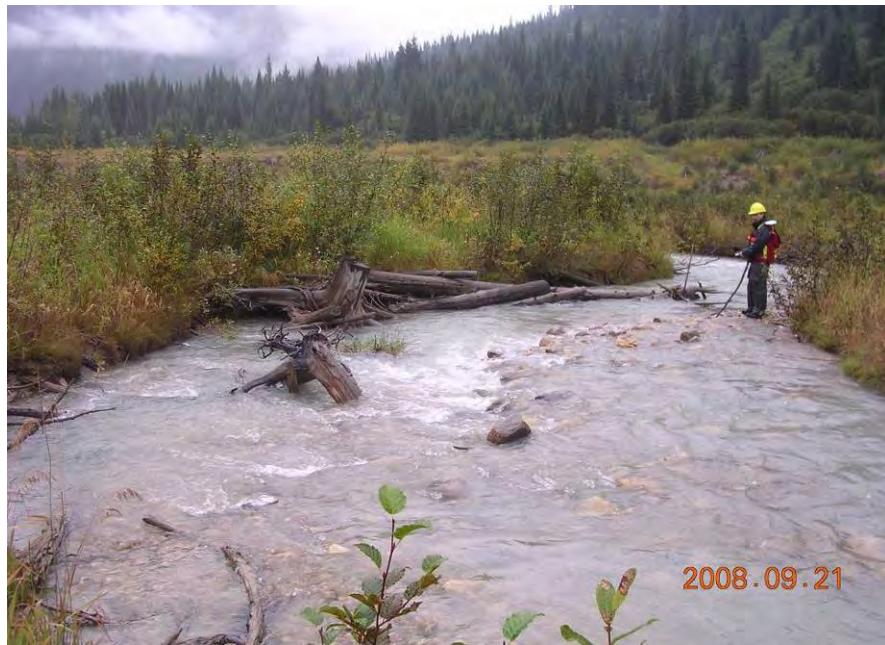
Photograph 4: Upper South Cranberry Creek Segment 5 facing downstream. Notice the height of the deciduous vegetation (e.g. Alder).

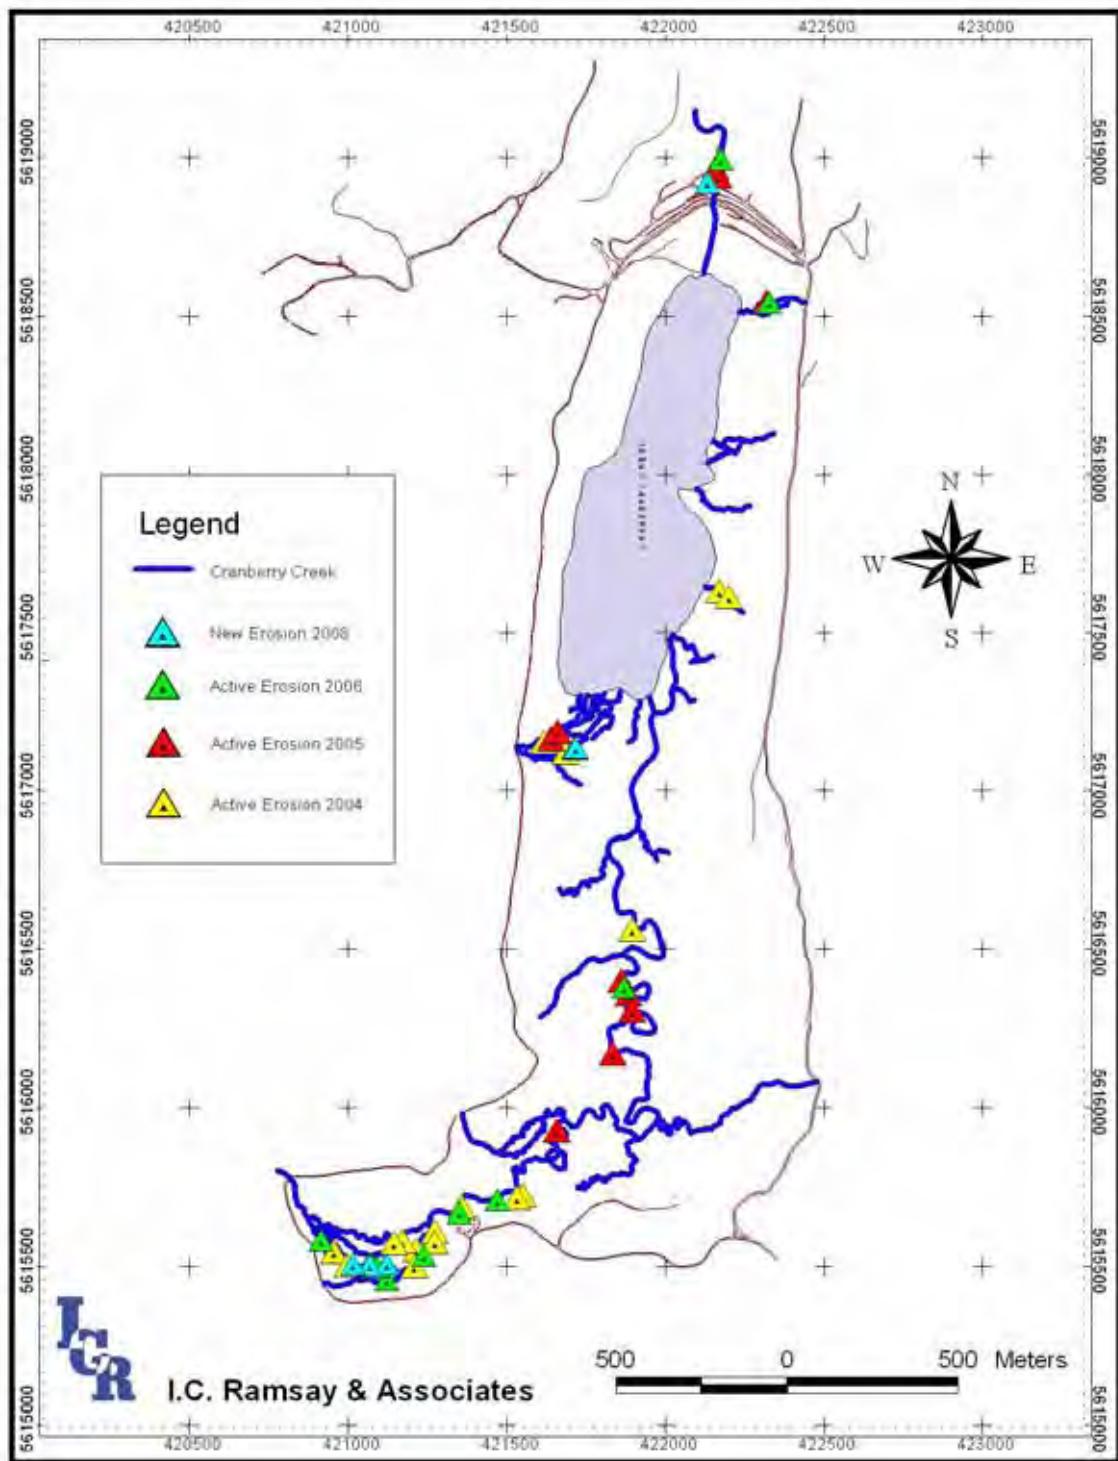
Upper S. Cranberry Creek	1	Linear Fractures and undercutting recorded	2 undercutting events and 3 future potential oxbow sites. Large+small woody debris jams	Sediment deposition where channel splits just upstream of Coursier Lake. General channel degradation – no significant morphological changes.	N/C	No
	2	Minor undercutting	N/C	N/C	Two previously recorded erosion sites still active	No
	3	1 new bank erosion	N/C	2 new erosion events; continued erosion of the 2004 site	Continued erosion of previously recorded sites	No
	4	Seven erosion sites including new down cutting, linear fractures in bank, and bank erosion/undercutting	N/C 2004 erosion sites still evident	2 new downcutting sites; 2 new erosion sites. 2 previously identified erosion sites active	Five previous erosion sites were still active; two new minor bank erosion sites were identified.	No
	5	New undercut bank and previous down cutting	Channelization occurring	Channelization occurring	Channelization occurring	No

Figure 3: Active erosion by year recorded within the South Cranberry Creek (Coursier Lake) watershed.

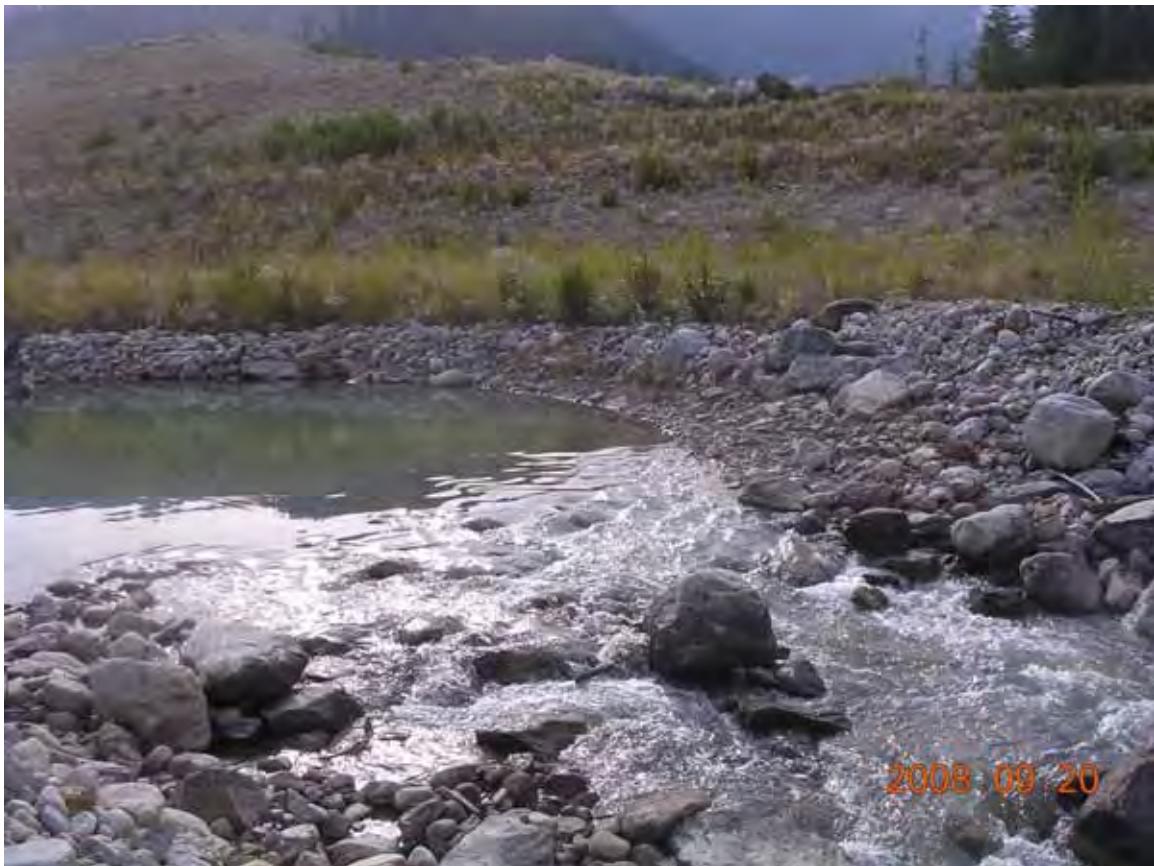
Photo 1: The outlet channel facing minor right bank scour just upstream of riffle #4.

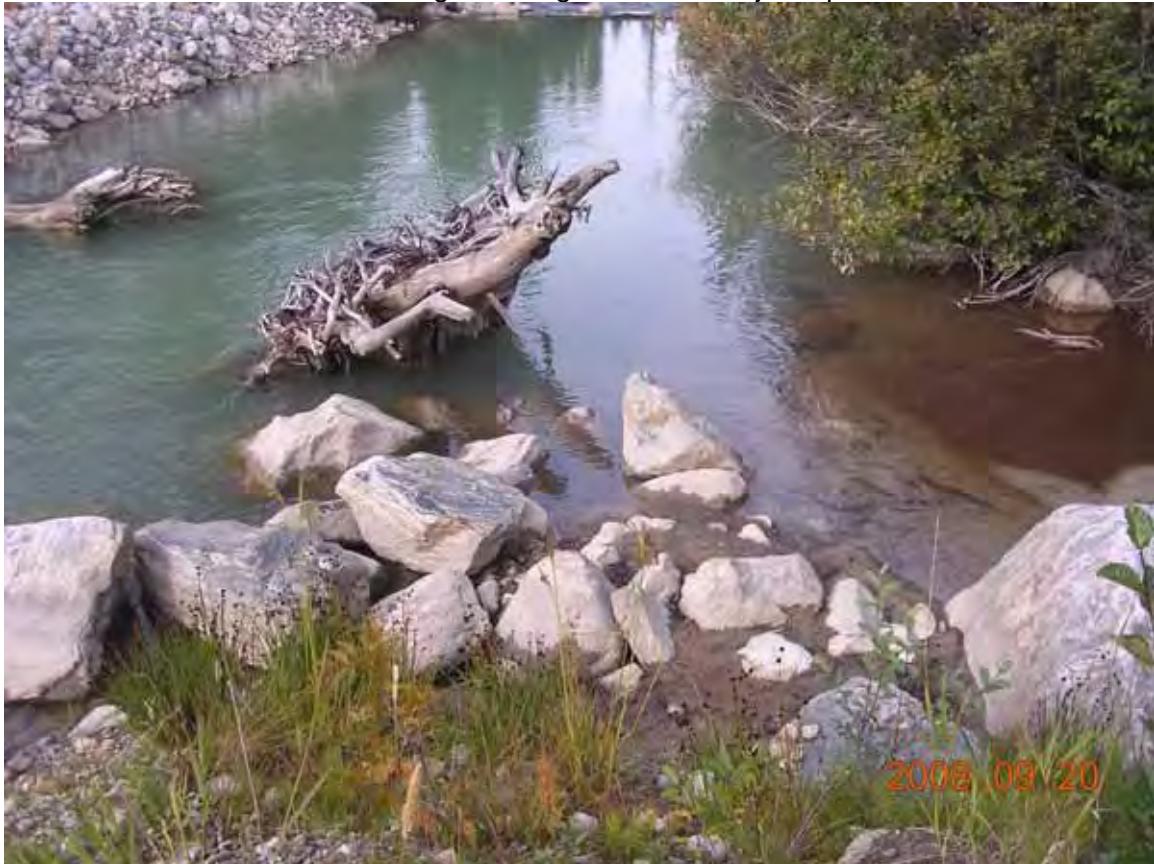
Photo 2: Stabilized right bank scour between riffle #4 and riffle #5.

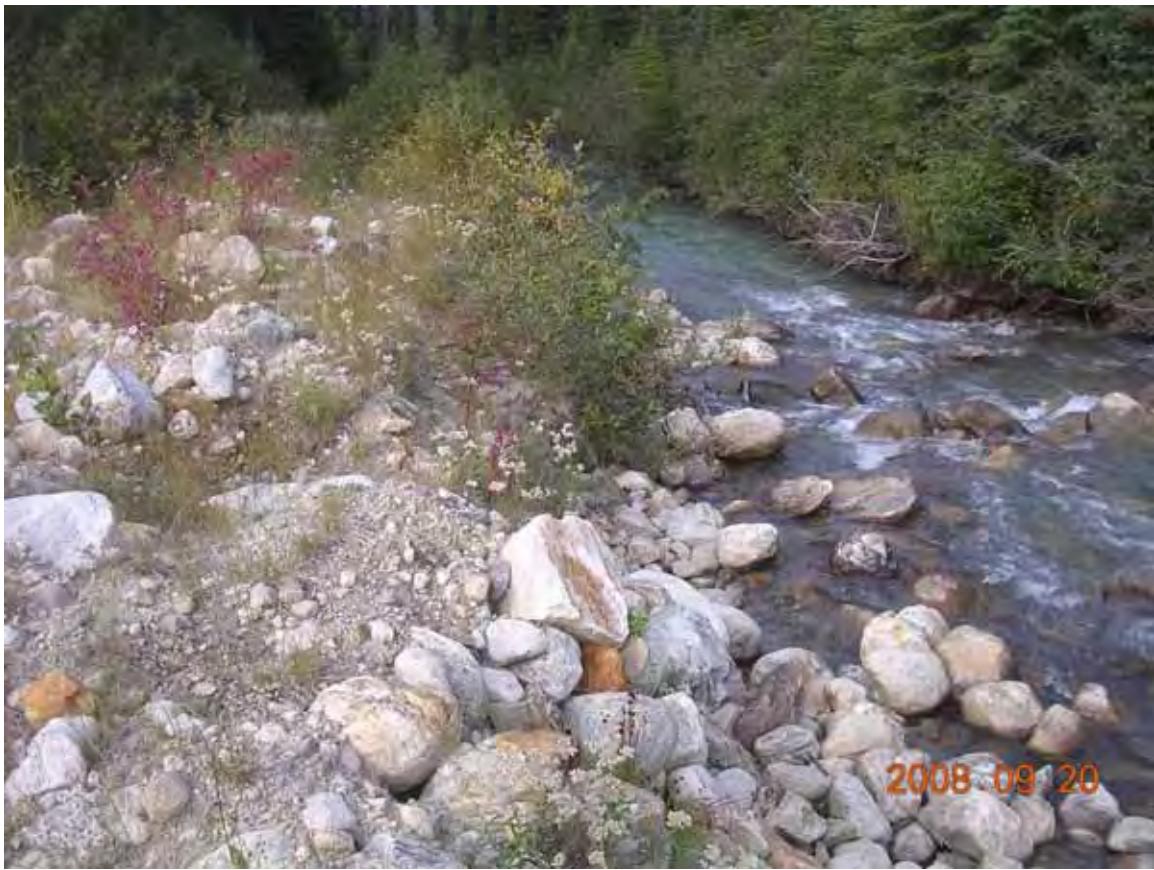
Photo 3: Stabilized left bank scour previously recorded at riffle #5 of the outlet channel.

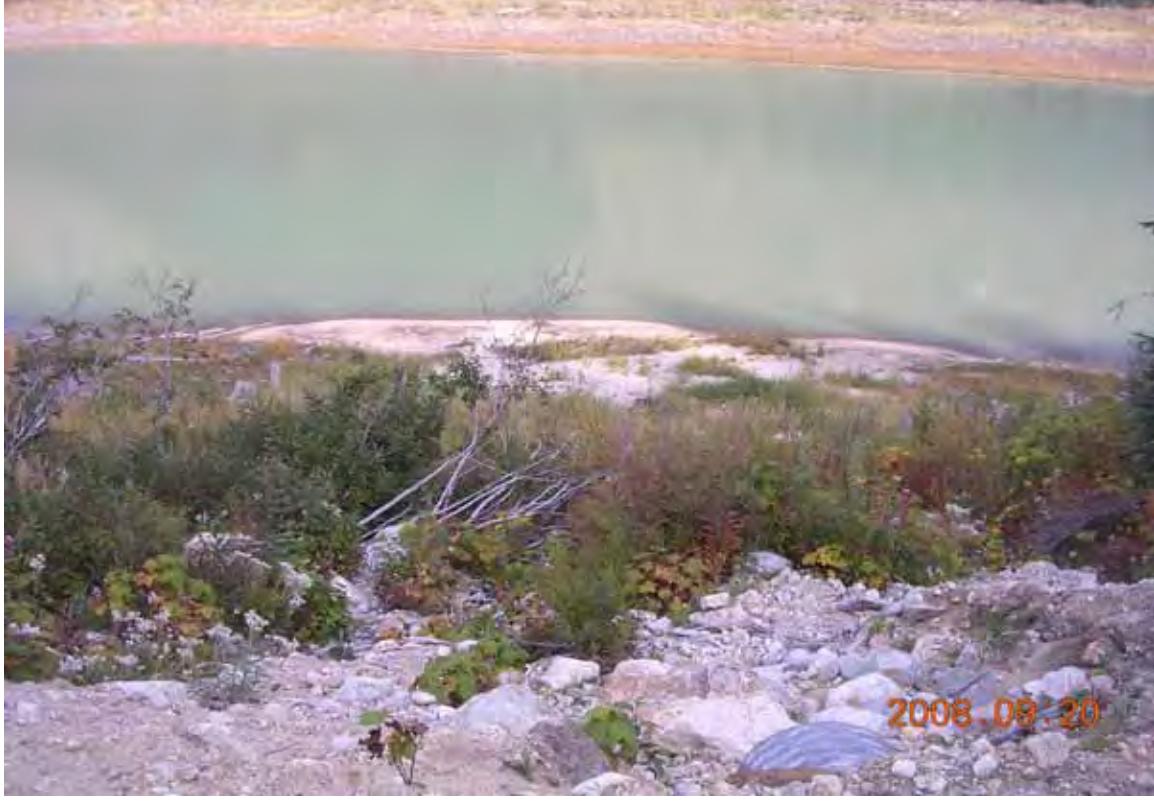
Photo 4: A Slide on the Westside of Coursier Lake recorded in 2006. No significant changes or additional erosion were recorded in 2008.

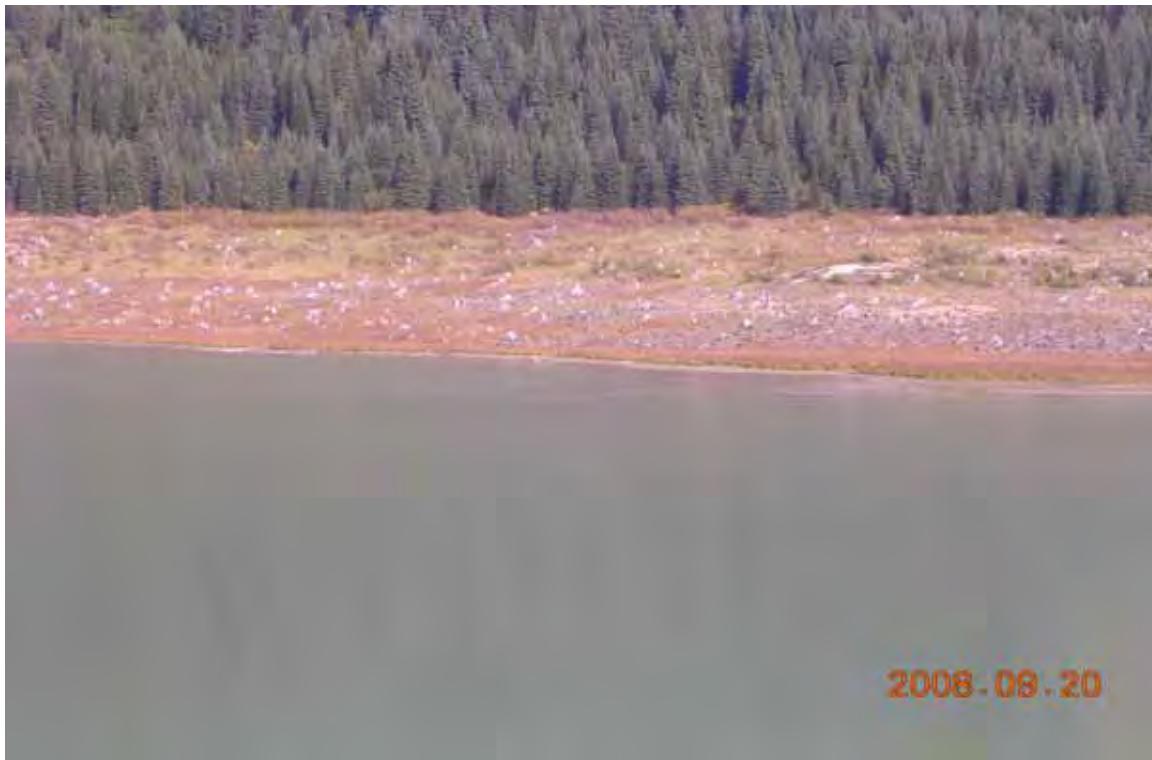
Photograph 5: Coursier Lake sediment deposition at the outlet of Upper South Cranberry Creek. No significant additional deposition was recorded in 2008.

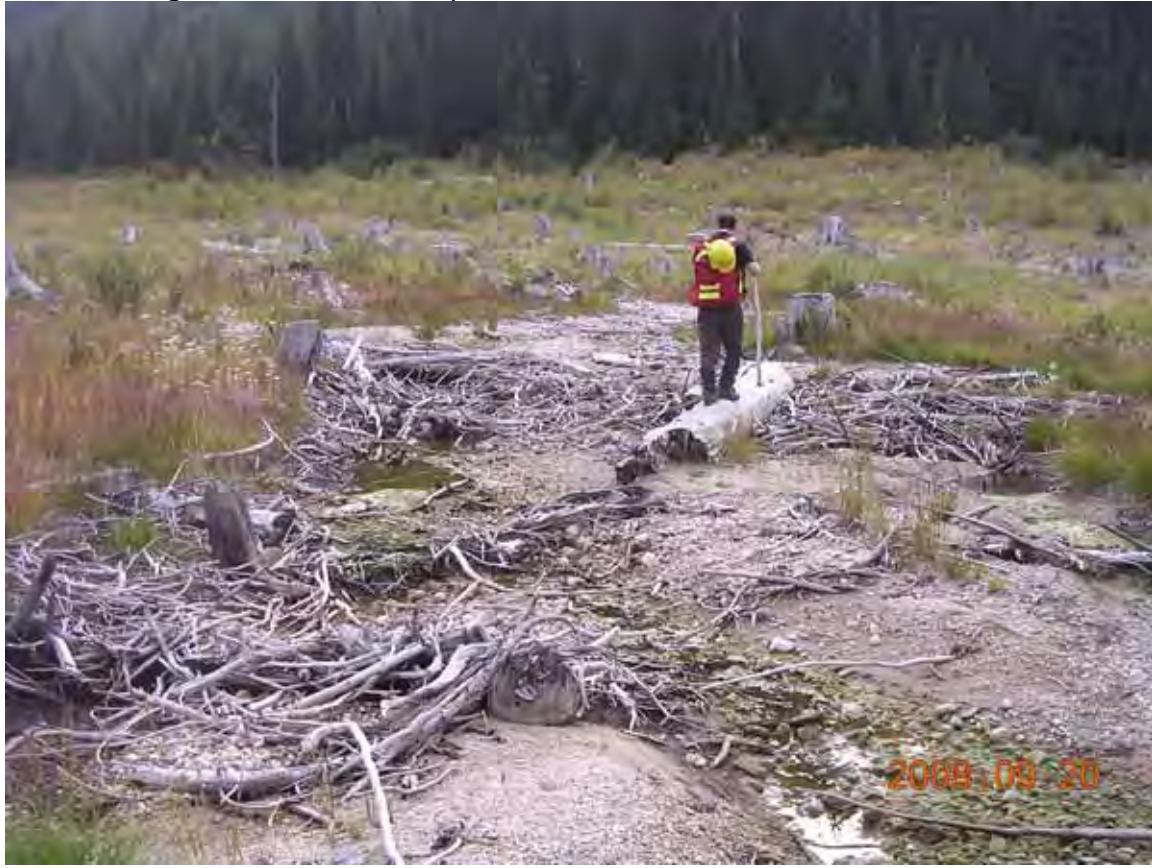
Approximately 20m downstream of the road culvert a debris jam splits the channel into two main channels: a northern channel and a southern channel. The predominant flow was in the southern channel during our assessment, however, at high flow both channels would be flowing. In 2008 we recorded some minor new erosion in the southern channel, continued yet slowed channel degradation in segment 2 and bed load deposition in segment 1. The extent of gravel deposition continues to migrate downstream from segment 2 into segment 1, however, the rate of gravel movement appears to have slowed and the creek is beginning to channelize and abandon some of the secondary stream channels in segment 1 (see the Watershed Channel Assessment Map, Appendix 4) (Photo 6, Appendix 1).

Photo 6: Westside Creek Segment 1 abandoned channel.

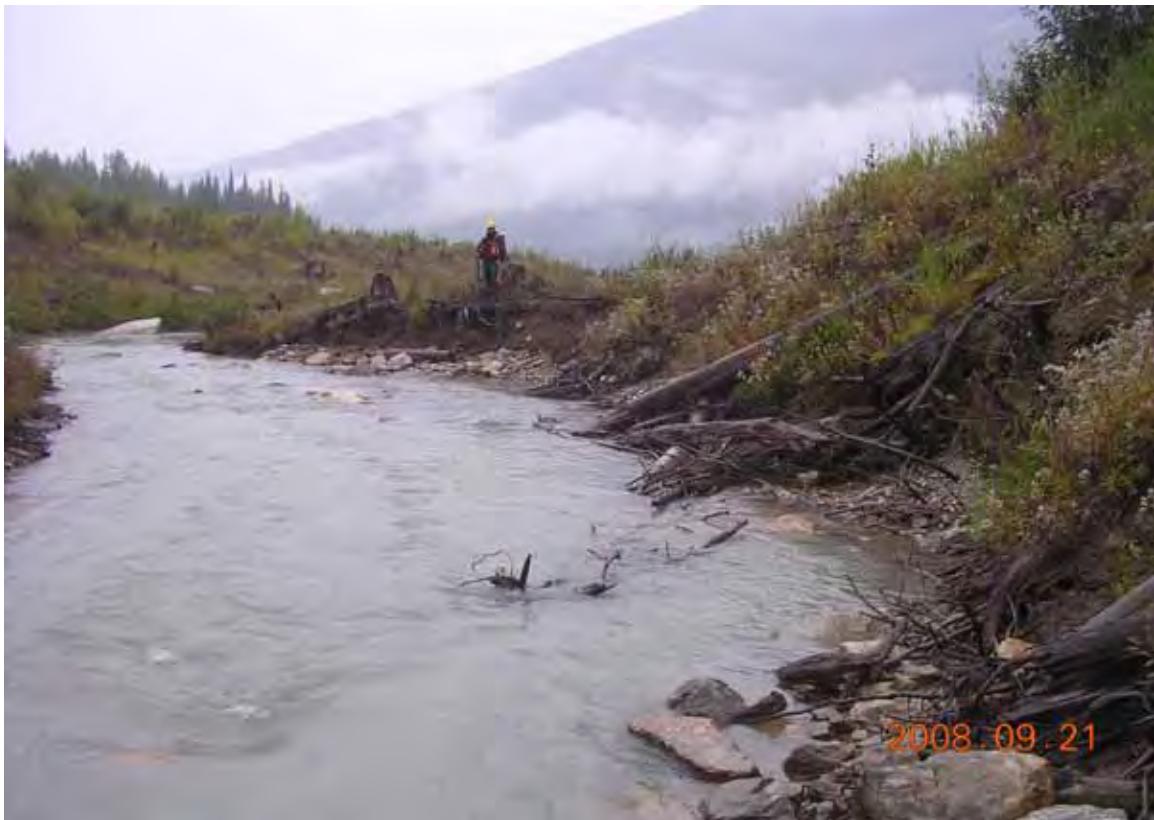
Photo 7: Erosion within Segment 3 identified as a separate upstream site in 2004 and a separate downstream site in 2006. The two sites are now one continuous right bank scour.

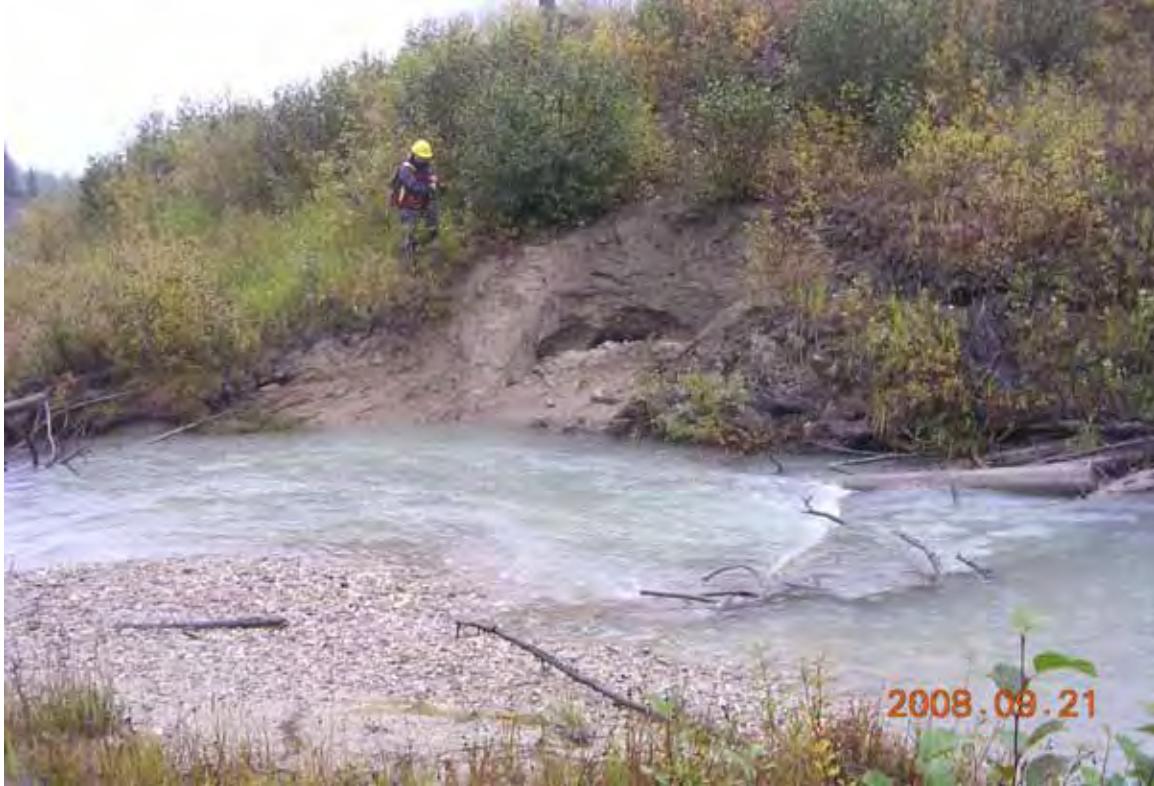
Photo 8: Active erosion at a previously recorded (2006) right bank erosion site in USCC Segment 4 just upstream of Segment 3. The photo was taken facing downstream.

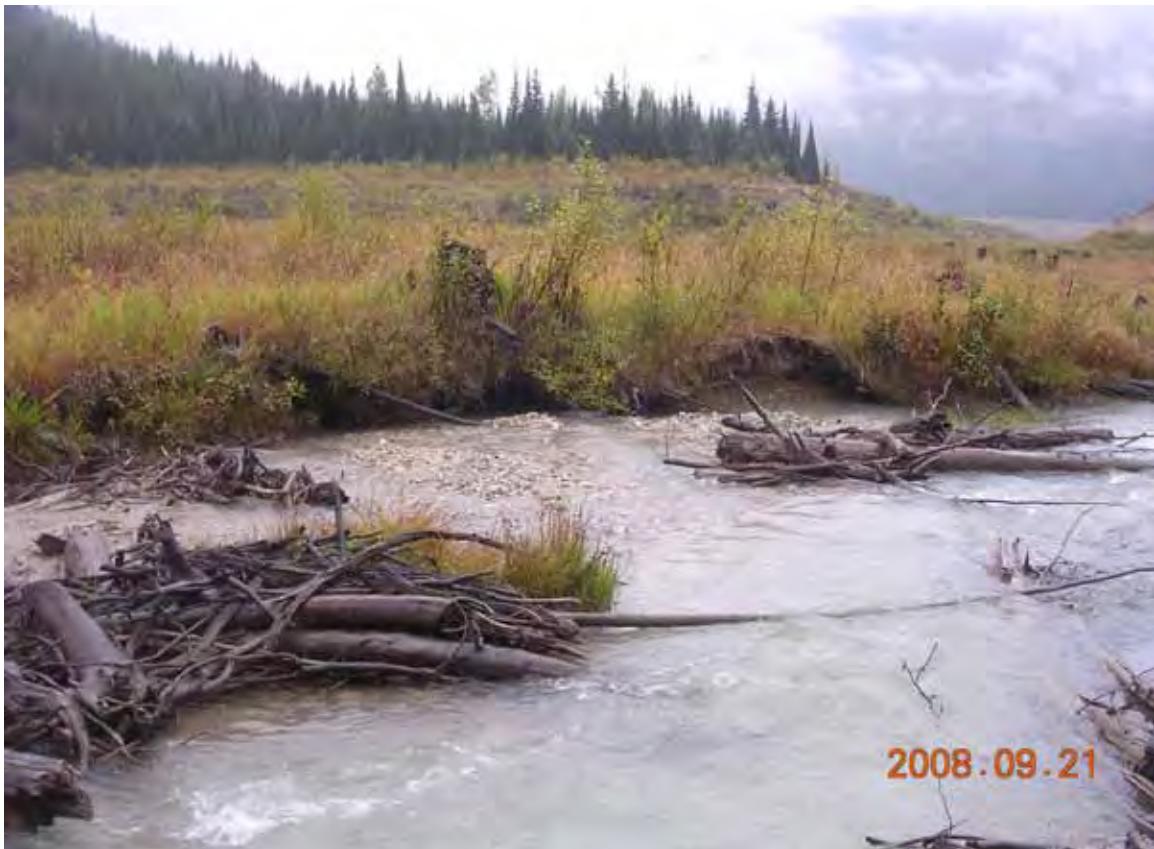
Photo 9: New bank erosion recorded on the left bank of USCC 4.

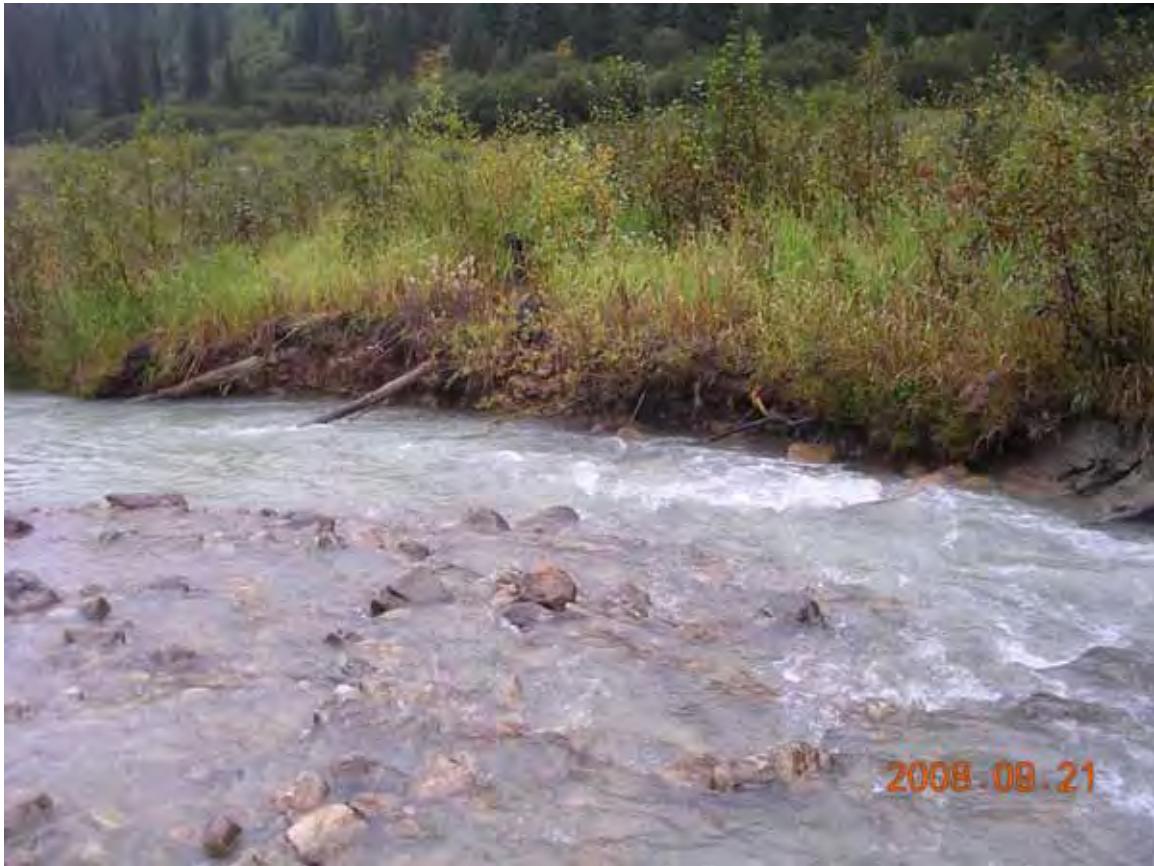
Photo 10: New bank erosion recorded on the right bank of USCC 4.

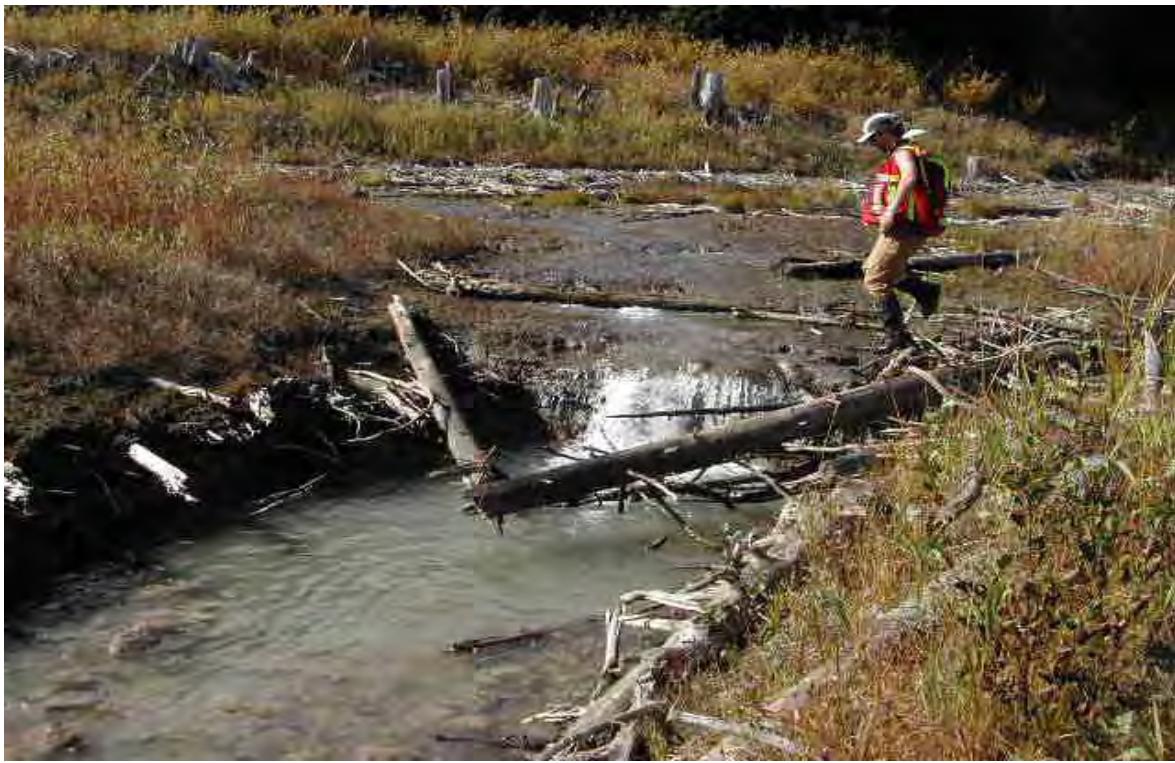
Photo 11: A previously identified downcutting event in USCC Segment 5. This photo was taken facing upstream in 2003.

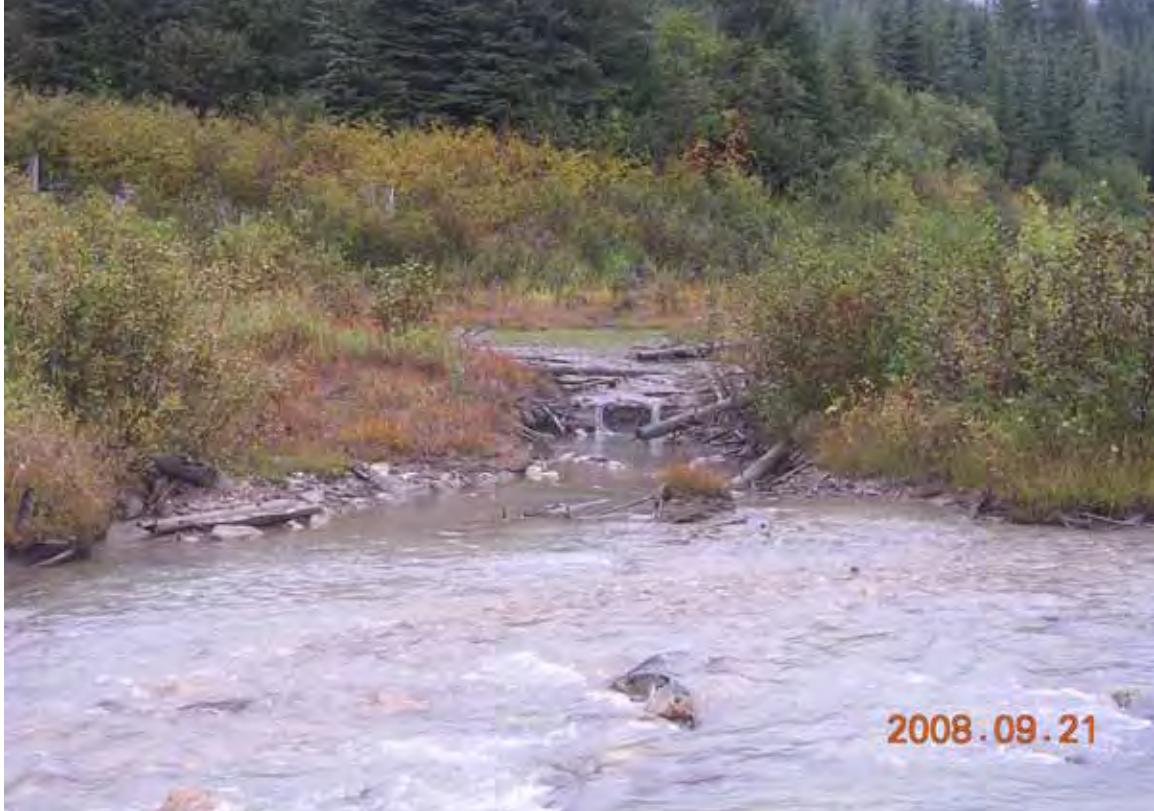
In general Upper South Cranberry Creek Segment 5 continues to degrade and channelize becoming more stable. The segment still contains significant small and large woody debris in secondary channels that are gradually becoming isolated.

Photo 12: The same downcutting event recorded in USCC Segment 5 in 2008. Notice vegetation growth and decrease in flow.

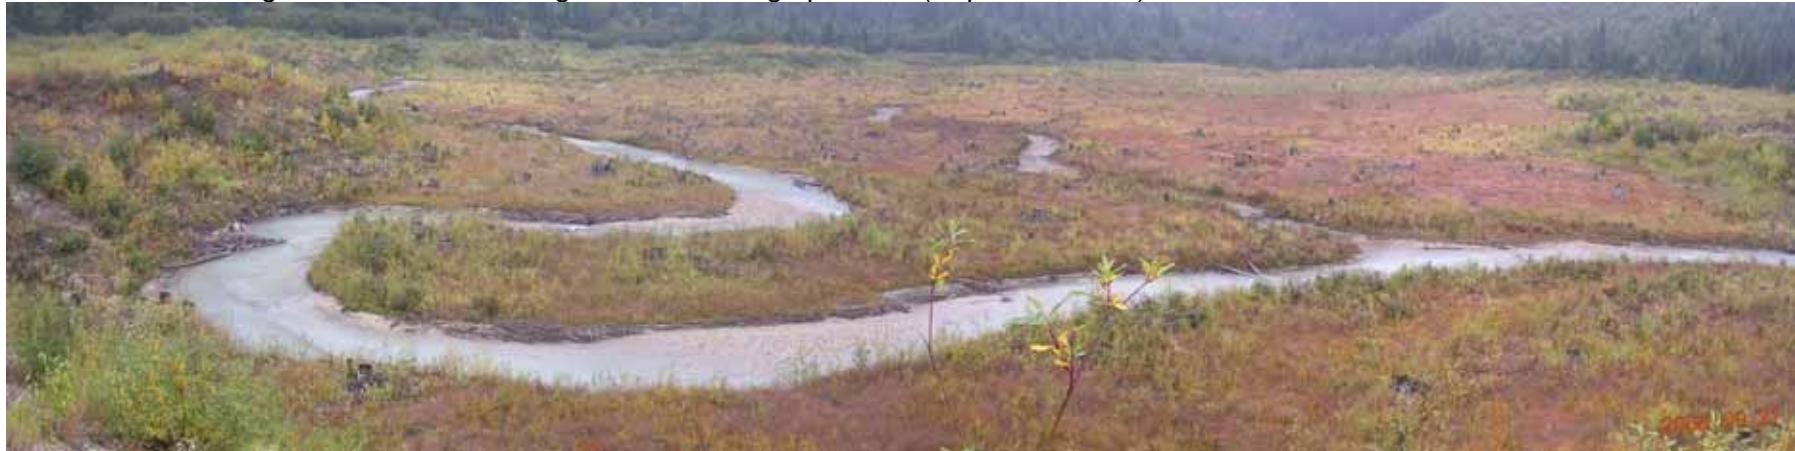
Photo 24: Monitoring Station 3 - USCC Segment 3&4 facing upstream (Sept 21st, 2008). Notice the debris jam forming along the right bank of the main channel (mid point on the bend).
