Project Name	Coastal GasLink Pipeline Project	Inspection Status	Final
EA Certificate #	E14-03	Inspection No.	IR2020-024
Project Status	Certified	Inspection Start	2020-05-13
Sector	Energy	UTM	10U 384635 5991618
Trigger	Planned Inspection	Inspection Type	Field
Project Description	The Coastal GasLink Pipeline Project (Project) is an approximately 650 kilometre (km) long natural gas pipeline connecting facilities in the vicinity of northeast British Columbia (B.C.) to the LNG Canada facility near Kitimat.		
Location Description	The Project is in the vicinity of Groundbirch (40 km west of Dawson Creek) in northeast B.C. and connects to the LNG Canada facility near Kitimat. This inspection focused on construction works within Section 5 of the Project at the Lejac Multi-Use Site (MUS) located near Fraser Lake, B.C.		
Inspection Summary	<p>On May 13, 2020 Environmental Assessment Office Compliance & Enforcement Officers Mike Bartos and Clayton Smith (EAO C&E) inspected the Project against the requirements of EAC #E14-03, Environmental Management Plan Revision 4 (EMP), dated December 14, 2018, EMP Appendix C: Contingency Plans, and EMP Appendix D: Management Plans (refer to Appendices 1 thr

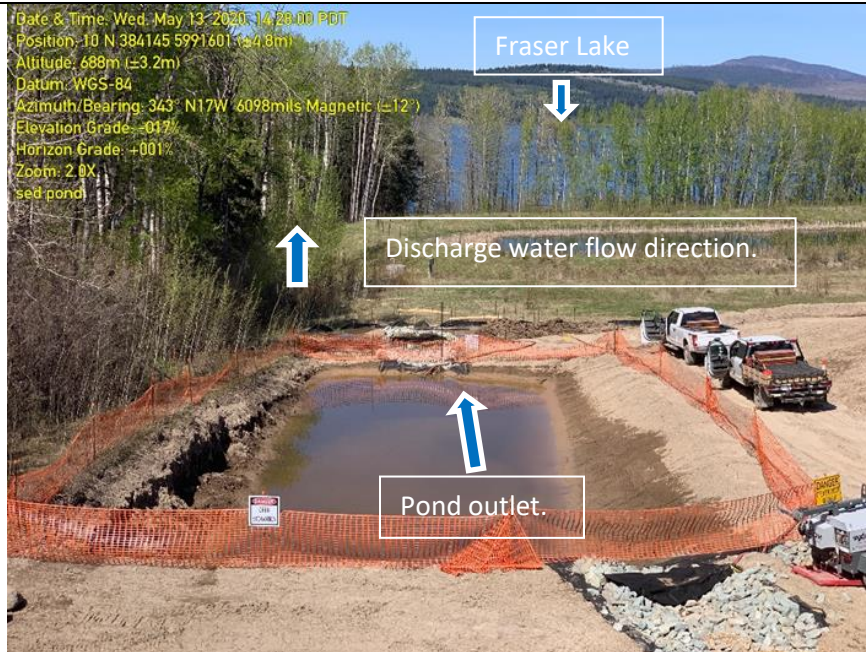
During the inspection of the Lejac MUS EAO C&E observed the pumping of turbid water out of an on-site settling pond, causing discharge water to migrate off the MUS footprint onto Canadian National Railway (CN Rail) property and subsequently into Fraser Lake via a nearby culvert (refer to photos 1 through 5). CGL representatives advised EAO C&E that no water quality testing was conducted prior to or during the dewatering of the settling pond.

EAO C&E observed that the erosion and sediment control measures at the pond's outlet had failed and were both overwhelmed and ineffective in mitigating the turbid water, by allowing the sediment to settle out (refer to photo 2). The settling pond is constructed in a manner to allow for a passive discharge through a partially rock lined outlet channel into a previously existing natural drainage feature and then into the environment when the pond is overwhelmed (refer to photo 1). However, the pond was being actively drawn down and discharged outside of the MUS boundary using pumps outfitted with filter bags at the hose outlet during the EAO C&E inspection; passive pond discharge was not taking place. Additionally, when EAO C&E asked the CGL representatives where the water from the pond ultimately reports to and if the drainage which the water was being pumped into has connectivity to Fraser Lake, the representatives told EAO C&E that the water flows downstream towards the CN Rail tracks and that they did not think the water had connectivity to Fraser Lake. EAO C&E walked the drainage downstream of the MUS approximately 230 metres (m) to where the water meets the CN Rail tracks. From there EAO C&E followed the water flow an additional 380 m (approximate) east to a culvert beneath the train tracks which discharges directly to Fraser Lake (refer to photo 5). EAO C&E did not observe turbid water directly entering Fraser Lake; the water appeared to clear prior to entering the culvert.

Photo 1: Settling pond with draw down taking place; high water mark visible. Note pond failure on left hand corner; introducing additional sediment into the pond.

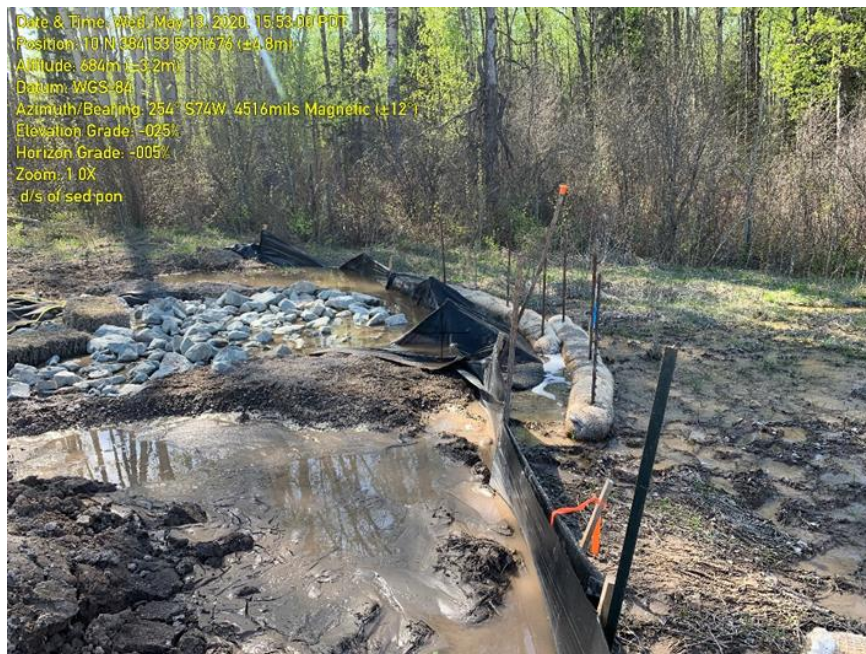
Photo 2: Failing ESC measures at boundary of Lejac MUS; ineffective in mitigating the turbid water discharge through active pumping.

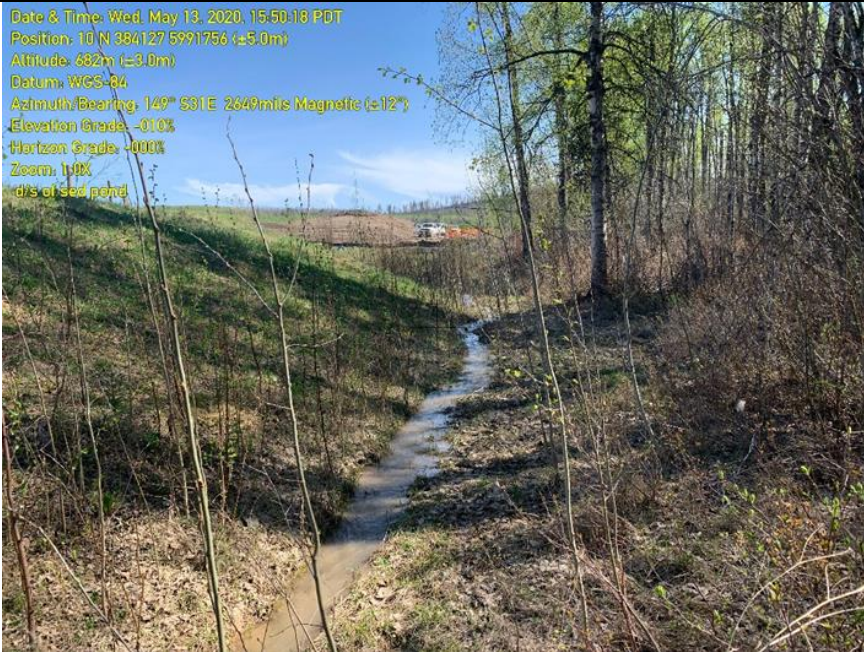
Photo 3: Turbid water flowing from the settling pond along the drainage. Looking upstream towards sediment pond outlet.

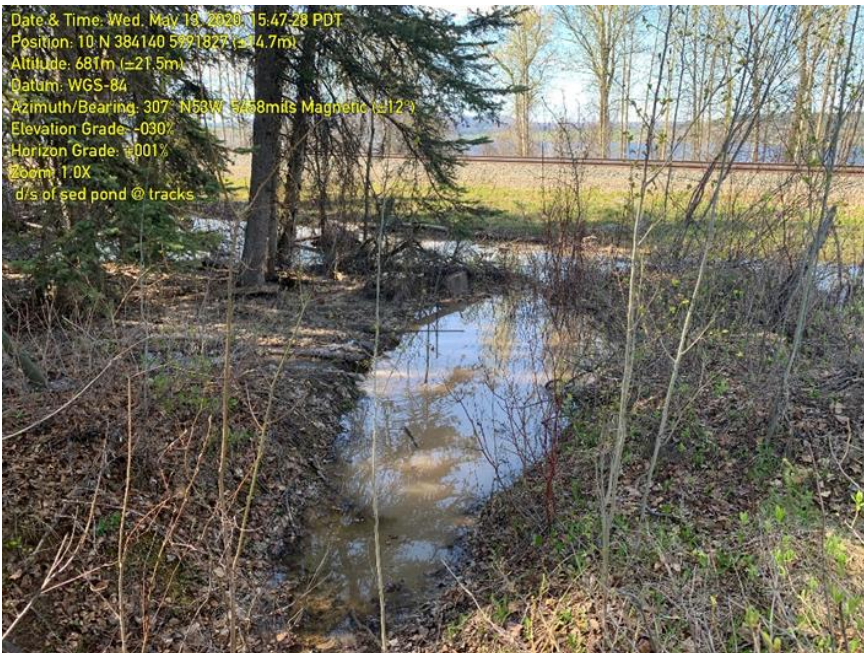
Photo 4: Same location as above photo – looking downstream. Turbid water discharged along CN Rail right of way. Train tracks and Fraser Lake in background.

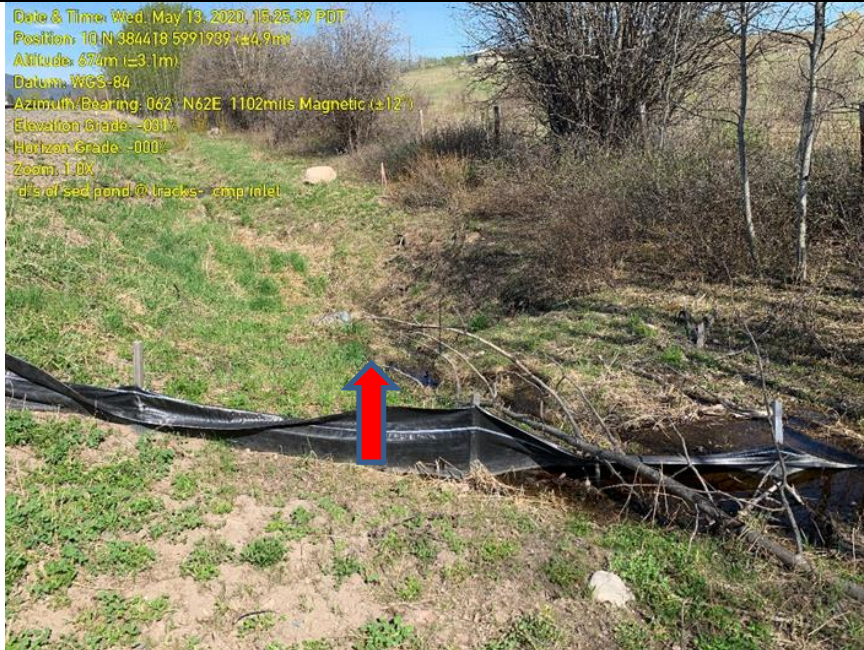
Photo 5: Culvert inlet leading beneath CN Rail tracks and directly into Fraser Lake, located within CN Rail right of way. Non-functioning ESC measures installed across the drainage.

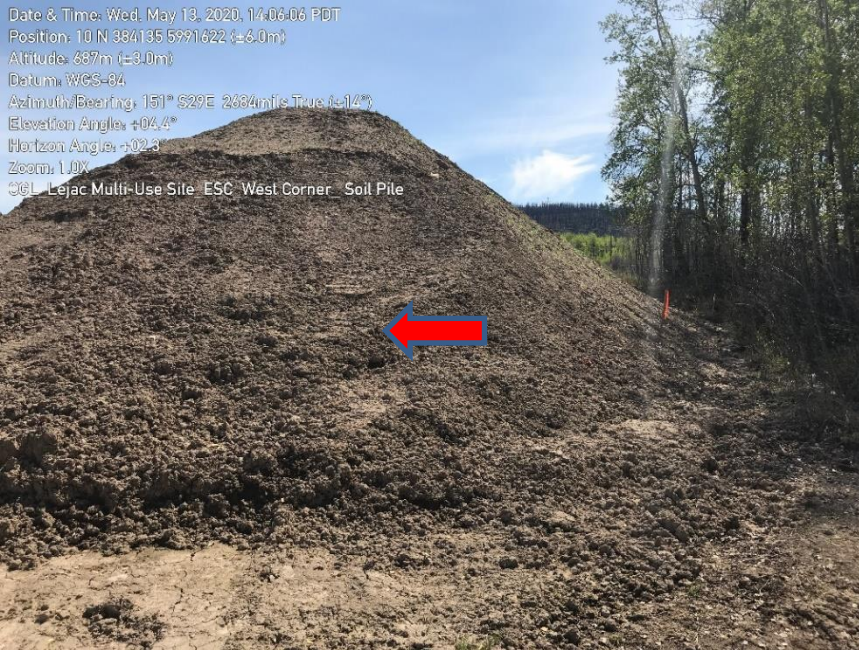
EAO C&E inspected topsoil berms and soil stockpiles located within Lejac MUS. EAO C&E observed erosion and sediment control (ESC) efforts were being partially implemented on some soil stockpiles (refer to Photos 6 through 8). EAO C&E did not observe evidence of hydroseeding, broadcast seeding or application of a tackifier on exposed soils. CGL representatives indicated a cover crop would be used this year to seed soil piles. As per information provided by CGL representatives, ESC measures for the MUS are being constructed in accordance to an engineered drainage plan developed by R.Radloff and Associates Inc (Radloff).

Photo 6: Soil Stockpile with no silt fence installed along base of slope, no evidence of seeding. Sluffing of soils depicted.

Since the time of the inspection, both subsoil stockpiles have been sprayed with hydro-mulch and are vegetated. The topsoil stockpile to the south is in construction phase as the material from this stockpile has been mostly relocated to the north side of the site to a new (since time of inspection) stockpile. The remainder of topsoil left in the south will be utilized on the slope of the pad once the pad construction is complete.

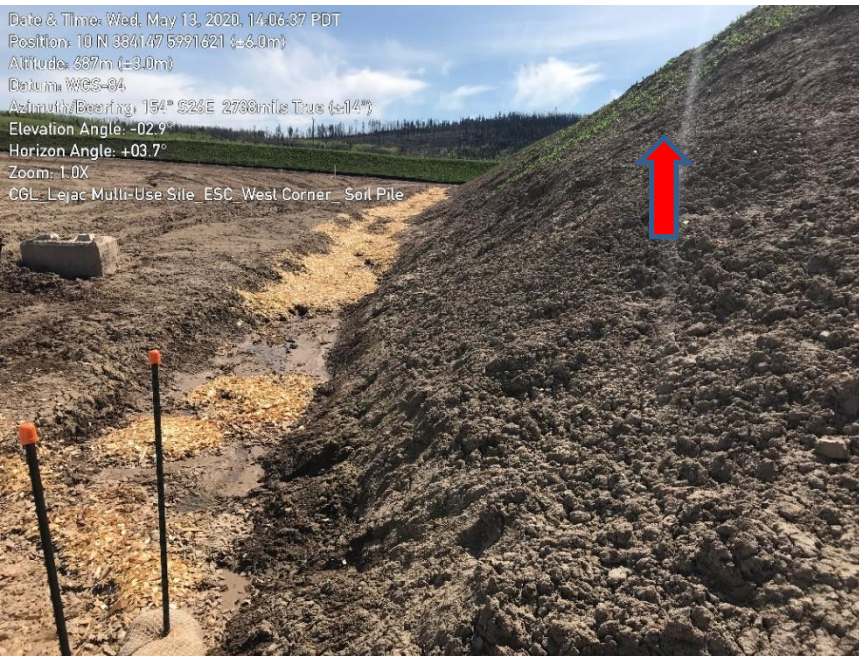
Photo 7: Soil pile with no silt fence installed along base of slope, no evidence of seeding. Vegetative growth depicted in background is weed growth associated with the seed bank within the soil pile.

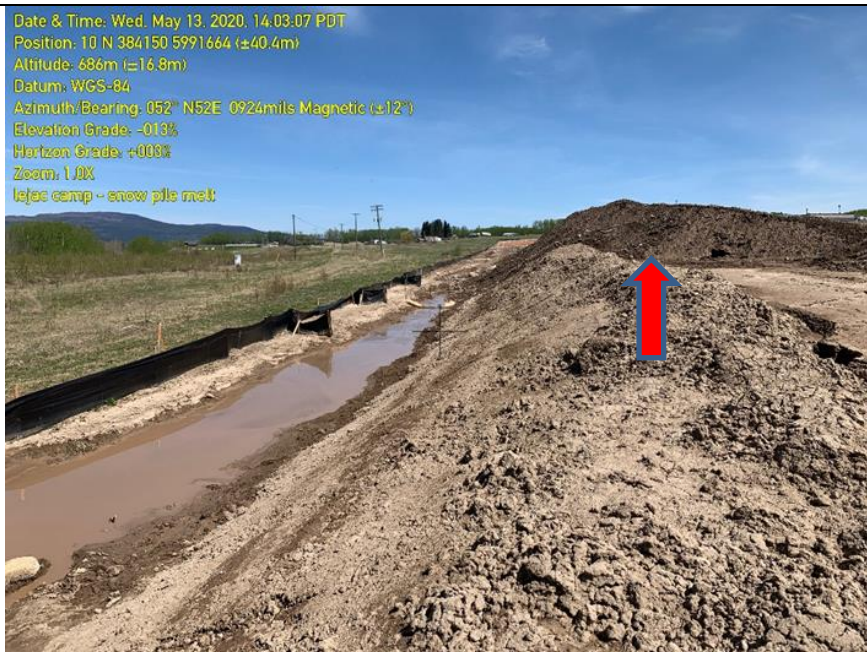
Photo 8: Snow stockpile depicted in background, ESC measures of wattle and silt fencing.

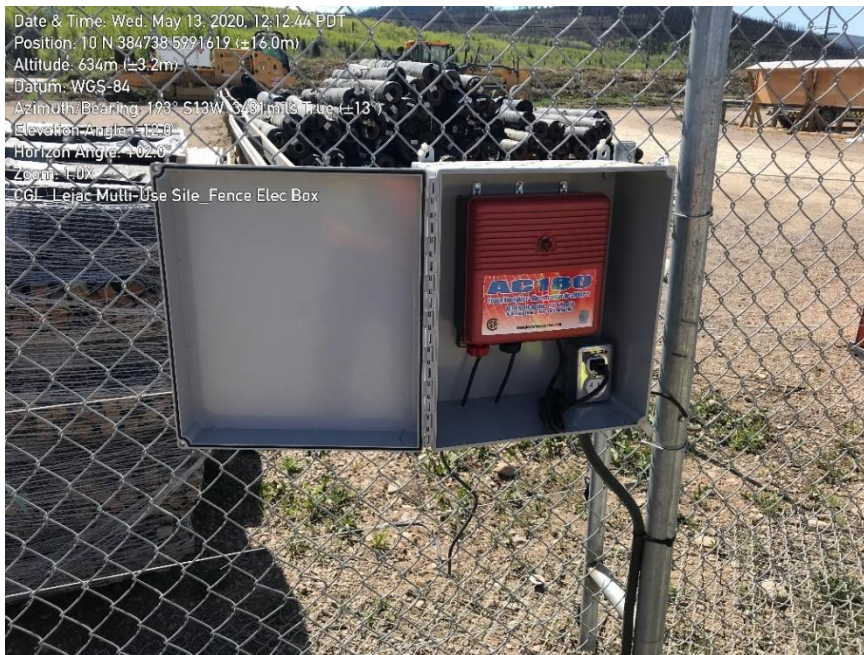
EAO C&E inspected the electric fence enclosing the entire MUS. (refer to Photos 9 through 12). CGL representatives advised that the electric fence was activated on May 7, 2020. For the purpose of the inspection, EAO C&E requested CGL representatives to confirm effective operation of electric fence. CGL representatives were unable to test the voltage of the electric fence as they did not have access to an electrician or handheld electric fence tester.

Photo 9: Electric fence energizer box – power indicator light not on.

- Photographs taken October 21, 2020 confirming electric fence functionality using a handheld voltage meter in the North, South, East and West portions of the fence line. The photographs show voltage readings ranging from 8.5 KV to 9.1 KV;
- Photographs confirming that materials have been added under the main gates to reduce the spacing identified beneath and around main access gates;
- Photograph showing that the gap under the gate in the NE corner has been remedied; and,
- Photographs showing that access gates have bungee cords attached to assist with gates closing and not remaining open unintentionally.

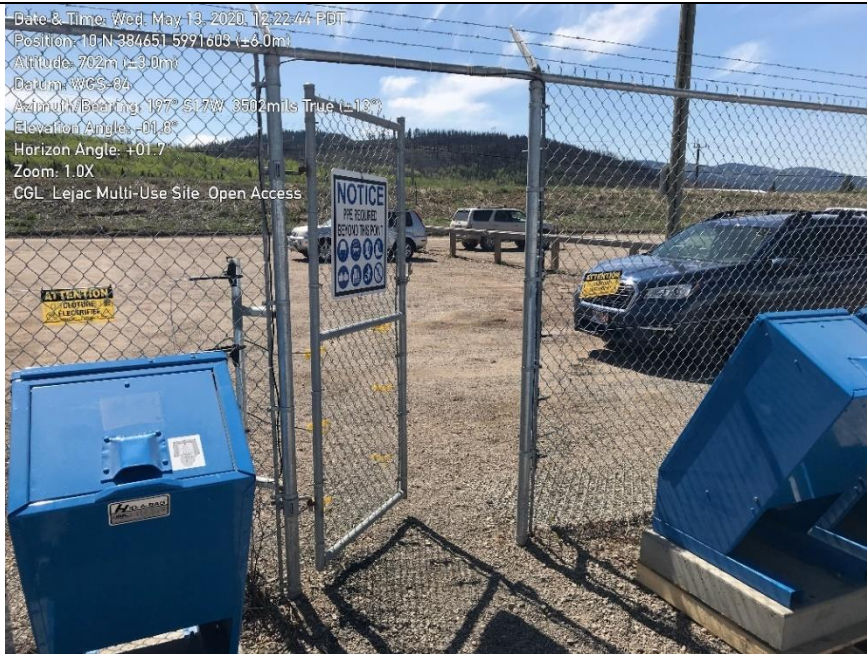
EAO C&E tested the functionality of the compound access gates and determined the gates do not “self close” after being opened (refer to Photo 10). EAO C&E identified spacing beneath and around main access gates that can allow unobstructed access into enclosure by small wildlife such as coyotes and even potentially smaller sized bears (refer to photo 11). EAO C&E identified the area of fence line located in the northeast corner has experienced water erosion which has created a potential access for wildlife into the MUS. This location was first identified and documented by EAO C&E via the December 11, 2020 EAO C&E inspection (refer to photo 12 and Appendix 8). This segment of the fence has not been remedied since being identified.

Photo 10: Access gate without functioning "self close" mechanism.

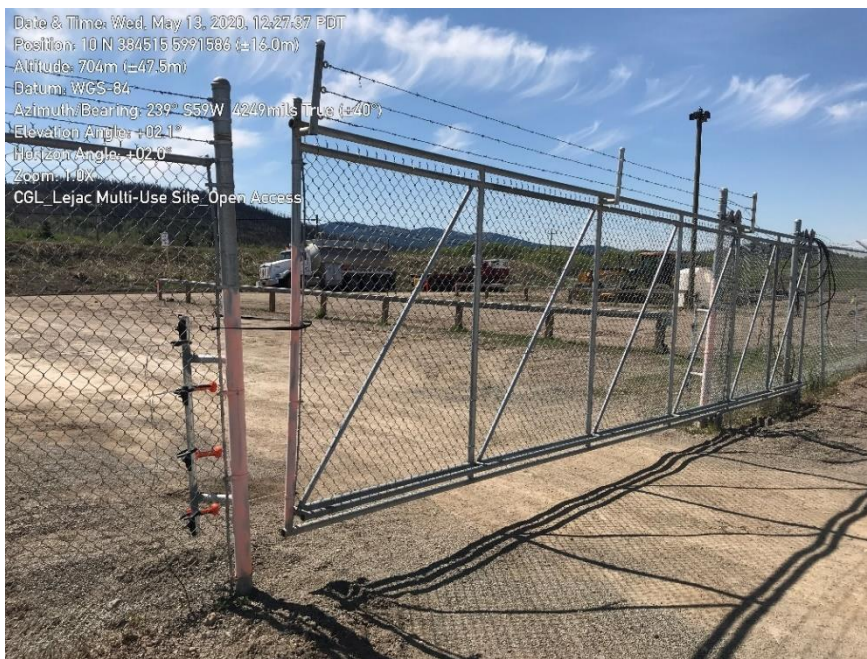
Photo 11: Main access gates depicting spacing beneath and around gate which allows access into enclosure by small wildlife.

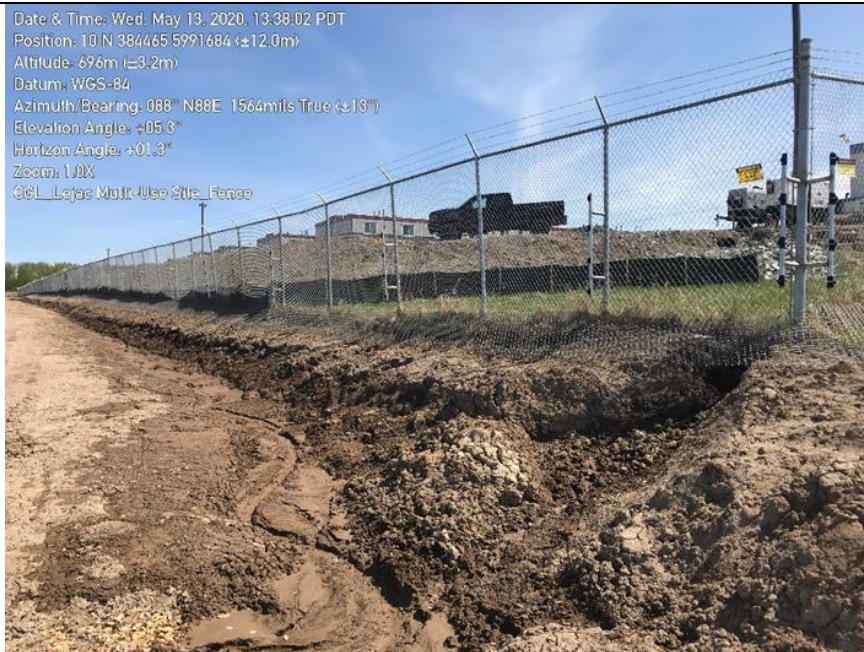
Photo 12: Northeast corner of fence line where water erosion has created a hole for animals to gain access into MUS. First identified as deficient by EAO C&E in December 2019.

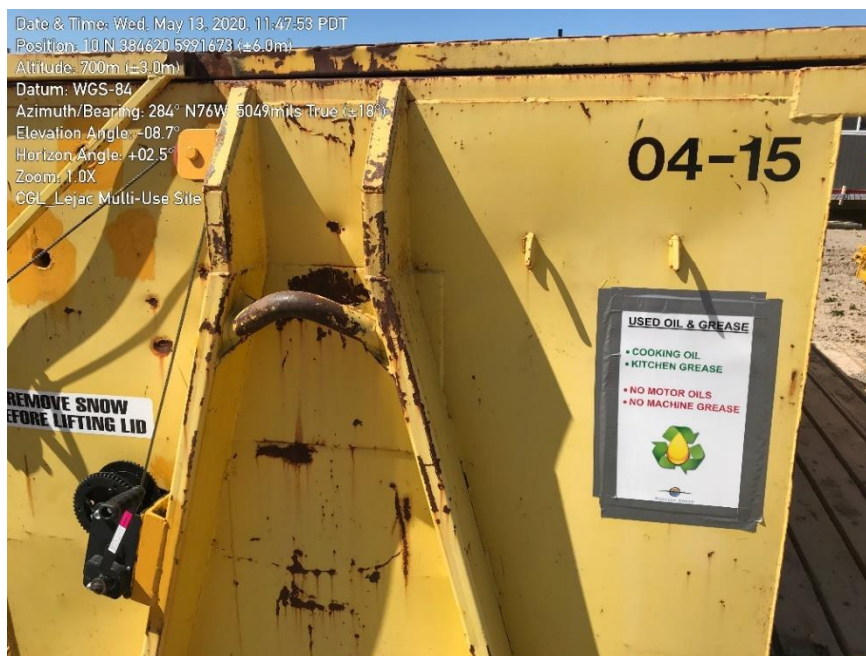
Photo 13: Secure container of cooking oil and kitchen grease.

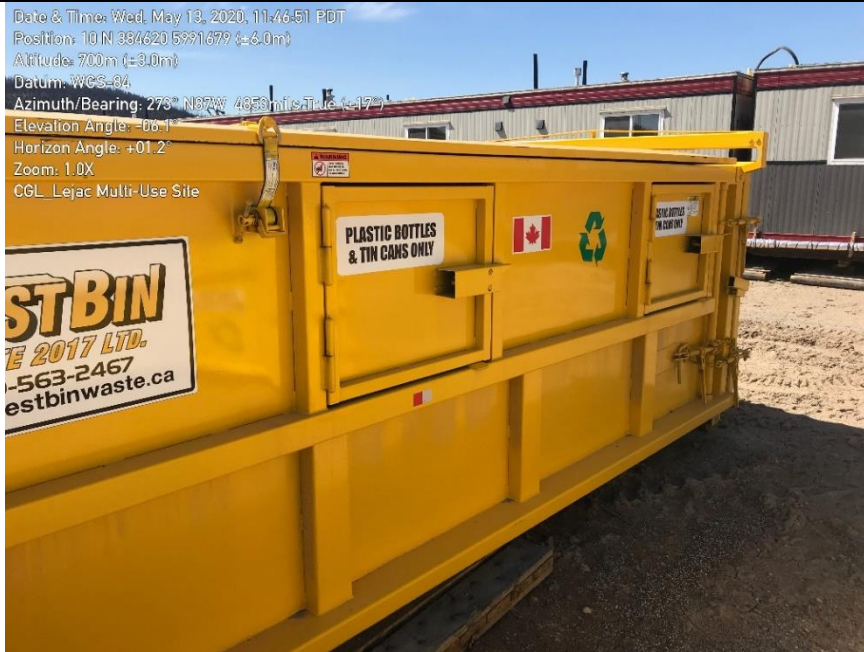
Photo 14: Area A, Plastic and tin containers for recycling.

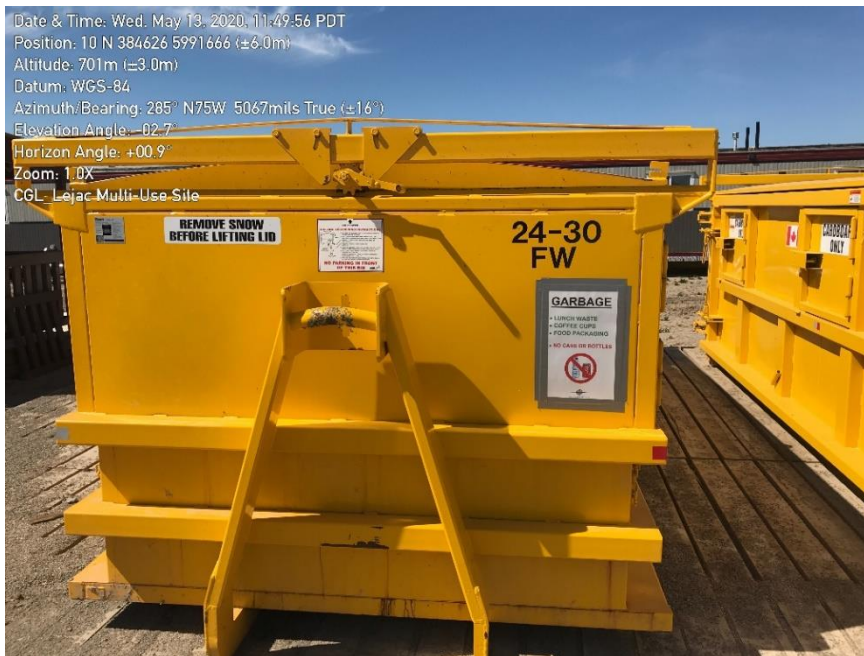
Photo 15: Area A, Bear proof container for general waste.

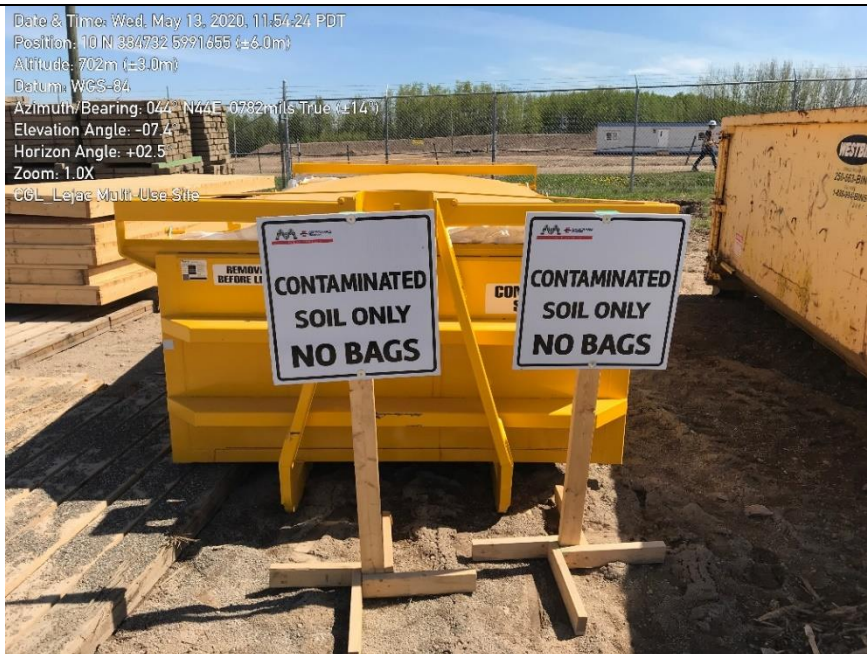
Photo 16: Area A, Hazardous waste containers for contaminated soils.

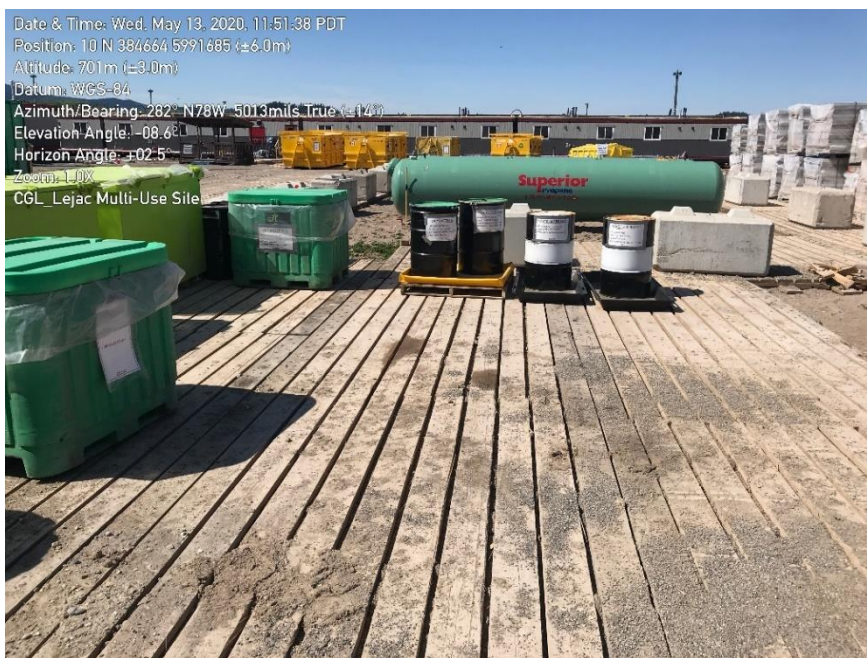
Photo 17: Area A, Hazardous waste containers for hydrocarbon products.

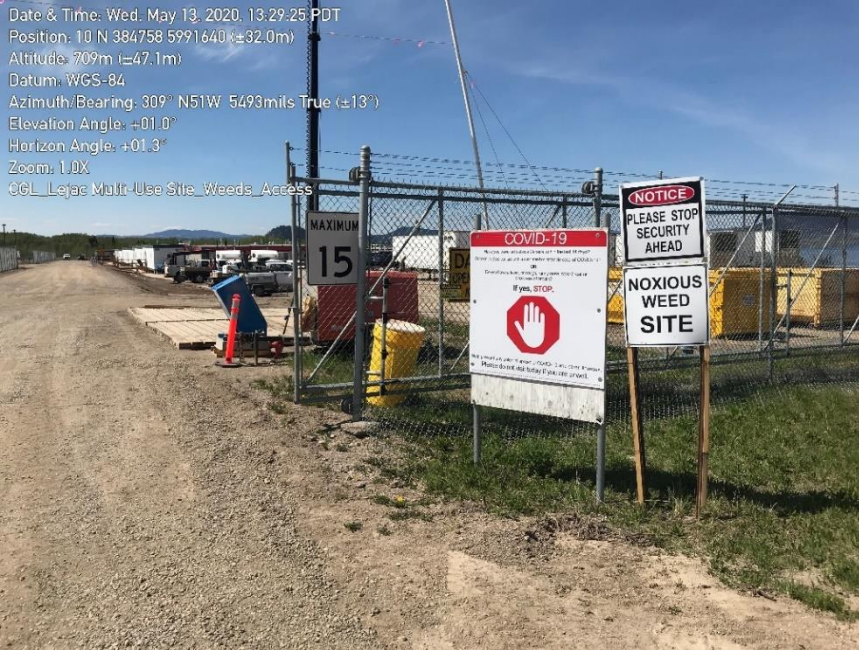
Photo 18: Access into Lejac MUS identifies the laydown as being a “noxious weed site.”

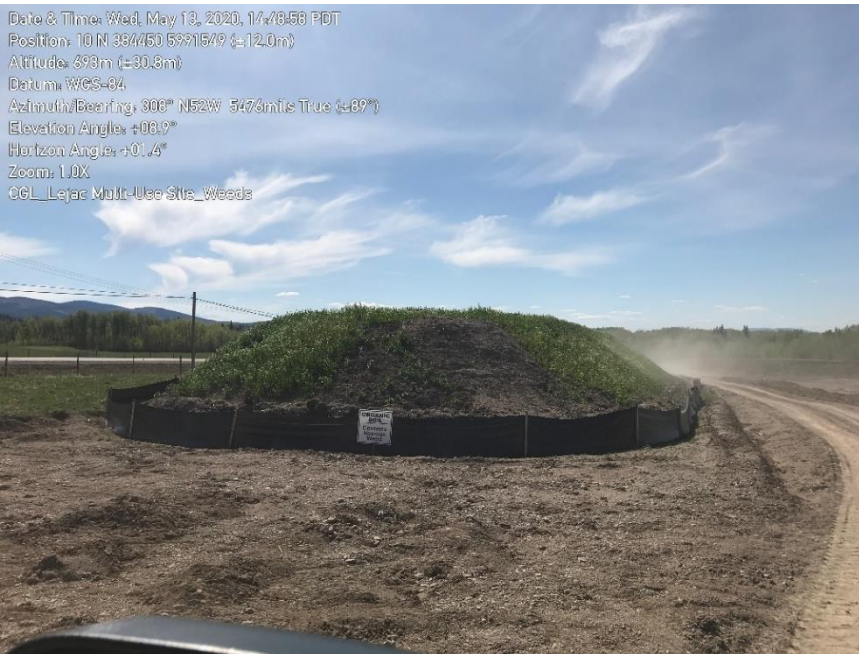
Photo 19: Area A, Topsoil stockpile depicting noxious weed growth.

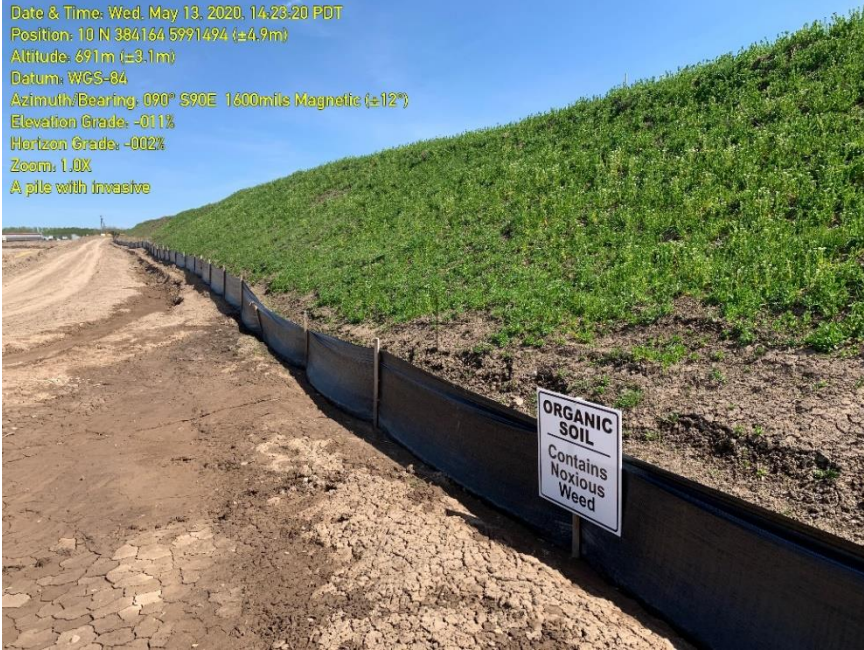
Photo 20: Area A, Topsoil stockpile depicting noxious weed growth.

- *Stockpile in Area A (south side of site), as noted in Photo 20 of the Inspection Record, contained topsoil however it was not tarped at time of inspection as this pile was expected to have additional disturbance in the near future.*

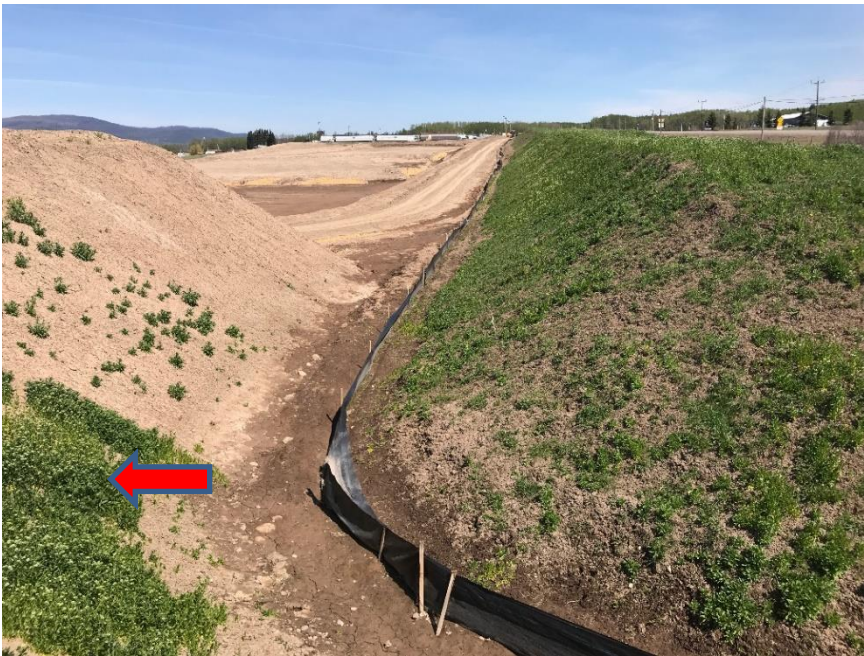
Lejac MUS is identified as being a “noxious weed site” and requires management in accordance with the Invasive Plant Management Plan (refer to photo 18). EAO C&E inspected two topsoil piles where invasive weeds were segregated and isolated from main soil stockpiles. Most noxious weed sites were delineated by use of silt fencing and made identifiable by use of signage. According to CGL representatives, common tansy (*Tanacetum vulgare*) was identified as being the invasive plant species being controlled. One topsoil stockpile was not tarped and showed weed growth (refer to photos 19 and 20). The other topsoil pile known to contain invasive plants was tarped to prevent further germination of topsoil piles (refer to photo 22). One soil stockpile located adjacent to a noxious weed site was observed to have weed growth, which is not identified with a sign, as per the requirement (refer to photo 21).

Photo 21: Area A, Noxious weed growth depicted on adjacent soil stockpile, no signage or mitigation measures implemented.

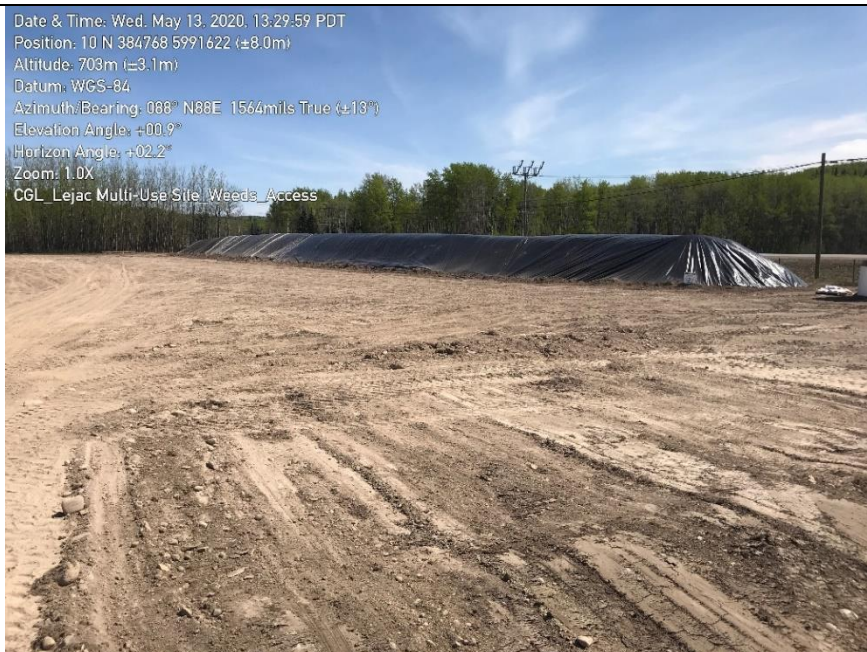
Photo 22: Area B, Covered topsoil stockpile to control noxious weeds.

- *Stockpile in Area B (Photo 22 from Inspection Record) was tarped as it contained topsoil and will not be disturbed until reclamation of the site.*
- *Two subsoil stockpiles at the east and west sides of the MUS were hydroseeded shortly after the inspection occurred and are included in the weed control program.*
- *Small topsoil stockpile just inside North fence was either to be hydroseeded and added to the control program or tarped. After the inspection, this stockpile was hydroseeded and added to the weed control program.*
