<b>Project Name</b>	Coastal GasLink Project	<b>Inspection Status</b>	Final
<b>EA Certificate #</b>	E14-03	<b>Inspection No.</b>	IR2021-008
<b>Project Status</b>	Certified	<b>Inspection Start</b>	2021-03-11
<b>Sector</b>	Energy	<b>UTM</b>	9U 614438.00 E, 6005813.00 N and 9U 608454.00 E, 6006629.00 N
<b>Trigger</b>	Complaint	<b>Inspection Type</b>	Field and Administrative
<b>Project Description</b>	The Coastal GasLink Project (Project) is an approximately 650-kilometre natural gas pipeline, currently under construction.		
<b>Location Description</b>	This inspection is specific to events that occurred at two locations near the Morice West Forest Service Road (FSR). <ul style="list-style-type: none"> <li>Pre-existing public spur road running south of the Morice River FSR at approximately KM 56.5 (Site 1)</li> <li>Pre-existing public spur road running south of the Morice River FSR at approximately KM 63 (Site 2).</li> </ul>

<b>Inspection Summary</b>	<p>On March 11, 2021 Chris Parks, Environmental Assessment Office (EAO) Director of Compliance and Enforcement (C&amp;E) initiated an inspection of the Project against the requirements of Environmental Assessment Certificate (EAC) #E14-03 (

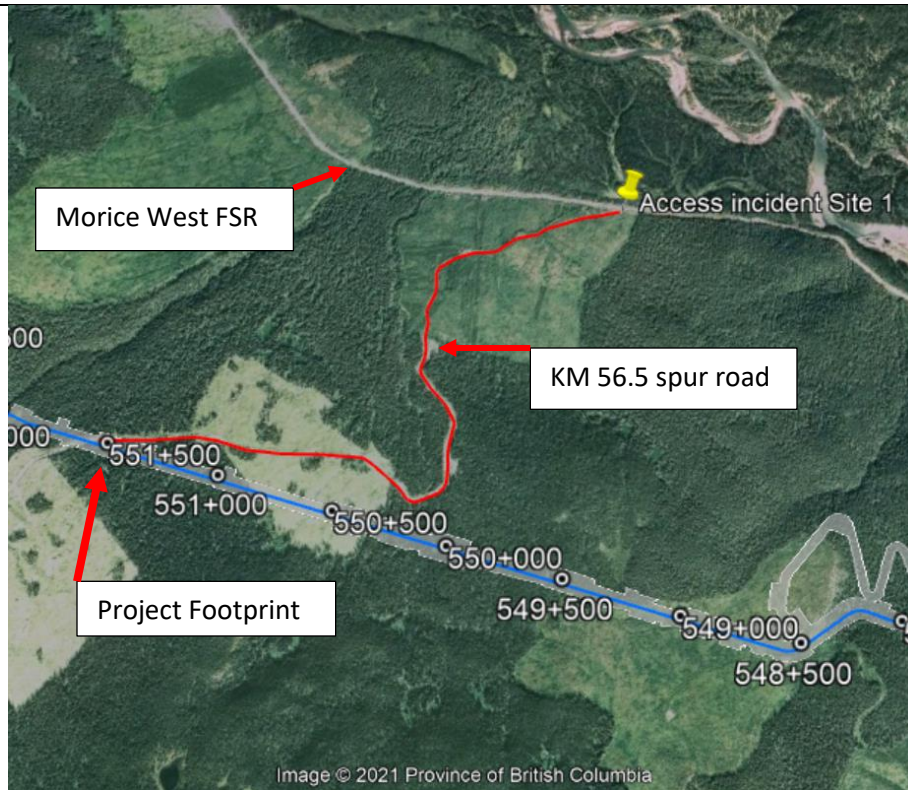
Figure 1: Site 1 location. Distance from incident location to Project footprint is approximately 3.6 kilometres.

The incident reports and video evidence document that on March 6, 2021 a Wet'suwet'en person attempted to access the KM 56.5 and KM 63 spur roads by truck. CGL security staff were parked on the spur roads at Site 1 and Site 2, at or near the intersection with the FSR, limiting travel on the spur roads to CGL project personnel only. When attempting access through Sites 1 and 2, CGL security staff stated that the Wet'suwet'en person could not proceed further, noted that there were active work zones ahead, stated that COVID 19 restrictions pursuant to orders issued by the Public Health Officer to CGL constrained the security staff's ability to allow the Wet'suwet'en person to proceed past the sites, and at one site referenced an injunction that restricts certain peoples' activities pursuant to that injunction. CGL security staff also offered to provide contact information for the Wet'suwet'en person to call CGL and organize an appointment to arrange future access.

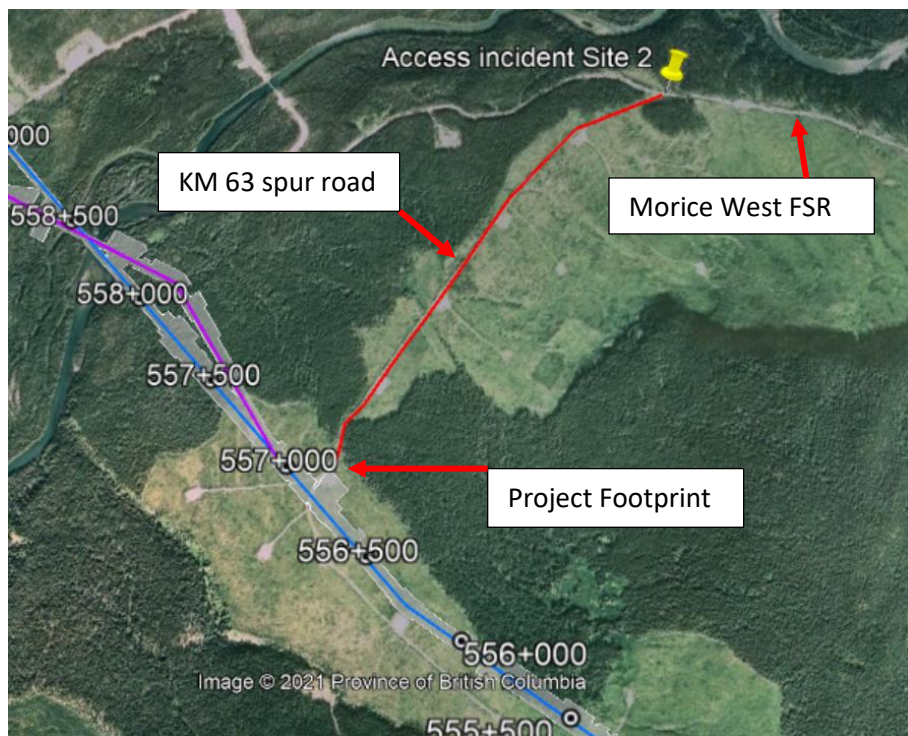
Figure 2: Site 2 location. Distance from incident location to Project footprint is approximately 2.3 kilometres.

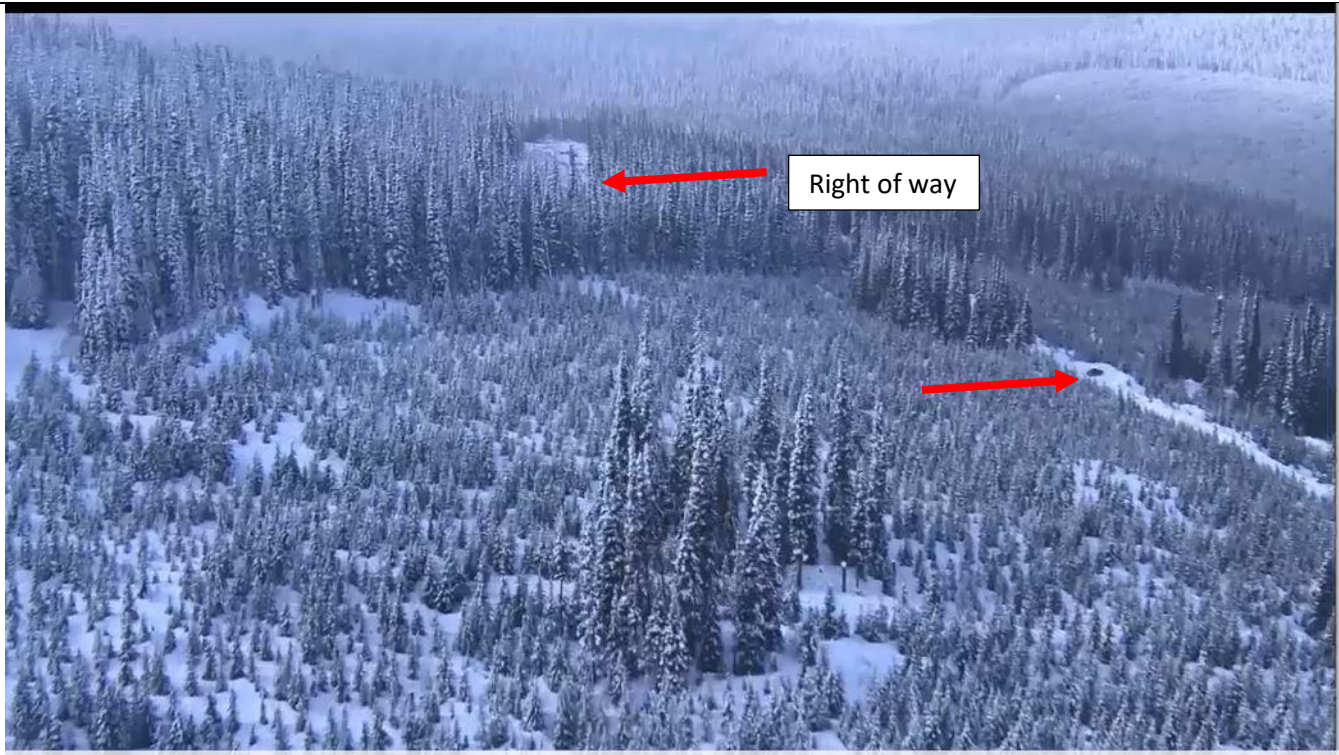
Pull outs or other areas are available to turn trucks in order to facilitate the use of these roads by construction vehicles are typically in-place on plowed access roads, consistent with C&E Parks experience on inspections of the Project, including under winter conditions. In addition, C&E Parks reviewed helicopter overflight video footage of the Project from February and March of 2021 (note that the footage is dated by month only) provided by CGL. The video footage shows pull outs and other opportunities where turn around areas are available, not within active worksites, and these areas can be used for trucks to clear the road to provide access in the event of an emergency. FSRs and road permit roads used by the Project are radio controlled using publicly available radio frequencies (Resource Road frequencies) in order to facilitate road traffic and emergency response. The complainants report that they had a radio with these frequencies, which is corroborated by the video evidence presented in Appendix 5. Note also that the "March" video footage shows that access on the KM 63 access road continues beyond the right-of-way. See Figures 3 through 8.

Figure 3: View of Site 1 access road from CGL supplied aerial footage, showing pull out and parked truck, at approximately 700 m from right-of-way, February 2021.

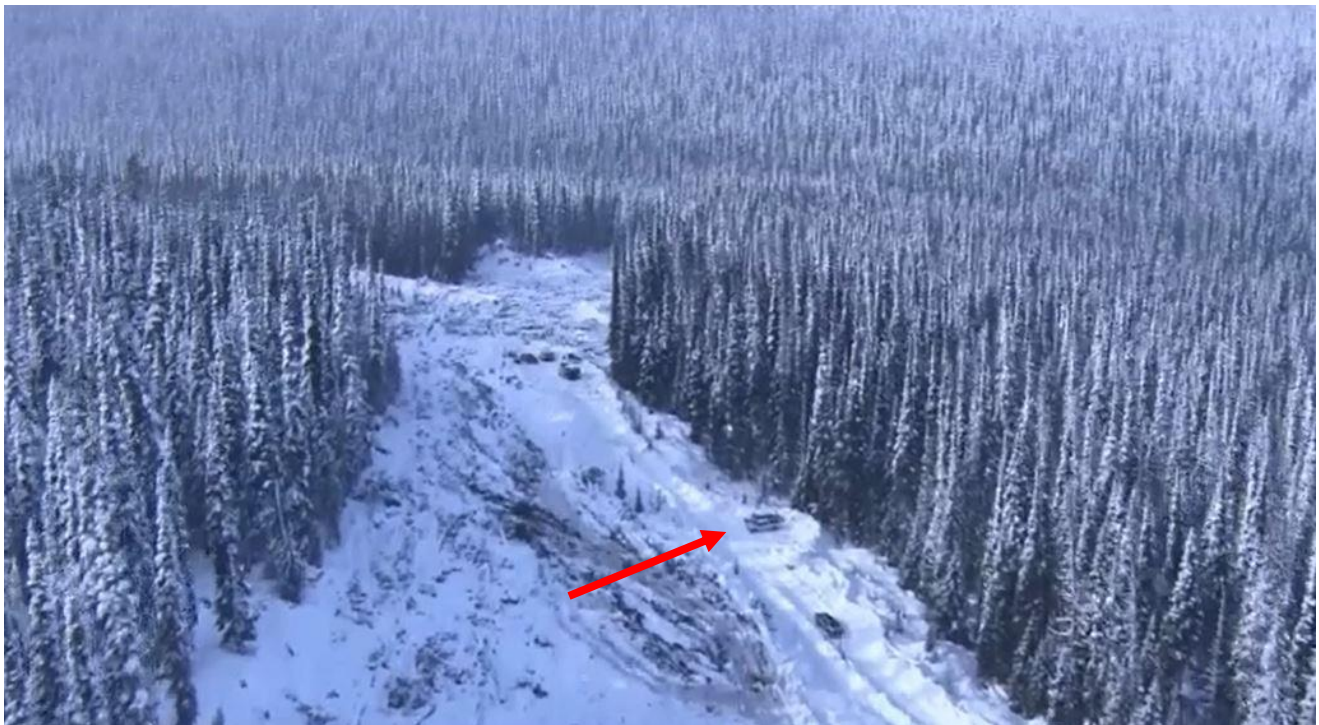
Figure 4: View of Site 1 access road from CGL supplied aerial footage, showing pull out and parked truck, at approximately 700 m from right-of-way, February 2021.

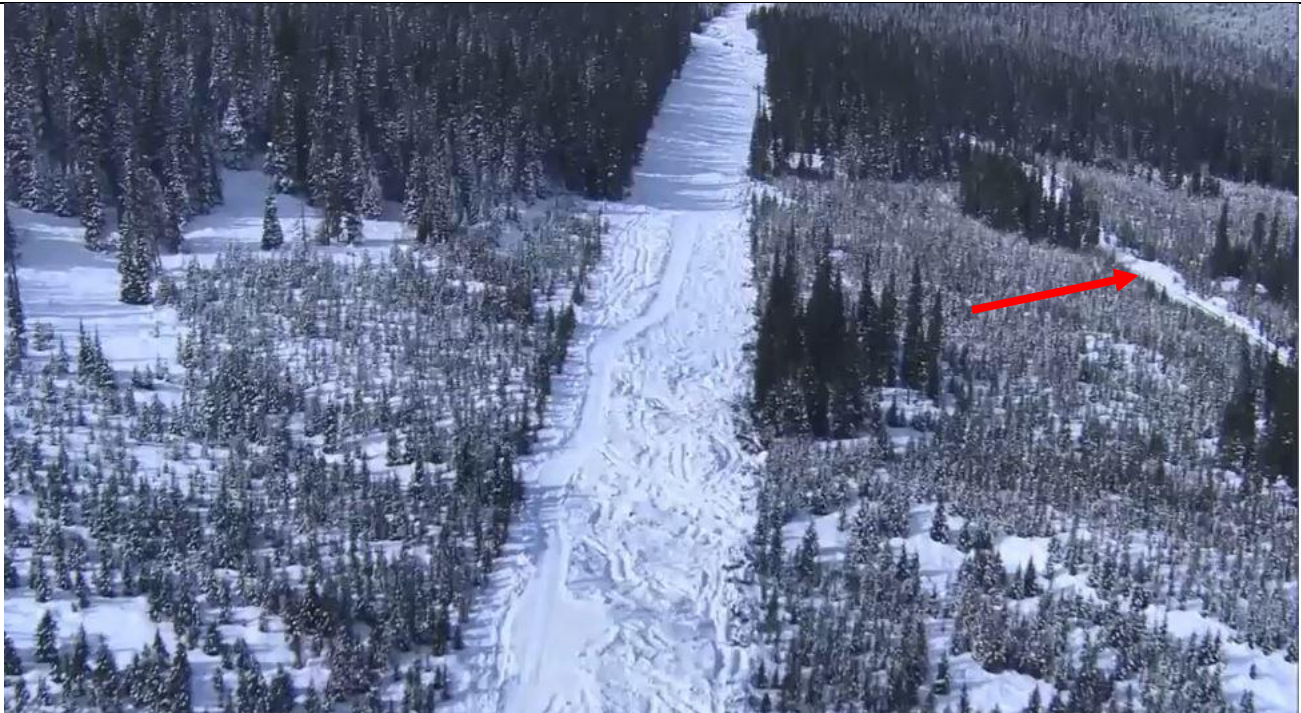
Figure 5: Site 1 access road, showing pull out identified in February 2021 image (Figure 3), March 2021 (CGL).

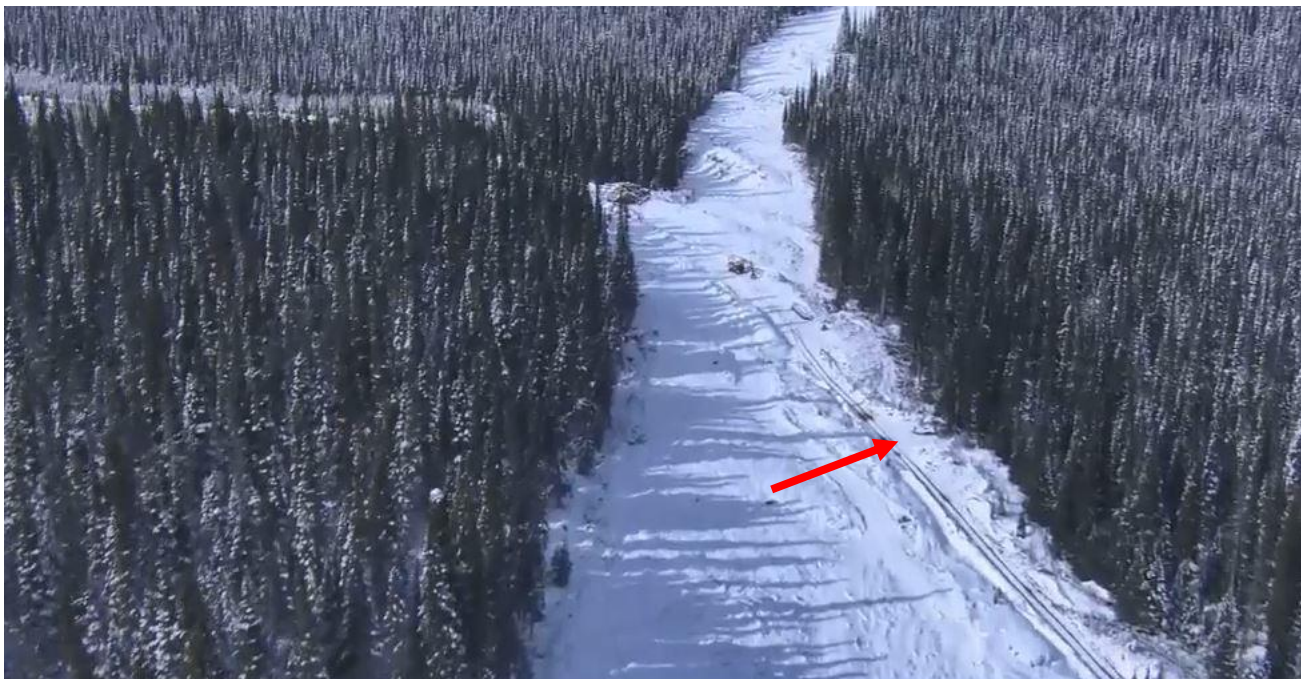
Figure 6: Site 1 access road, showing turn around area at right-of-way, March 2021 (CGL).

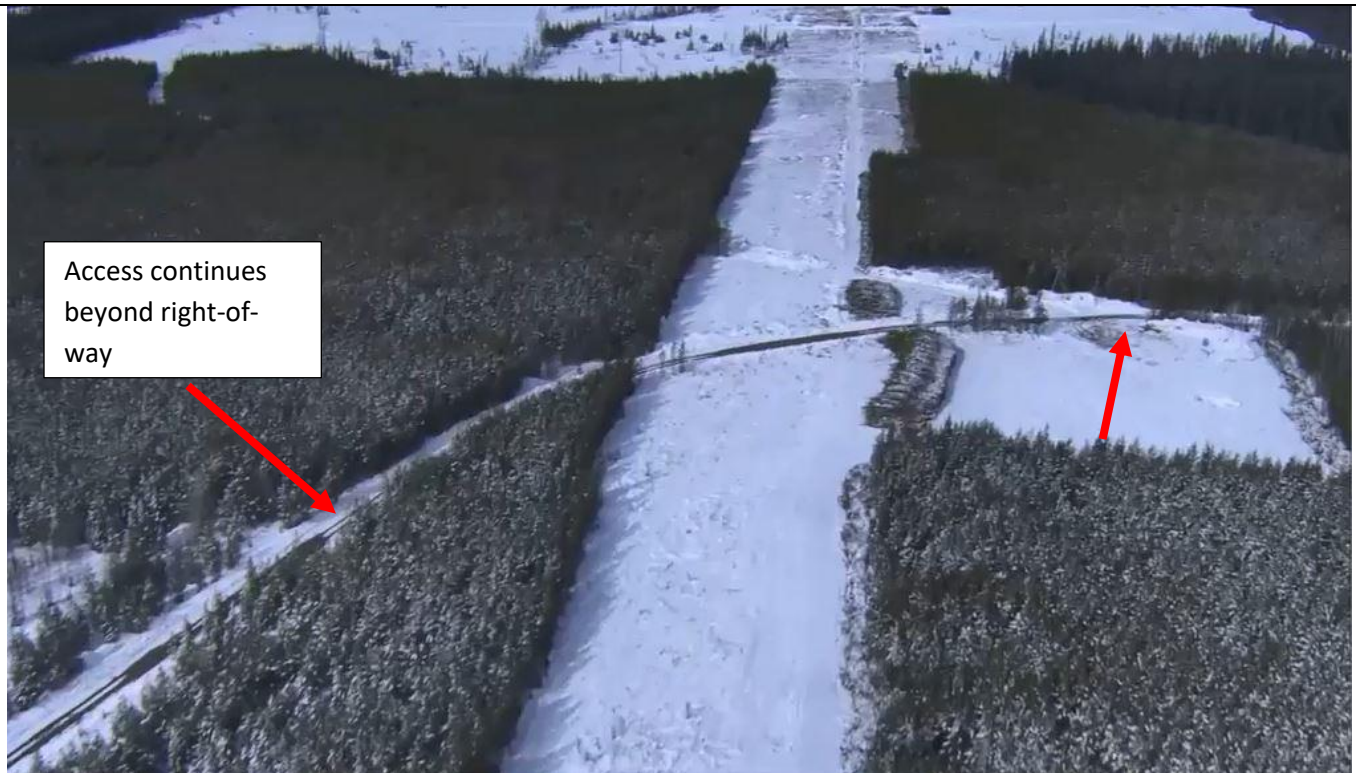
Figure 6: Site 2 access road, showing access through and beyond right of way, and turn around areas, March 2021 (CGL).

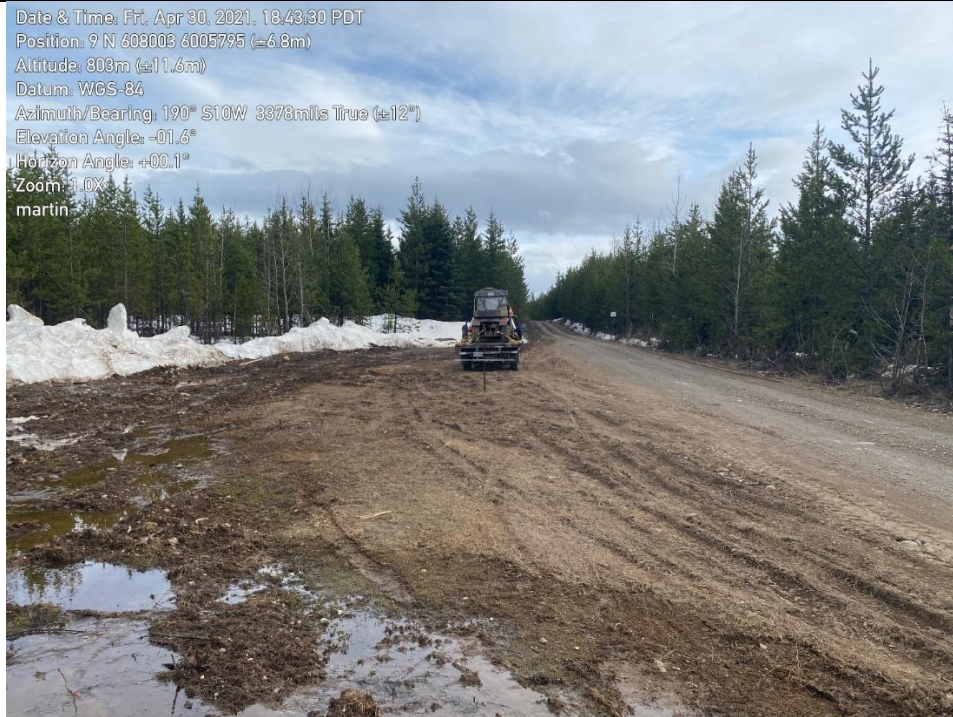
**Site 2/580 Road (Martin Road):** The road intersects the right-of-way at approximately KP556+850. The Mainline Clearing Inspection Report (Appendix 11) notes active work on the right of way west of KP 556+900. The report also notes that a medic and morooka (tracked vehicle) are staged at the Martin Road laydown. See Figures 9-11 noting arrangement of project tenure with access road and turn location. No active work areas are reported on the Site 2/580 road that would impact the use of this road by the complainant on March 6, 2021.

Figure 8: Site 2 access road, showing location where turn out and turn around can occur between intersection of Morice West FSR and Project tenure (C&E Parks).

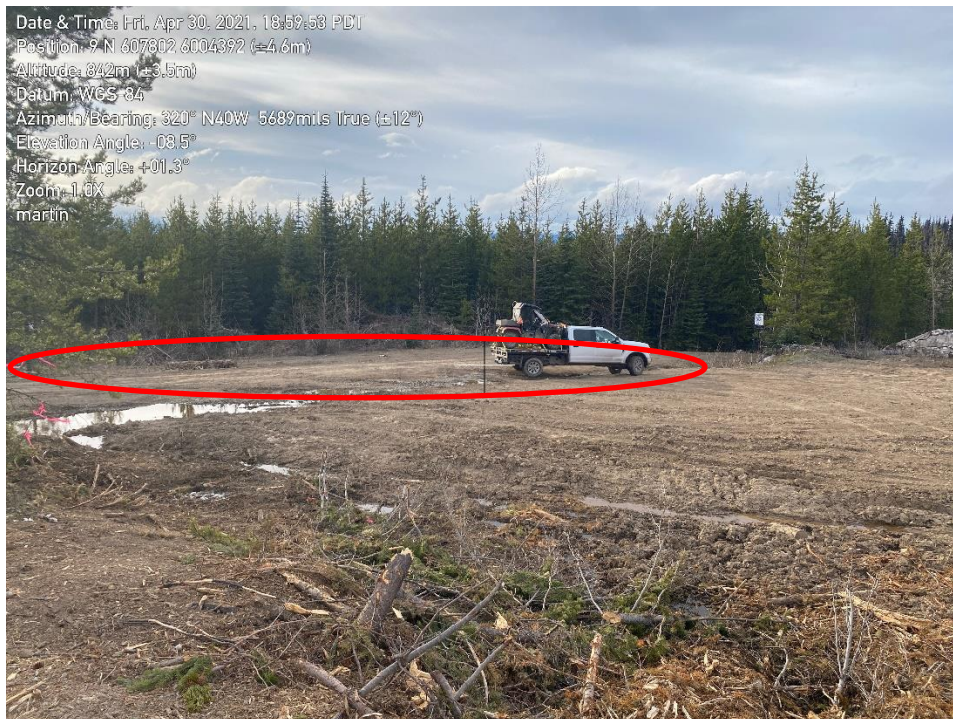
Figure 9: Site 2 access road. Circled area is outside Project tenure and provides turn around opportunity without entering tenure or active worksite (C&E Parks).

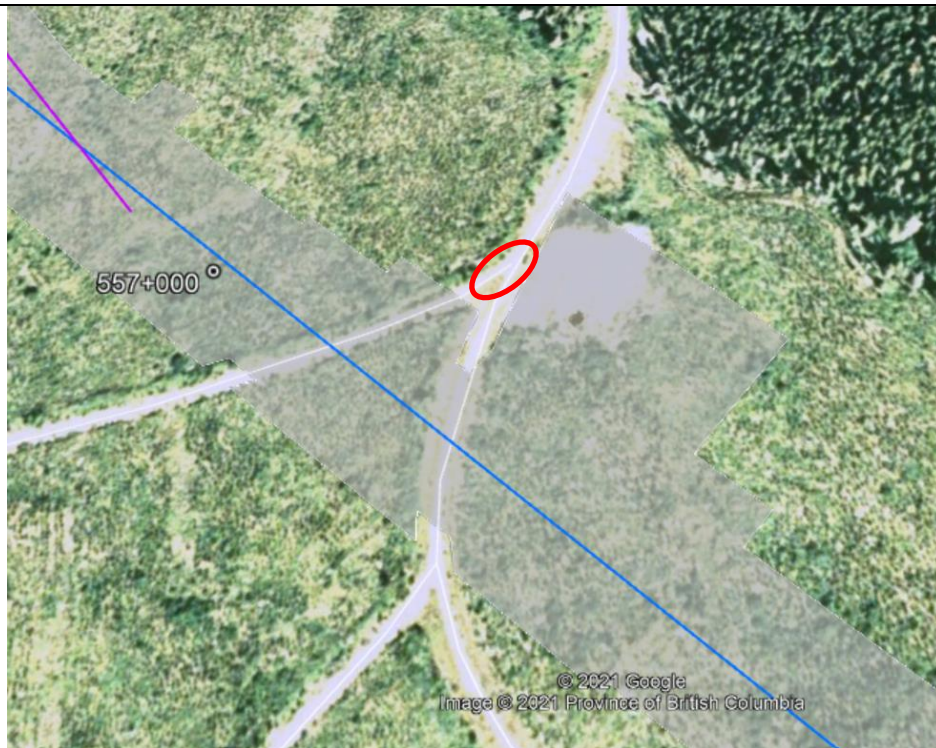
Figure 10: Site 2 access road, showing same location in Figure 9 where turn out and turn around can occur between intersection of Morice West FSR and Project tenure. Circled area is outside Project tenure (Google Earth/CGL).

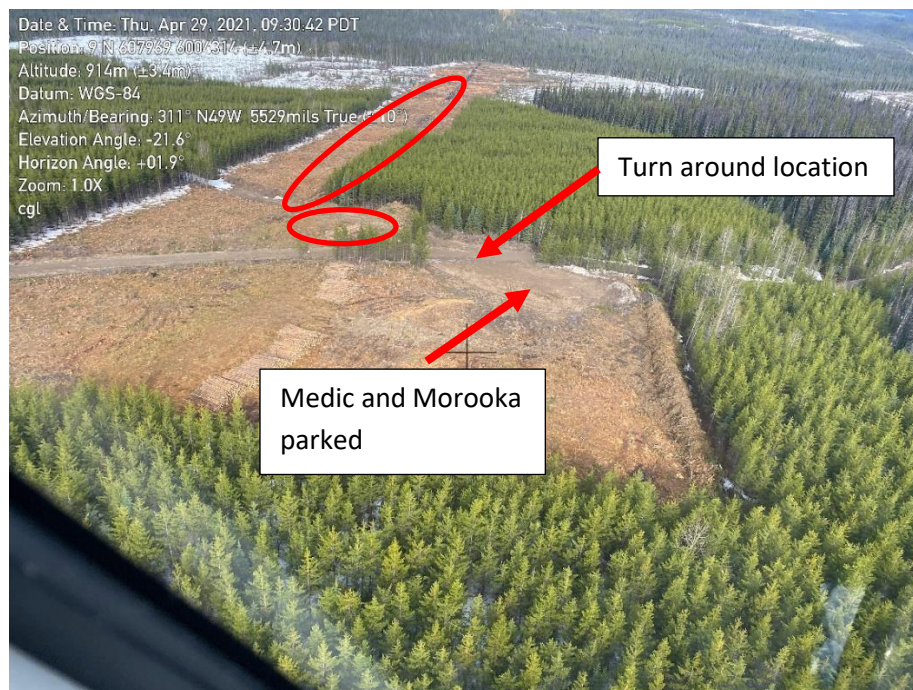
Figure 11: Site 2 access road, showing approximate areas of active work (red circles) reported on March 6, 2021 (Appendix 11) in relation to turn around location (C&E Parks).

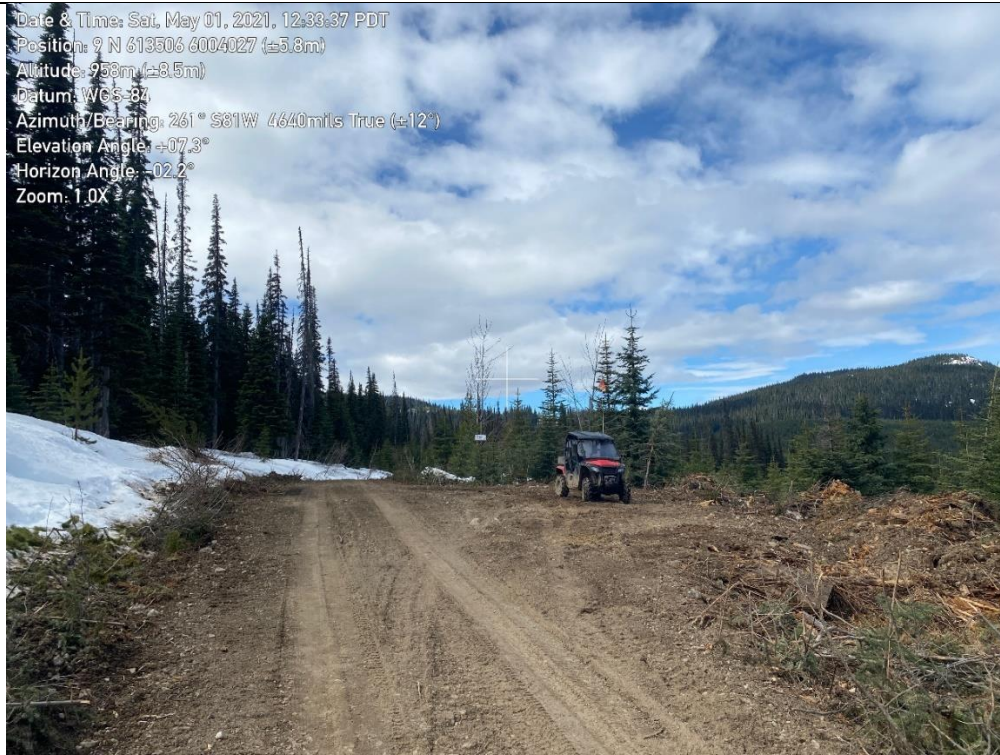
**Site 1/590 Road:** Right-of-way works are noted to be more than 200 metres from the intersection of the right-of-way and the Site 1/590 Road. The road intersects the right-of-way at approximately KP551+500, and works are noted to be occurring at KP551+300, and between 552+300 and 553+800. The report also notes that a grader was conducting grading of the access road, and that workers completed falling of snags and danger trees. The specific location or locations where the faller removed danger trees would be considered active work areas for the duration that the activity was underway, and it is reasonable and compliant with requirements under the Act to delay access at a location where danger trees are being felled. However, that delay should be at the portion of the road that is an active worksite, and for the duration that work is underway. With regard to the grader operating on the road, in consideration of the length of the access road and the range of CGL and contractor traffic identified in the inspection report, on the balance of probability it is likely that turnouts or other areas where vehicles could pass or turn around without entering an active work area were present on the Site 1/590 Road on March 6, 2021.

Figure 12: Site 1 access road, showing location where turn out and turn around can occur between intersection of Morice West FSR and Project tenure (C&E Parks).

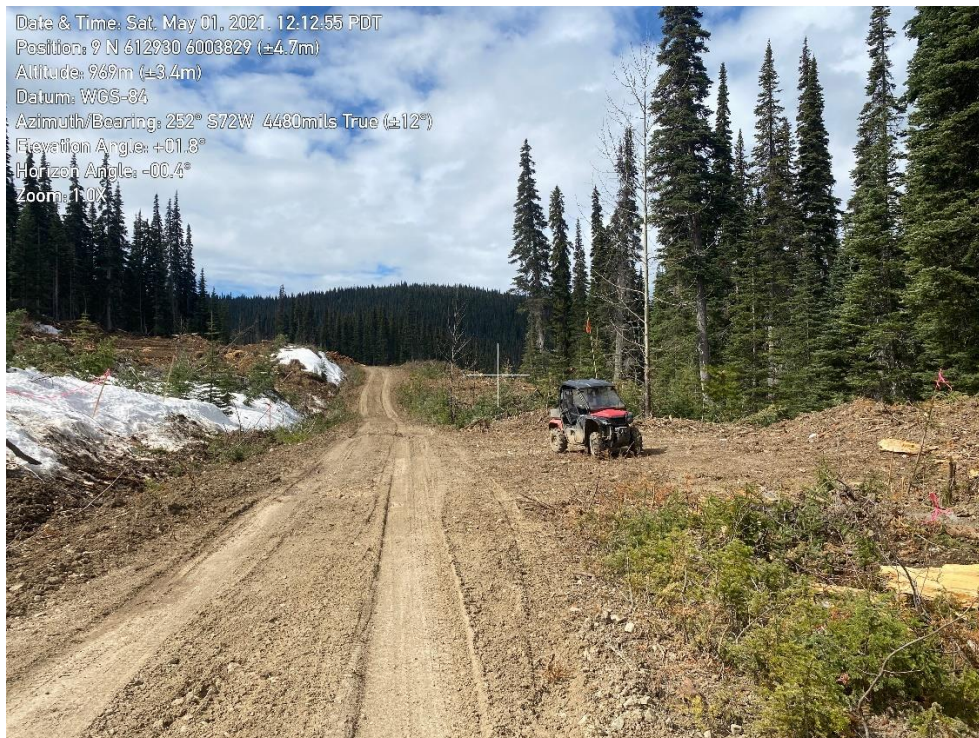
Figure 13: Site 1 access road, showing location where turn out and turn around can occur between intersection of Morice West FSR and Project tenure (C&E Parks).
