CGL4703-CGP-BCEAO-REG-LTR-4953

**Re: Coastal GasLink Pipeline Project (Project)
Inspection Record IR2021-027 Opportunity to Respond
Environmental Assessment Certificate (EAC) #E14-03
October 14 to 21, 2021 Project wide inspection**

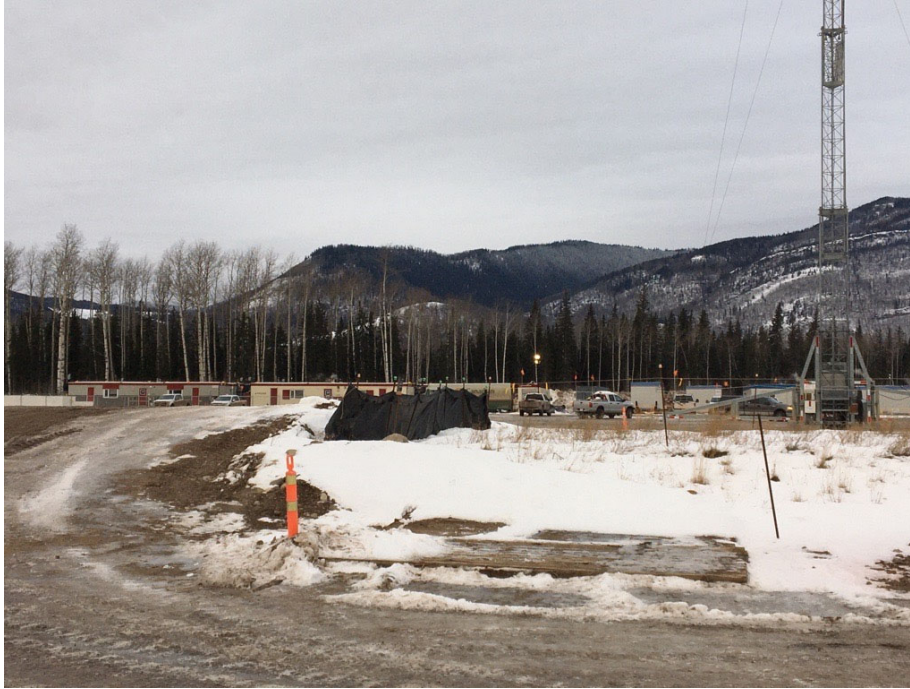
Photo 1: Previous location of bulk containers at Sukunka MUS.

The hydrocarbon containers (bulk containers) and other liquid chemical containers identified in IR2021-027 Photo 25 were staged for pickup and have been removed from site, please see Photo 1.

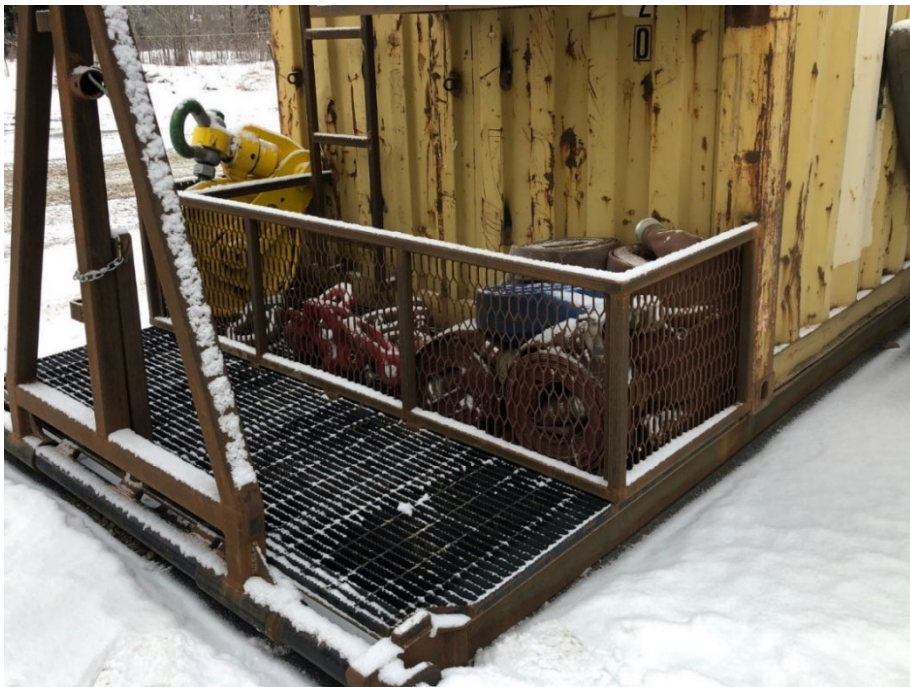
Photo 2: Sukunka MUS - Jerry cans are no longer stored on the skid.

The jerry cans identified in IR2021-027 Photo 26 have been removed from the skid and properly stored – see Photo 2 below.

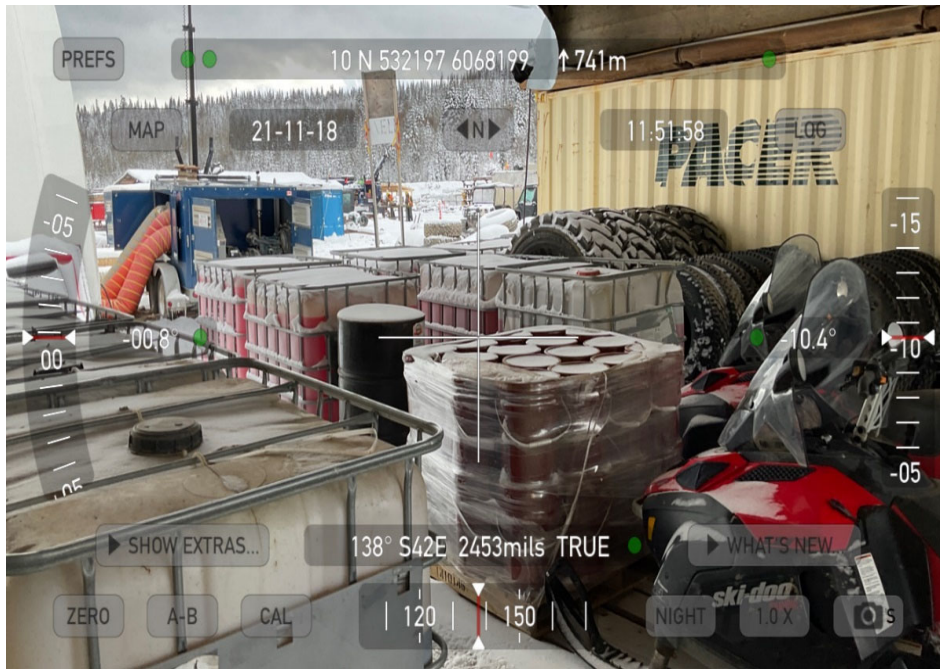
Photo 3: Parsnip MUS - Covered lubricant and antifreeze storage.

The bulk oils e.g. hydraulic and motor oil and antifreeze identified in IR2021-027 Photo 27 are now stored in a covered storage area.

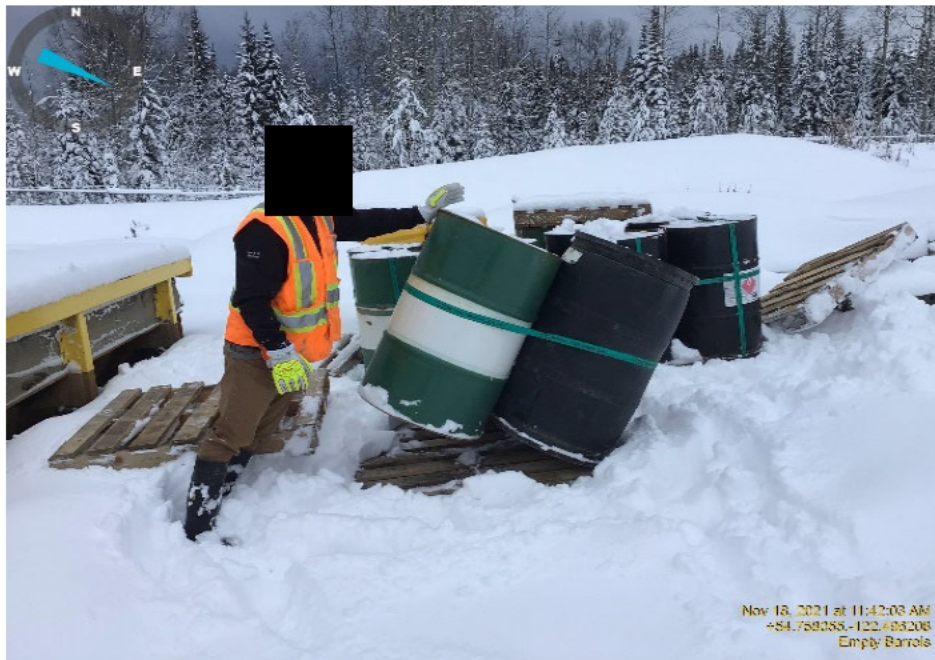
The barrels identified in IR2021-027 Photo 28 are empty methanol and methyl hydrate barrels and therefore were not placed in secondary containment as there was minimal risk of release to the environment. See Photo 4 below.

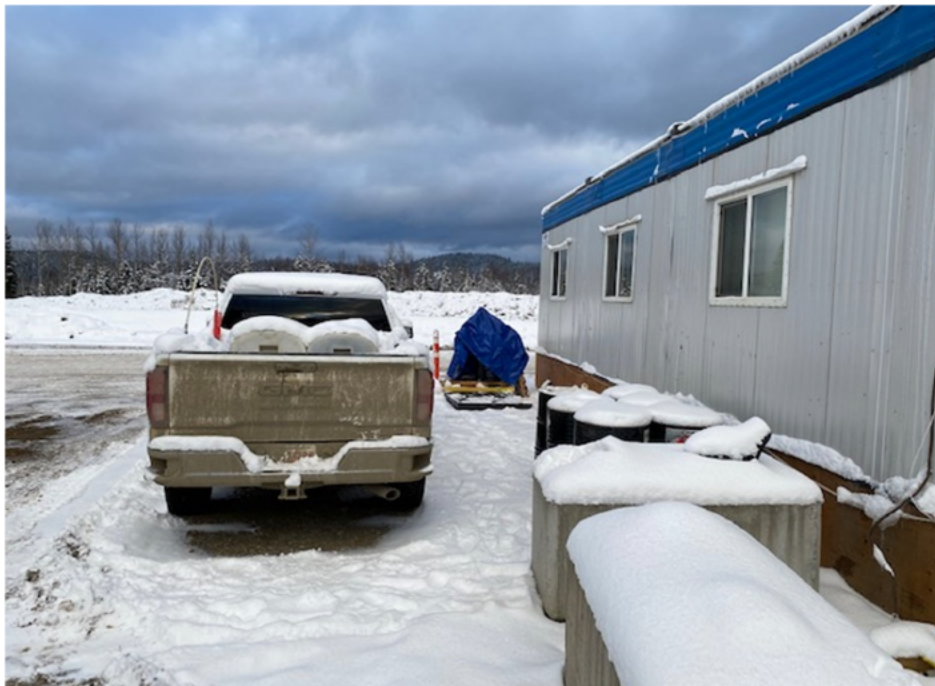
Photo 6: Parsnip MUS - Secondary containment added, and containers covered with a tarp.

Photo 4: Parsnip MUS - The bulk chemical liquids stored without secondary containment were empty. The barrels identified in IR2021-027 Photo 29 and Photo 36 are now stored on a secondary container tray and the barrels have been covered with a tarp to prevent rain and snow from collecting in the tray (Photo 6).

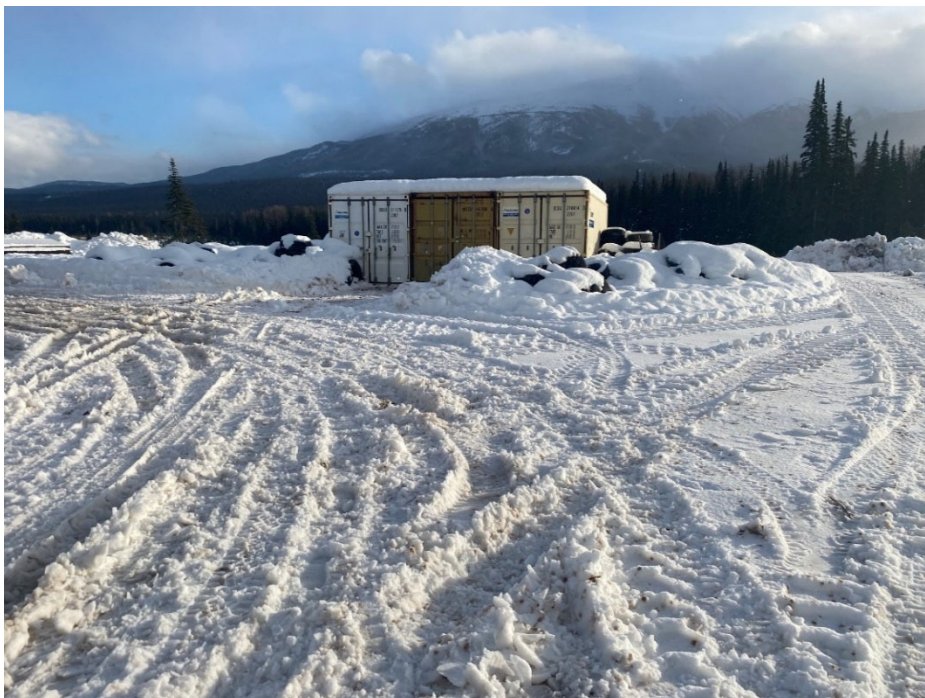
Photo 8: MUS 9A - DEF totes have been removed from site.

The liquid stored within the unmarked 1000 litre (L) plastic totes was diesel exhaust fluid (DEF). These totes have been removed from MUS 9A and are stored within a sea can near KP 588+300. Photo 8 and Photo 9 shows the same area as noted in Photo 31 from IR2021-027 confirming that the totes and the batteries are no longer stored in this location. Photo 10 shows the DEF totes stored in a sea can.

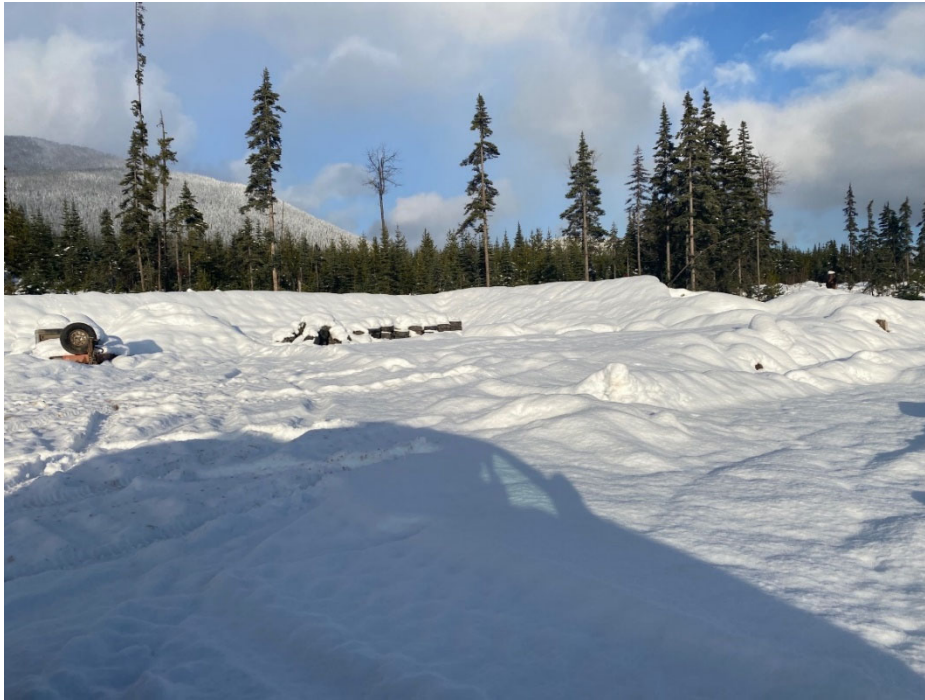
Photo 9: MUS 9A - DEF totes have been removed from site.

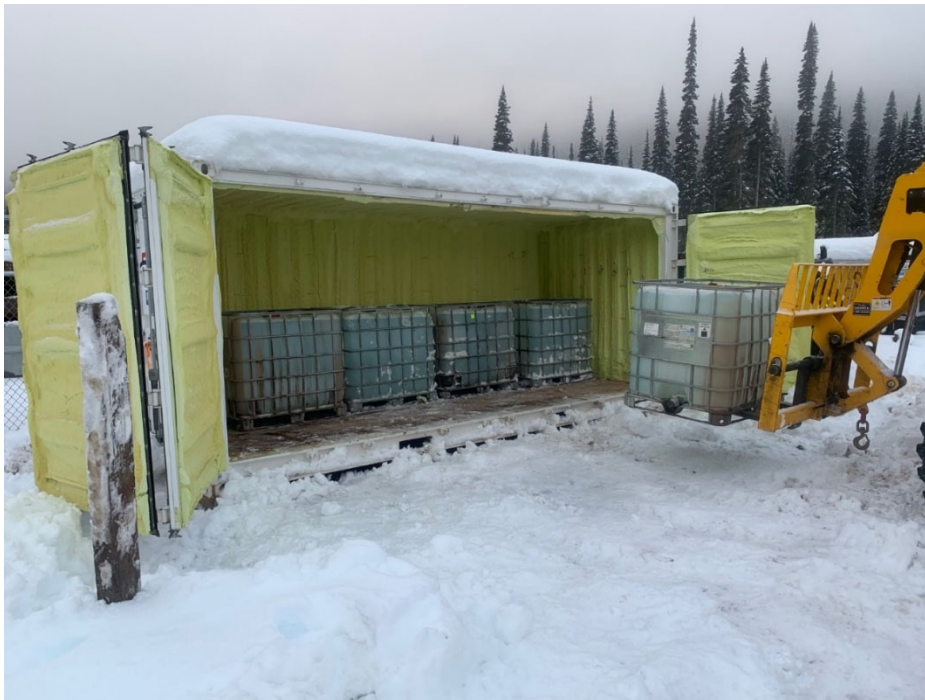
Photo 10: KP 588+500 - DEF totes stored in sea can container.

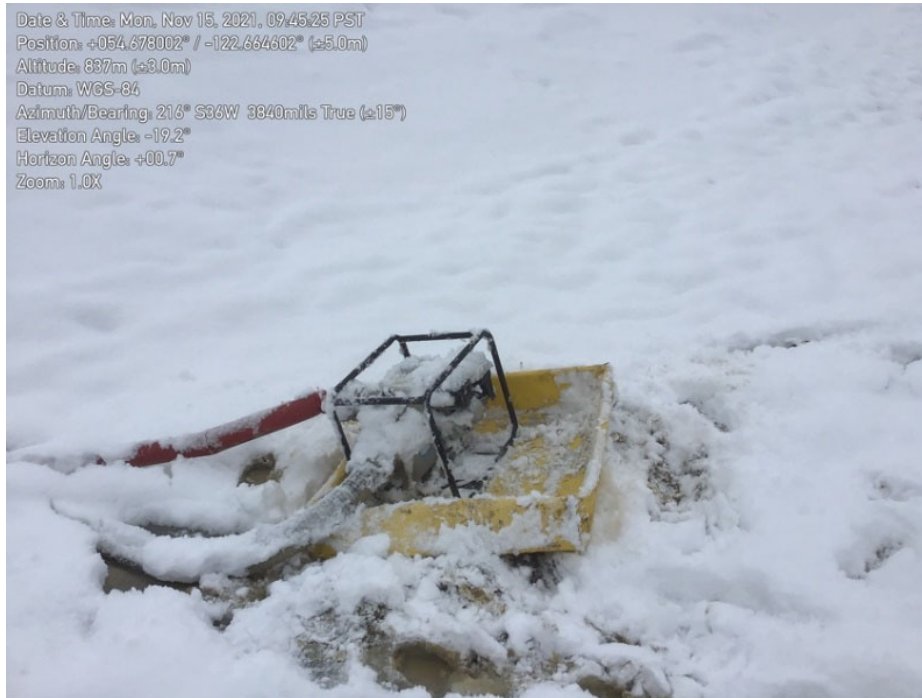
Photo 11: KP 205+700 - Pump and secondary containment on solid ground, the pump has been removed from this location

The water level in the sump, as shown in IR2021-027 Photo 33, was lowered and the pump and secondary containment are no longer situated within the pooled water (see Photo 11).

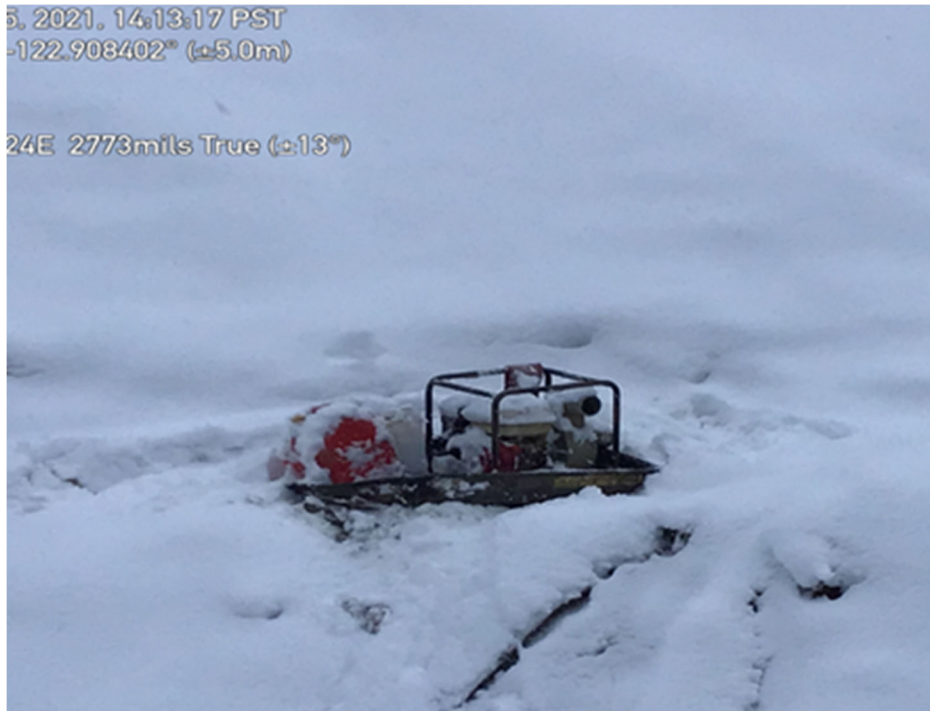
Photo 12: KP 224+500 - Secondary containment cleaned out

Photo 34, 35 and 37 of IR2021-027 show examples of secondary containment containing water under fuel containers and pumps. Please see Photo 12, 13 and 14 displaying the secondary containment with water and/or snow removed. The volumetric capacity of the secondary containment is now more than 125% of the fuel storage amount.

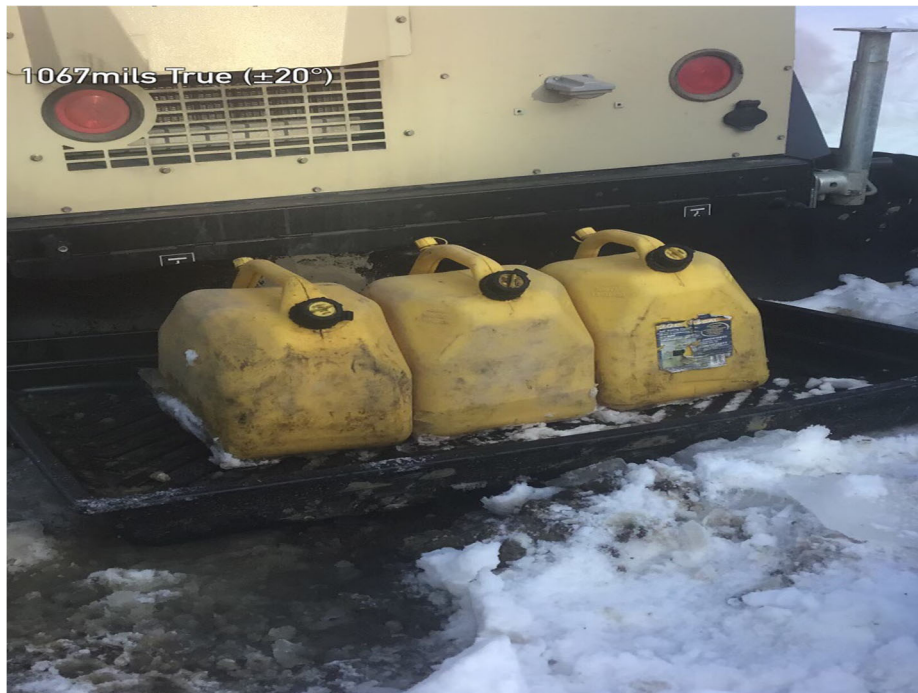
Photo 13: KP 223+578 - Spill tray under fuel containers has been emptied of water.

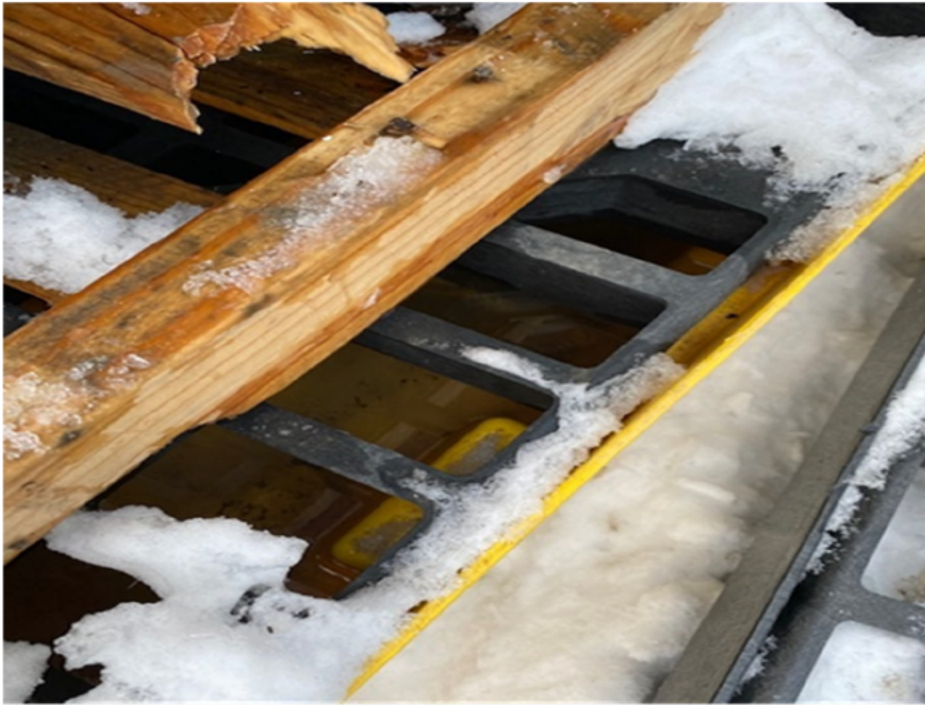
Photo 14: Spill tray has been emptied

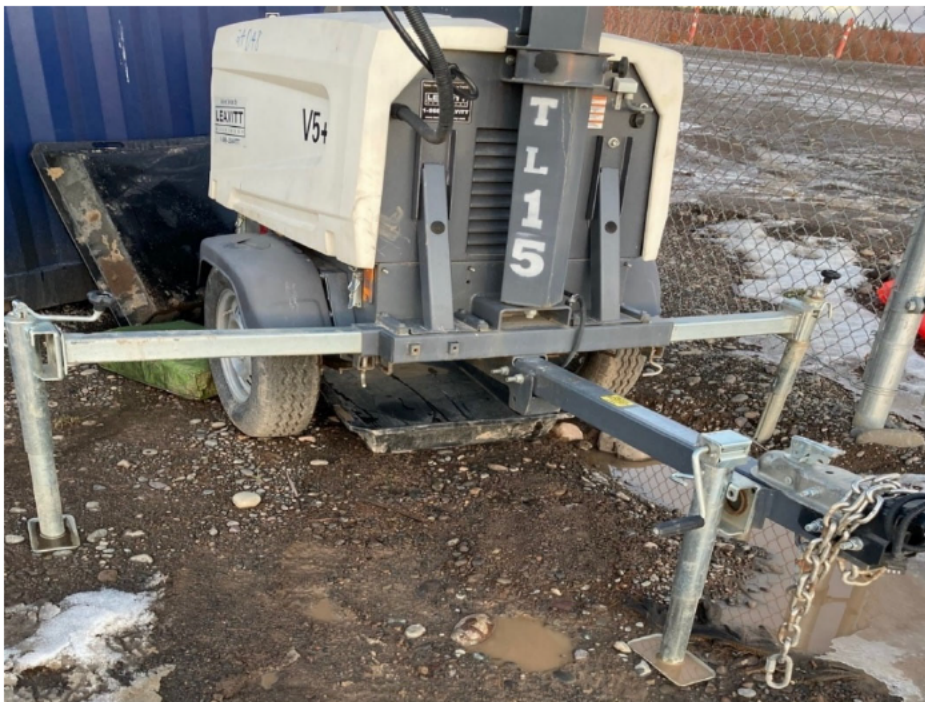
Photo 15: 7-Mile MUS light plant secondary containment re-positioned and dry.

Secondary containment beneath light plant, identified in IR2021-027 Photo 38, has been re-positioned and emptied of water as shown in Photo 15 below. The pump and associated secondary containment shown in IR2021-027 Photo 39 has been removed from site.

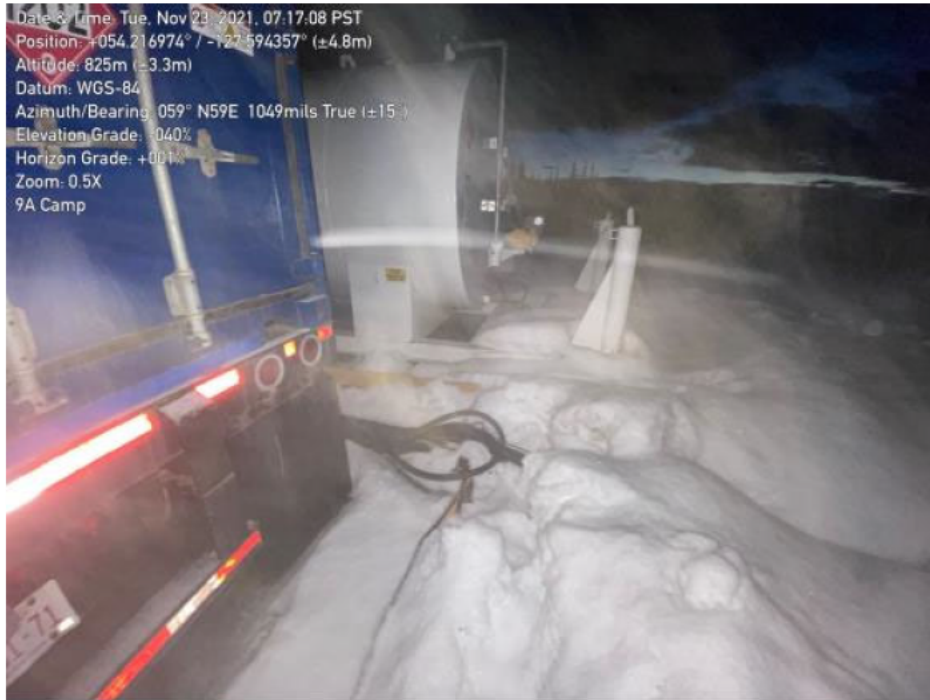
Photo 16: MUS 9A fuel island - secondary containment covered by recent snowfall

Secondary containment at fuel island has been emptied of water however, due to a recent snowfall, snow will also need to be removed (see Photo 16). Used spill pads, noted in IR2021-027 Photo 40, were removed from the drip tray and disposed of properly.

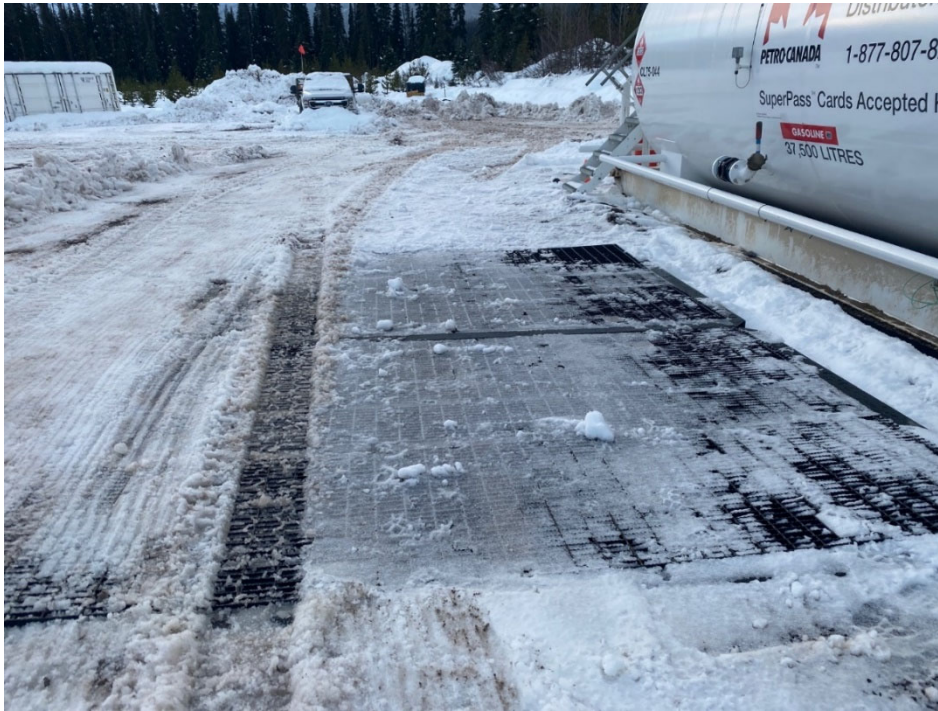
The purpose of the grating at the fuel island (referenced in Photo 41 of IR2021-027) is to capture accidental releases during fueling of trucks/equipment. It does not serve as secondary containment for the fuel tanks as these tanks are double walled with secondary containment built into the unit itself. The pit below the grate is monitored regularly and pumped out as needed. This structure was emptied on October 22, 2021 to a nearby 1000L tote with an attached hydrocarbon filter. Since that time, heavy snowfall has blanketed the area, including the grated pit. During winter, it is challenging to empty snow and ice out of the grate area and determine if there is hydrocarbon contamination (see Photo 17). To account for this, drip trays are placed at all pumps and must be used during re-fueling (see Photo 18).

Photo 17: Grated area at MUS 9A fuel island.

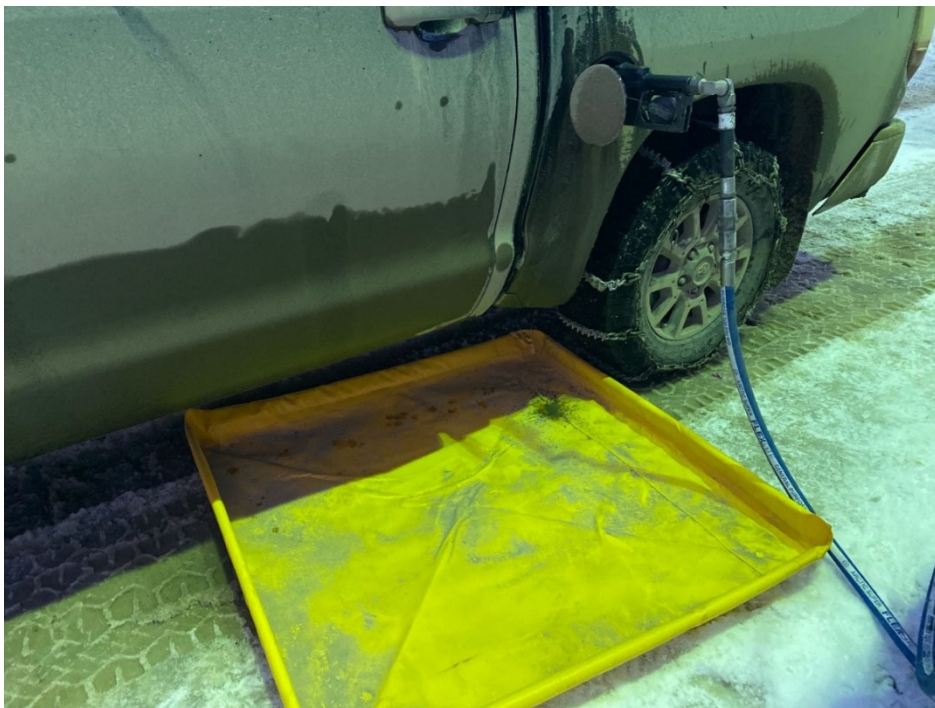
Photo 18: Drip trays in use while re-fueling at MUS 9A.

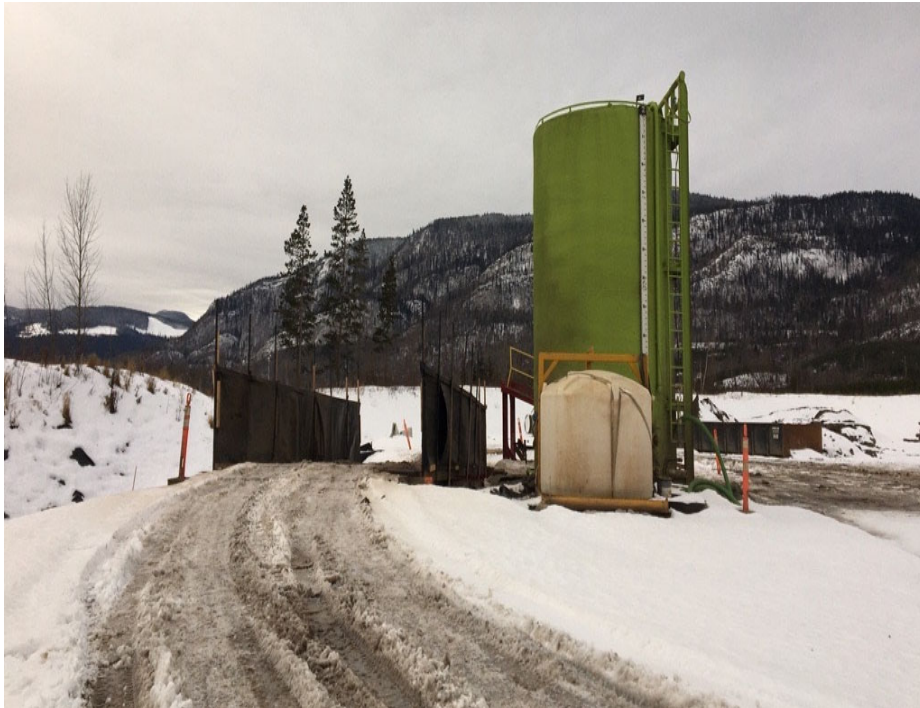
Photo 19: Sukunka Laydown 12 - Geotextile walls added to wash station.

The carwash location design has been revised and the wastewater catchment has been excavated below grade to increase storage capacity and geotextile walls added to contain materials which are dislodged from vehicles and equipment.

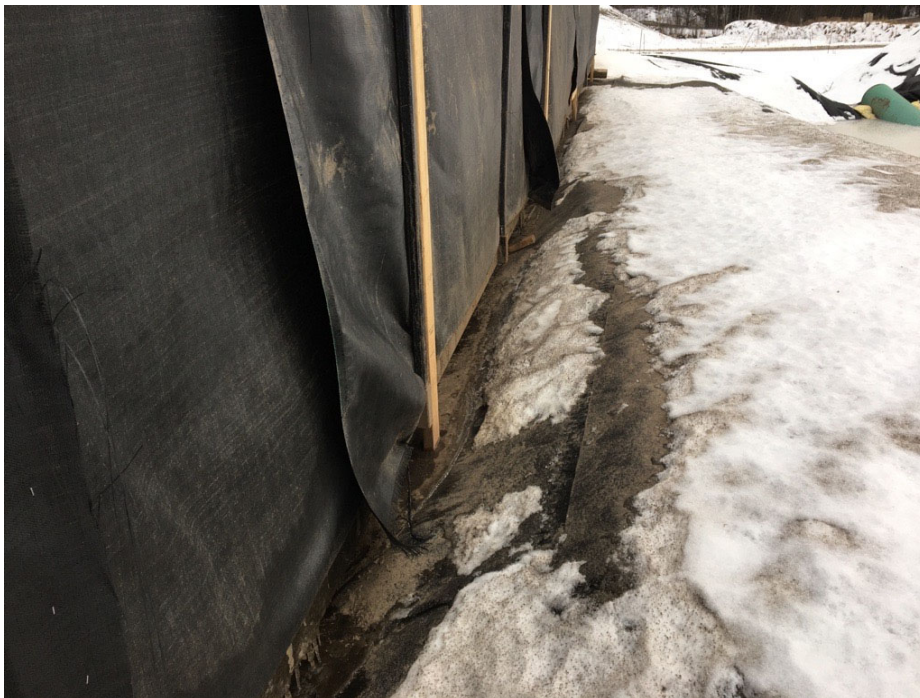
Photo 20: A view of the excavated soils outside the wash station. Note an inverted weir in the top right constructed to mitigate against hydrocarbon release.

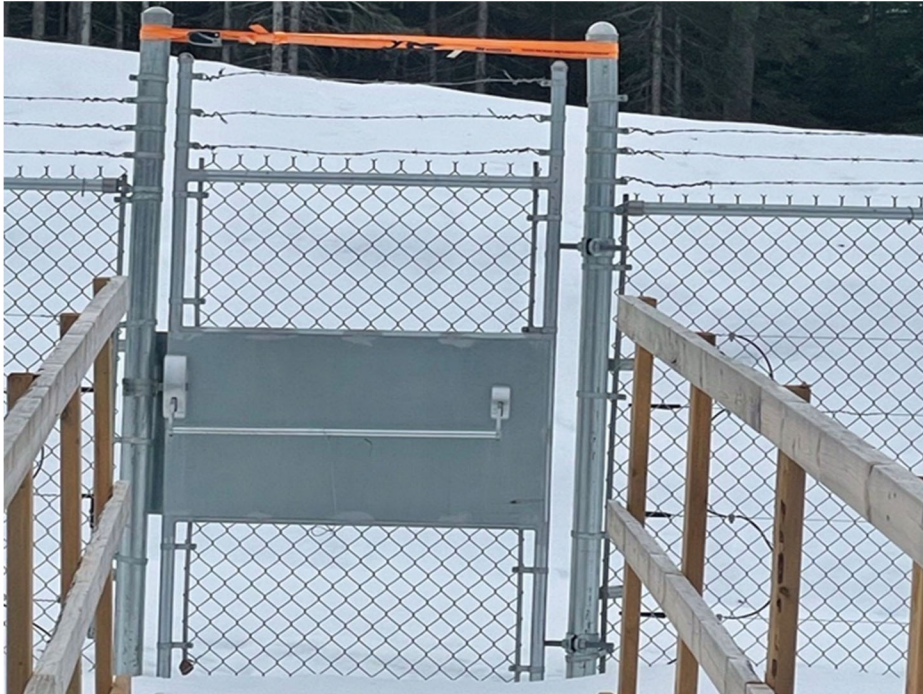
Photo 21: Headwall MUS man-gates with latches installed.

The bungy cords have been removed from the man-gates (as shown in IR2021-027 Photo 45) and replaced with latches to properly secure the gates.

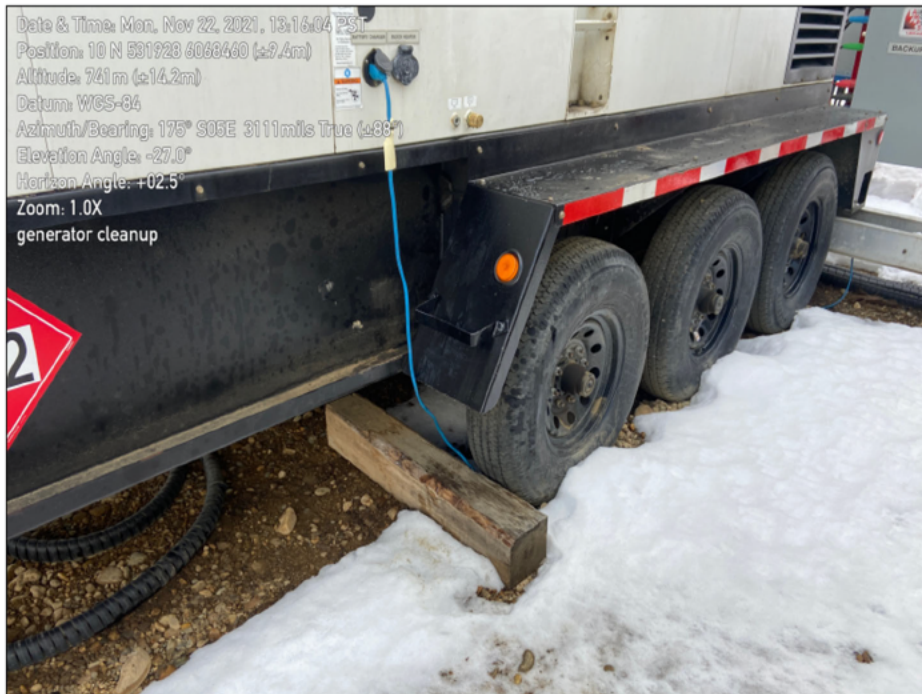
Photo 22: The spill has been cleaned up and leak repaired.

The spill to ground identified at Parsnip MUS (IR2021-027 Photo 46 and 47) has been cleaned up and repairs made to the generator to prevent further leaks.
