<b>Project Name</b>	Coastal GasLink Pipeline Project	<b>Inspection Status</b>	Final
<b>EA Certificate #</b>	E14-03	<b>Inspection No.</b>	IR2022-053
<b>Project Status</b>	Certified	<b>Inspection Start</b>	2022-10-28
<b>Sector</b>	Energy	<b>UTM</b>	10 N 552651 6093782
<b>Trigger</b>	Planned Inspection	<b>Inspection Type</b>	Field
<b>Project Description</b>	The Coastal GasLink Pipeline Project (Project) is an approximately 650 kilometer (km) long natural gas pipeline connecting facilities in northeast British Columbia (BC) to the LNG Canada facility near Kitimat.		
<b>Location Description</b>	The Project commences near Groundbirch (40 km west of Dawson Creek) in northeast BC and runs 650km west to the LNG Canada facility near Kitimat. This inspection covered work being carried out in Section 3 of Work Pack 2, in the upper Anzac River watershed. The Universal Transverse Mercator referenced above is approximately in the center of the sections of where the inspection took place.

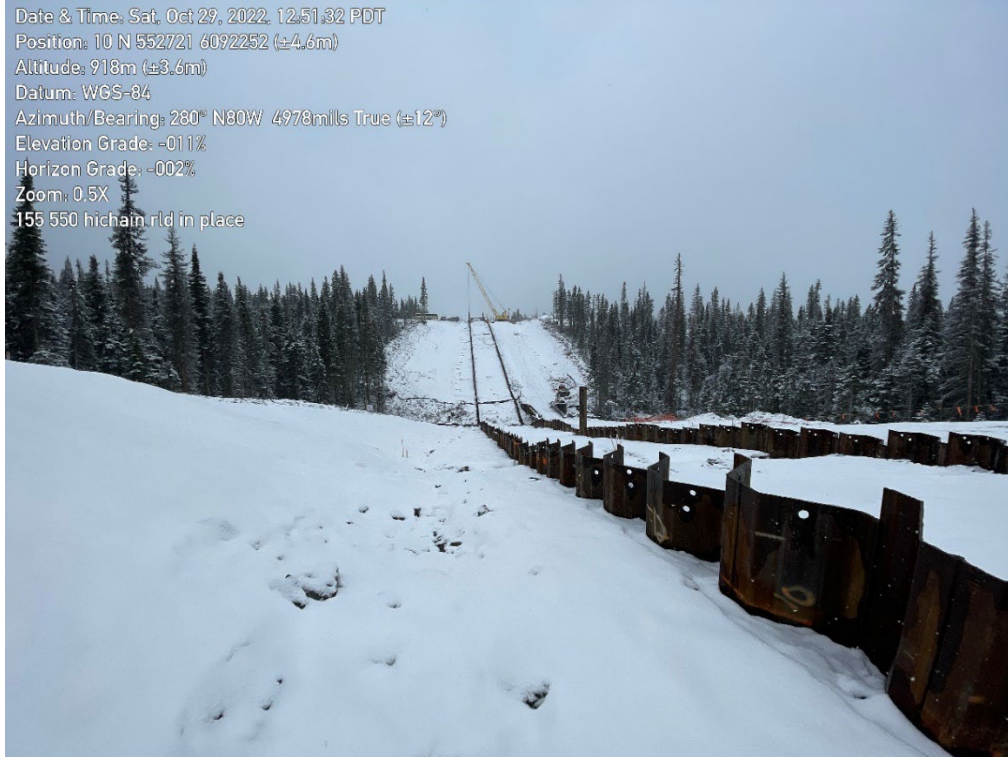
- Waterbar not installed at approximately KP154+700.
- Woody debris berm missing on hichain side of WC46C at approximately KP155+725.
- Sheet Piles were noted to be installed between approximately KP155+550 to 156+825. The sheet pile walls intercept the waterbars specified by the WEPs in these locations. With the exception of the waterbars on either side of the ESR, there are no voids or openings in the sheet pile wall to allow the waterbars to function. See Photos 1 and 2. See also requirement 4 with respect to maintenance of the waterbars where voids have been cut in the sheet pile wall.

Photo 1: overview of sheet pile walls intercepting waterbars at approximately KP155+550, looking hichain. Waterbars do not penetrate the sheet pile with exception of lowermost waterbar on either side of watercourse and will not function as prescribed by the ESCP.

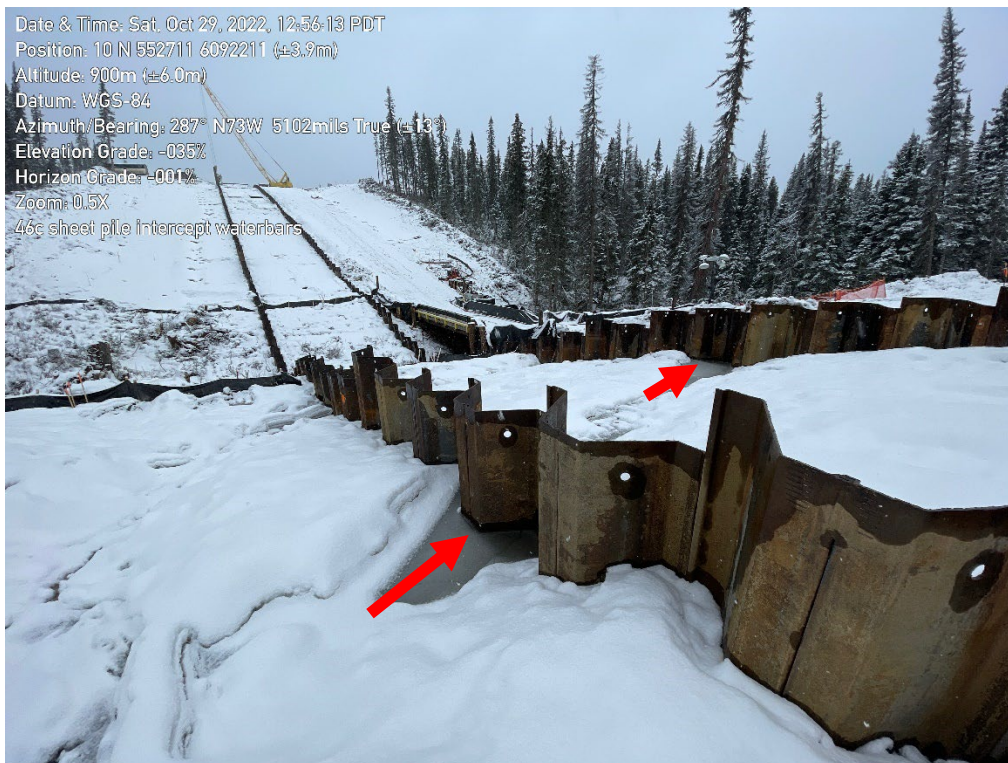
Photo 2: Sheet pile walls intercepting waterbar at approximately KP155+675. Note lack of opening in sheet pile wall.

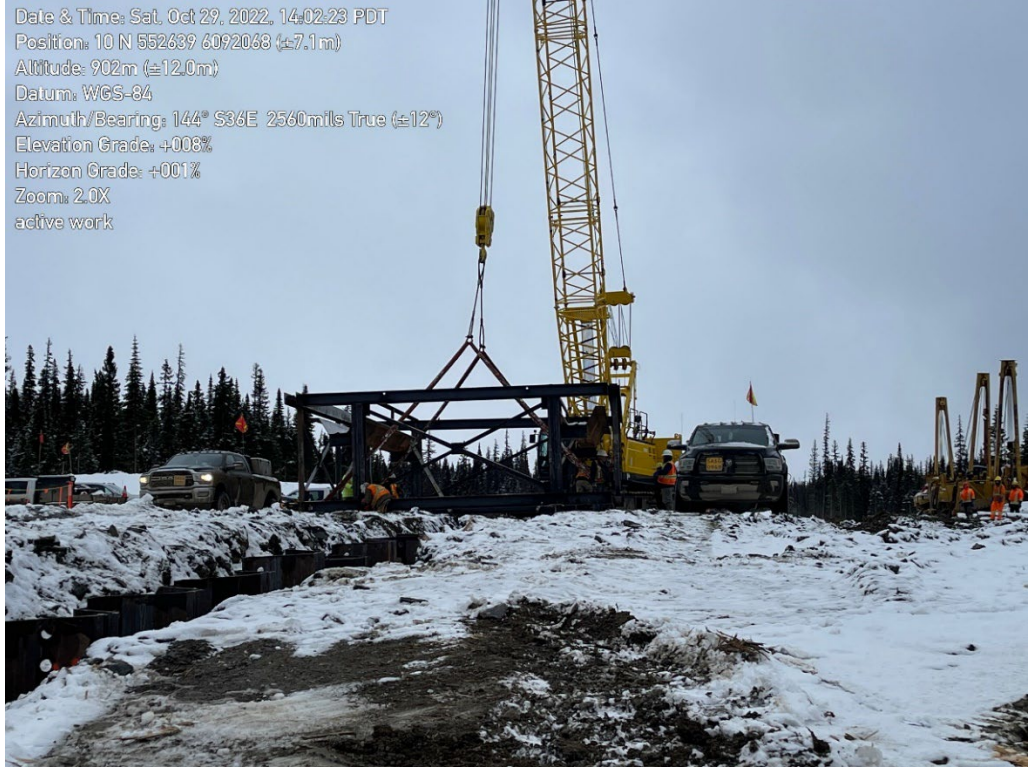
On October 29, 2022, Officer Parks observed active construction within an identified area included in the WEP for KP154+000 to 157+000. Crews were observed driving sheet pile, repositioning sheet pile equipment, welding, and operating heavy equipment (Photo 3). On October 28 and 29 EAO C&E documented noncompliance with WEP requirements within WEP KP154+000 to 157+000 (See Requirement 1). Clause 1 of EN2022-028 states that construction may not occur within any Identified Area unless in full compliance with an Approved WEP.

Photo 3: Active construction in WEP KP154+000 to KP157+000, October 29, 2022. Note photograph UTM for location.
