<b>Project Name</b>	Coastal GasLink Pipeline Project (CGL)	<b>Inspection Status</b>	Final
<b>EA Certificate #</b>	E14-03	<b>Inspection No.</b>	20230019_IR001
<b>Project Status</b>	Certified	<b>Inspection Start</b>	2023-04-05
<b>Officer Name</b>	Shayla Frechette (Frechette)	<b>UTM</b>	10N 551564 6087217
<b>Trigger</b>	Planned Inspection	<b>Inspection Type</b>	Field and Administrative
<b>Project Description</b>	The Coastal GasLink Pipeline Project (Project) is an approximately 650 kilometre (km) long natural gas pipeline connecting facilities in northeast British Columbia (B.C.) to the LNG Canada facility near Kitimat.		
<b>Location Description</b>	The Project is near Groundbirch (40 km west of Dawson Creek) in northeast B.C. to the LNG Canada facility near Kitimat.		
<b>Inspection Summary</b>	<p>The Project was in Construction at the time of inspection.</p> <p>Officer Frechette inspected against field and administrative project requirements.</p> <p>The following requirements were inspected against:</p> <ol style="list-style-type: none"> <li>1. Condition 10 with respect to traffic speed limits during critical timing widows for Caribou;</li> <li>2. Condition 10 with respect to Caribou

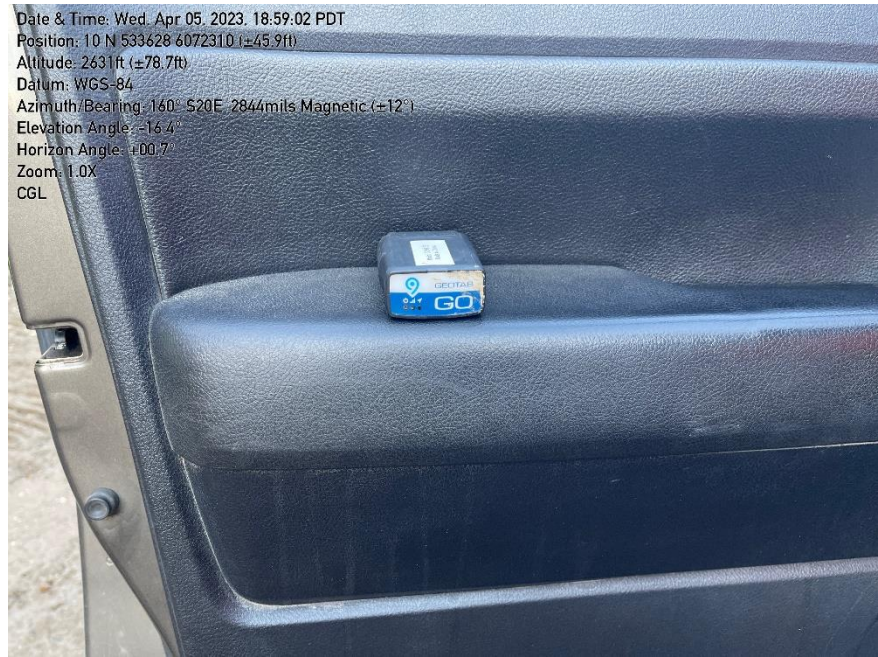
<p><b>Findings:</b></p> <p>On April 5, 2023, EAO Officers noted Project specific speed limit signs posted along the Crocker Forest Service Road within the Ungulate Winter Range for the Caribou Hart Range (KP 137.2 to 189.3). CGL representatives stated that radar is used to monitor speeds and that all Project related vehicles are equipped with in-vehicle monitors, which track and record speeds (Photo 1).</p> <p>On April 6, 2023, Officer Frechette requested information on how the in-vehicle monitors work and how these are used for employee speed monitoring and how speed limits are enforced within the ungulate winter range.</p> <p>On April 18, 2023, CGL responded with the following information: <i>“In-vehicle monitoring systems (IVMS) are best-practice components of motor vehicle safety systems employed by industry to support worker safety. IVMS are electronic devices that are installed in vehicles and enable the collection and monitoring of vehicle data focused on certain factors regarding safety and performance of the driver and vehicle, with the objective of improving road safety performance. IVMS combine the use of automatic vehicle location in individual vehicles with software that collects fleet data for a comprehensive picture of vehicle location, speed and seat belt use.</i></p> <p><i>Coastal GasLink has established minimum requirements for safe driving operations on the Project that apply to all Prime Contractors and are intended to minimize motor vehicle accidents by encouraging safe driving practices. Coastal GasLink requires all Prime Contractors to include IVMS as part of their road safety management systems.</i></p>

The observations and information obtained provides evidence of compliance with speed limits in the Ungulate Winter Range.

Photo 1: CGL in-vehicle monitor.

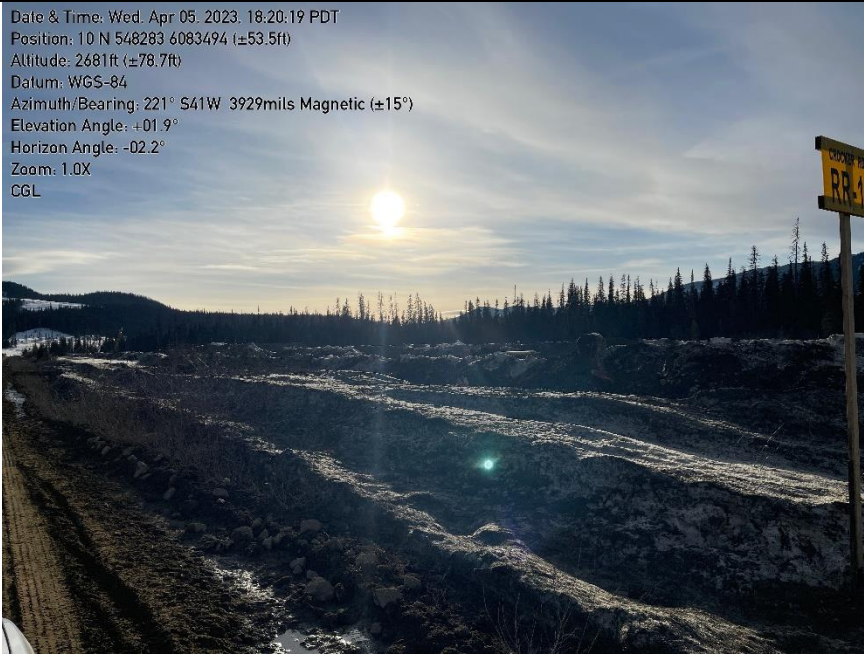
On April 5, 2023, Officer Frechette and Smith inspected for snow gaps every 500 metres (m) at portions of the ROW between KP 160 and KP 190. It was noted that the soil stockpiles and snow piles that exceeded 1.5 m high along the ROW and Shoofly Road had periodic breaks, which were no longer than 500 m each stretch (Photo 2 and 3).

The observations during the inspection provide evidence of compliance with respect to gaps in snow berms.

Photo 2: Snow piled along ROW approximately 450 m long.

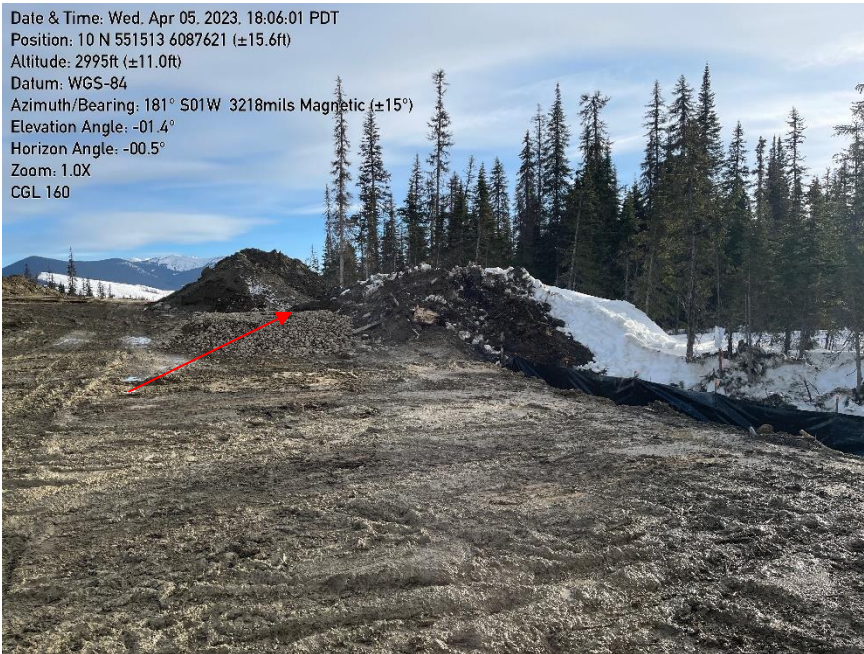
Photo 3: Gap in snow berm along ROW.

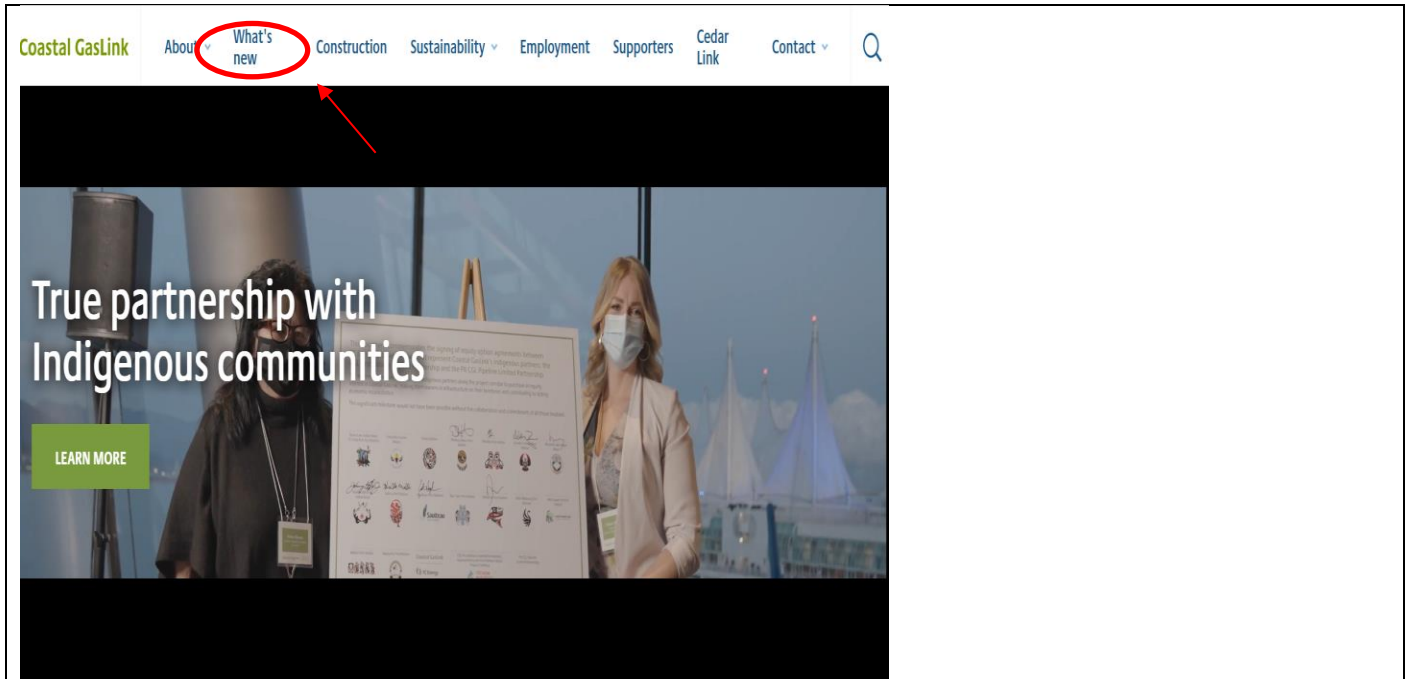
Officer Frechette conducted an administrative review of the CGL website and noted a tab called “what’s new”, which had up to date information on monthly construction updates, milestones, photographs, videos and a website link to other related information. Additionally, the website included a “newsletter signup” and a “get construction updates” signup where the public can subscribe for construction updates. Officer Frechette also noted contact information including phone numbers, a fax number and an email address (Photo 4).

The information obtained during the website review provides evidence of compliance with respect to public information.

Photo 4: Photo of Coastal GasLink website.

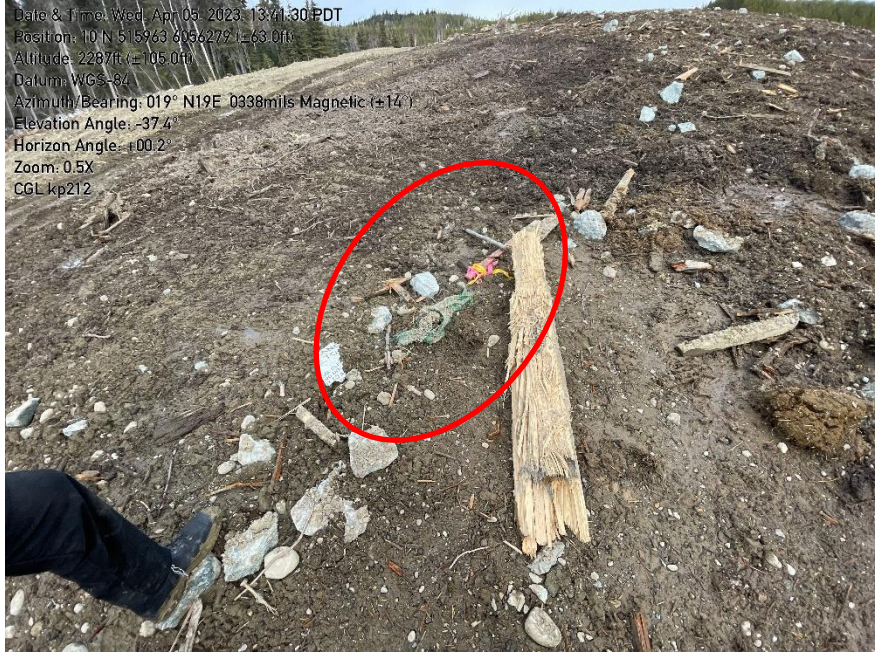
On April 5, 2023, Officer Frechette and Smith inspected the ROW at KP 212, which had recently been reclaimed. Officers noted waste including, hard plastics, fabrics, wire, screws, paper, rope, bags, signs, flagging tape and recyclables scattered along the ROW between the roll back logs (Photo 5).

The observations noted at the time of the inspection provide evidence of non-compliance with respect to non-hazardous construction waste disposal.

Photo 5: Fabric and plastic construction waste left on reclaimed ROW.

**Compliance Determination:** Out - Notice of Non-Compliance

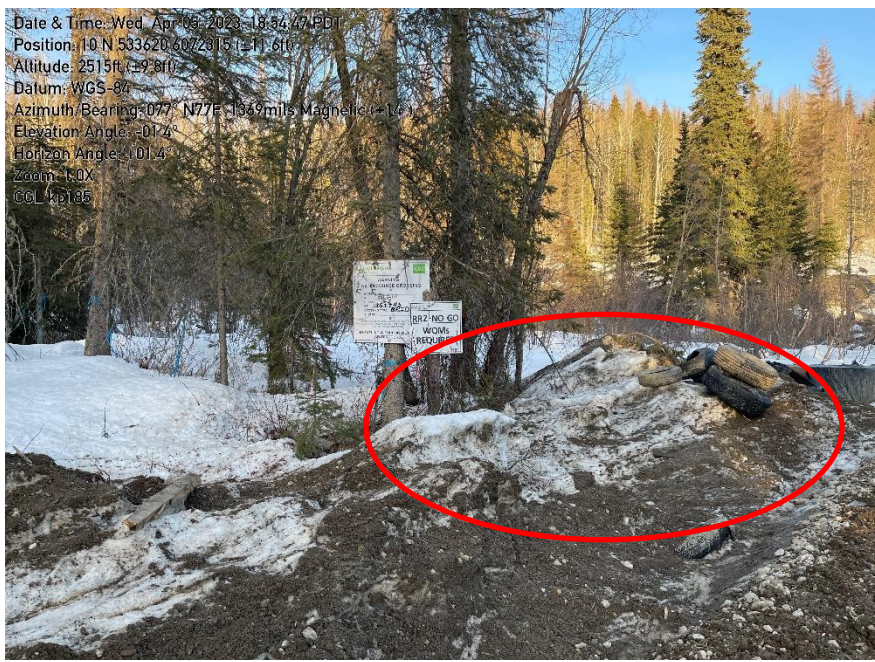
On March 15, 2023, Officer Frechette inspected Shoofly Road 15 and observed watercourse crossing BR218 at KP 185 + 746. The melting snow appeared to be plowed and pushed next to the bridge approaches rather than away from the watercourse. It was also noted that melting, dirty snow was pushed over the bridge approaching wing walls into the forested area next to the ditch, which flowed towards the watercourse (Photo 6 to 8).

The observations during the inspection provide evidence of non-compliance with respect to stormwater management near to watercourses.

Photo 6: Dirty melting snow pile next to stream crossing and ditch directed towards watercourse.

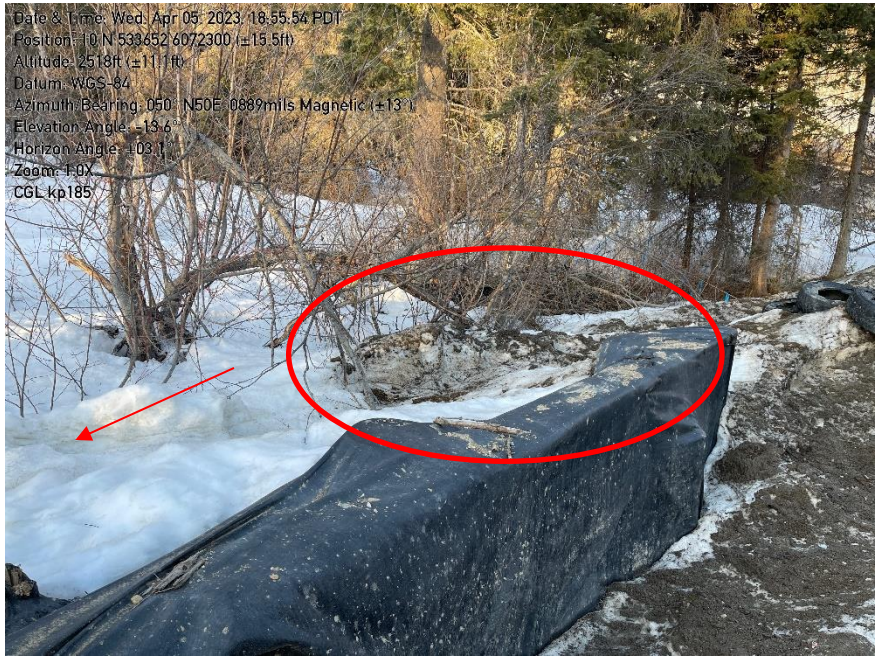
Photo 7: Dirty melting snow piled next to bridge crossing.

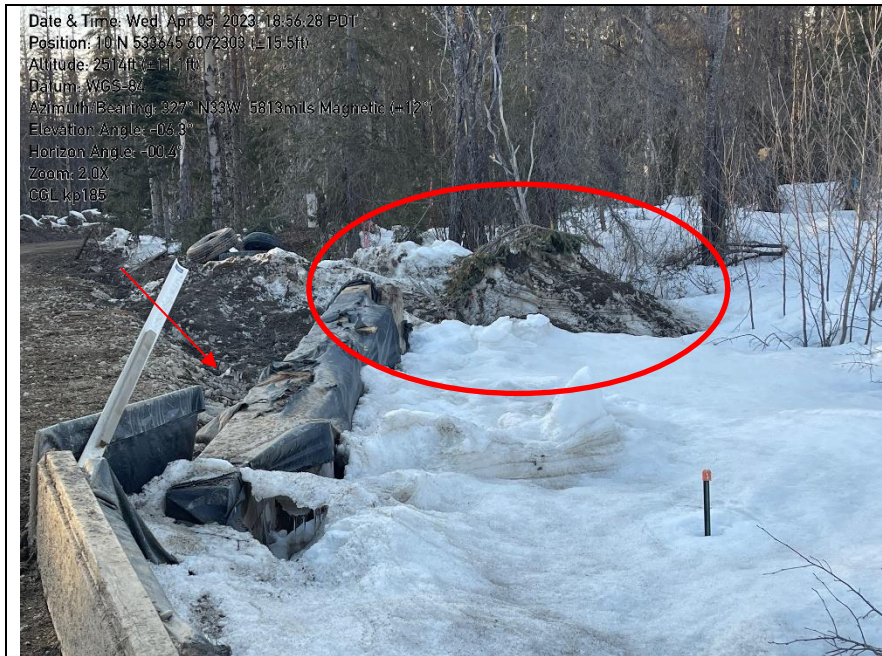
Photo 8: Dirty melting snow pile next to watercourse and ditch directed towards watercourse.

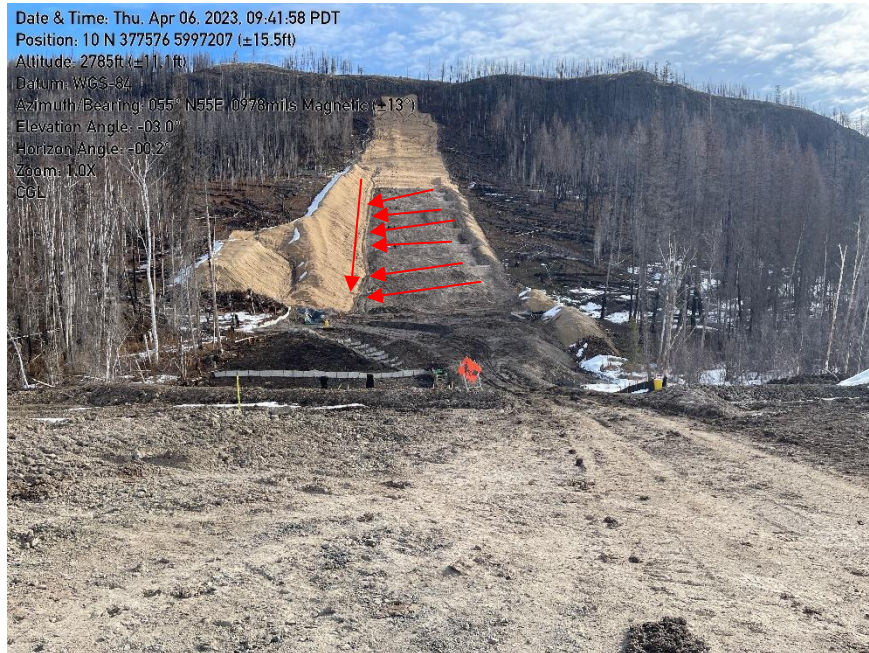
- KP381+350 to 381+575 - Missing seven correctly installed straw wattles on northeast side of ROW along cross ditch as specified by the SSECP (Photo 9 to 12);
- KP381+350 to 381+575 - Missing rock lined feature on northeast side of ROW along north to south ROW cross ditch prior to entering the east to west drainage ditch as specified by the SSECP (Photo 9 to 12); and,
- KP381+575- Topsoil piles lacking wattles at base of storage piles at bottom of slope (Photo 13).

Photo 9: View of cross ditches.

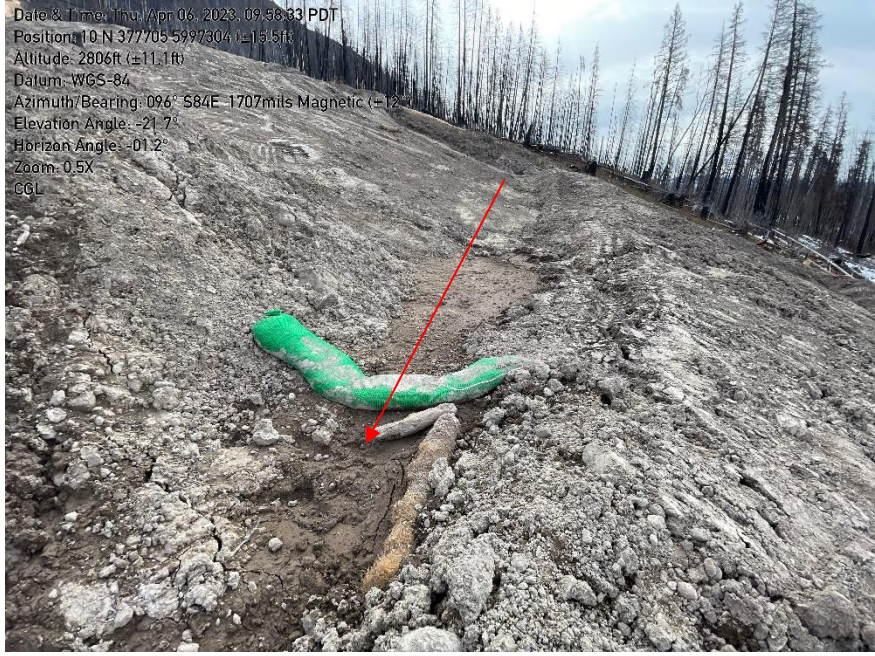
The observations noted at the time of the inspection provide evidence of non-compliance with respect to the implementation of the WEP and EN2022-028.

Photo 10: Cross ditch missing correctly installed straw wattles and missing rock lined feature.

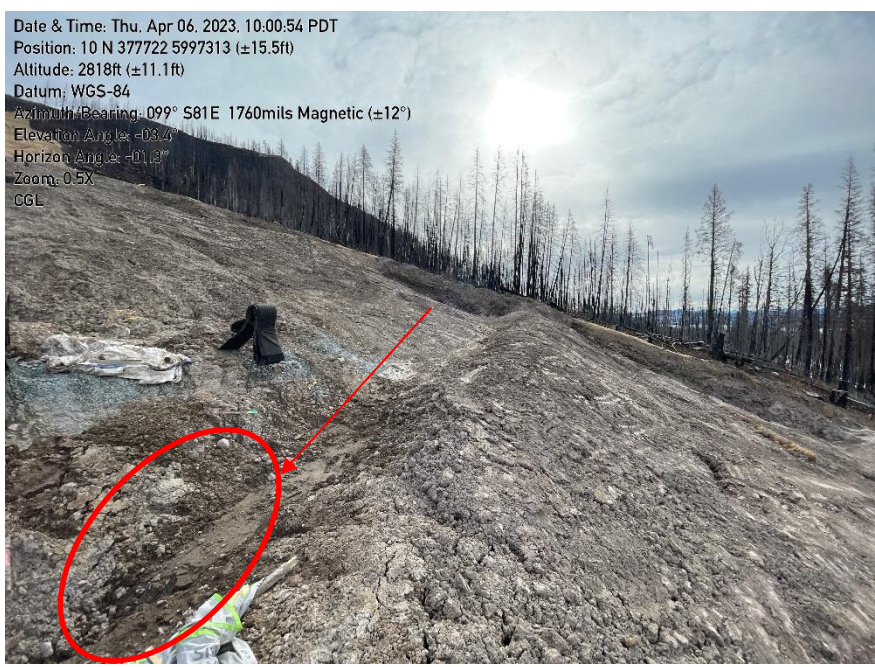
Photo 11: Cross ditch missing straw wattles and missing rock lined feature.

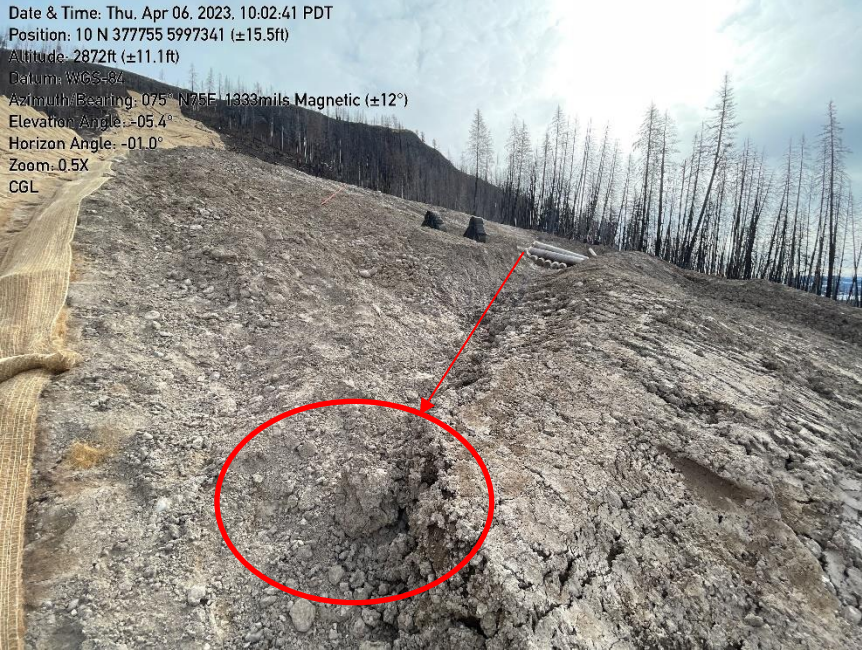
Photo 12: Cross ditch missing straw wattles and missing rock lined feature.

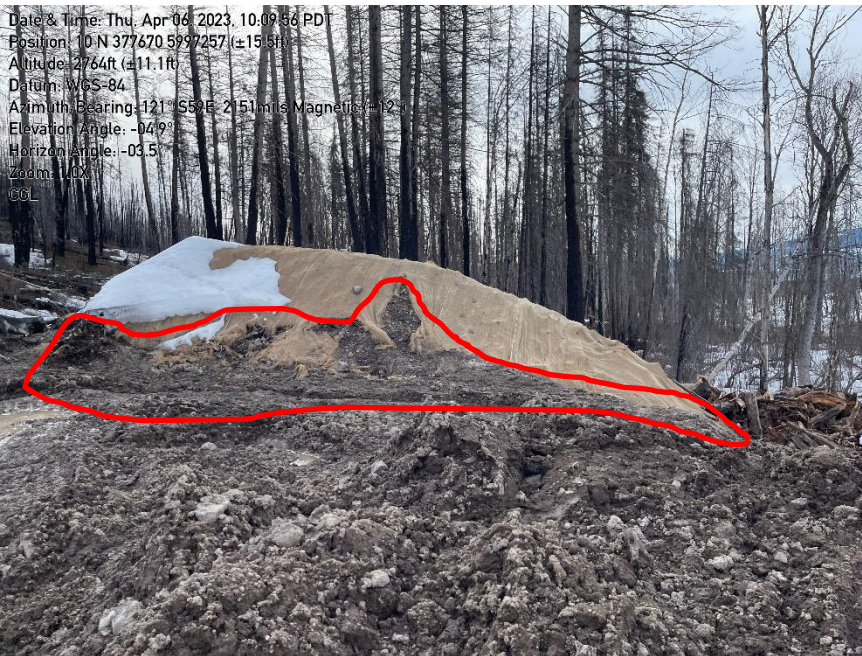
Photo 13: Soil stockpile cover in need of maintenance and missing straw wattles around base.
