## **GALORE CREEK PROJECT MEMORANDUM**

<b>To:</b>	<b>NovaGold Resources Inc.</b>	<b>Doc. No:</b>	
<b>Attention:</b>	<b>Dean Lindsay</b>	<b>CC:</b>	
<b>From:</b>	<b>L. Wilchek / J. Brash / I. Bruce</b>	<b>Date:</b>	<b>14 Nov 2006</b>
<b>Subject:</b>	<b>Galore Creek – Tailings Dam Geologic Conditions - Update</b>		
<b>No. of Pages (including this page):</b>	<b>30</b>	<b>Project No:</b>	<b>0386-003-04</b>

Subject: Galore Creek –Tailings Dam Geologic Conditions

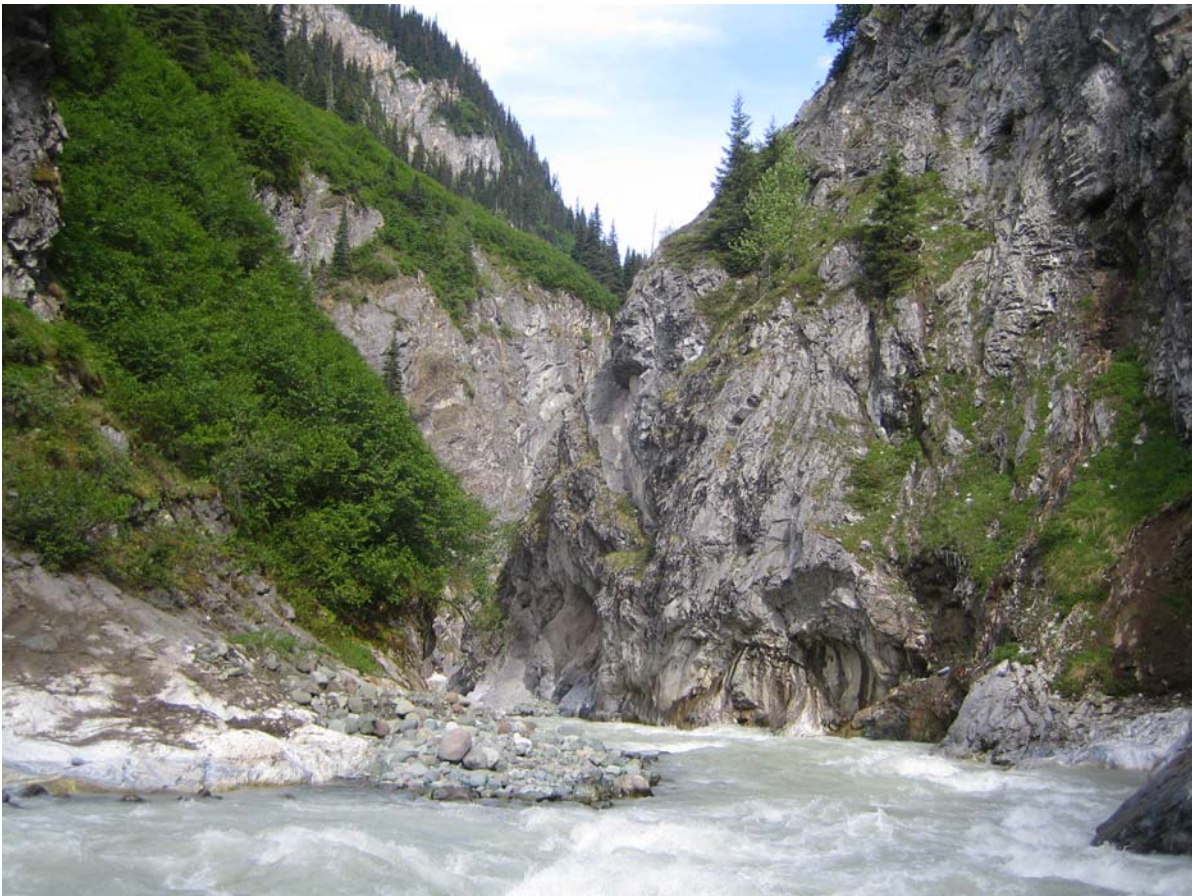
Limestone in the general area is karstic. However only minor evidence of karst has been revealed at the dam footprint by mapping. Photo 1 shows the first appearance of limestone in the valley bottom. Photo 2 shows solution widening (up to 1 m wide) of vertical joints in the steep limestone cliffs. Small cavities (up to 1 m across) are also noted on vertical limestone faces near drillhole PC06-019 (Photo 3). No large solution voids or caverns have been observed in surface limestone outcrops within the dam footprint.

Photo 1. Looking downstream (north) at limestone under footprint of tailings dam.  
June 13, 2005

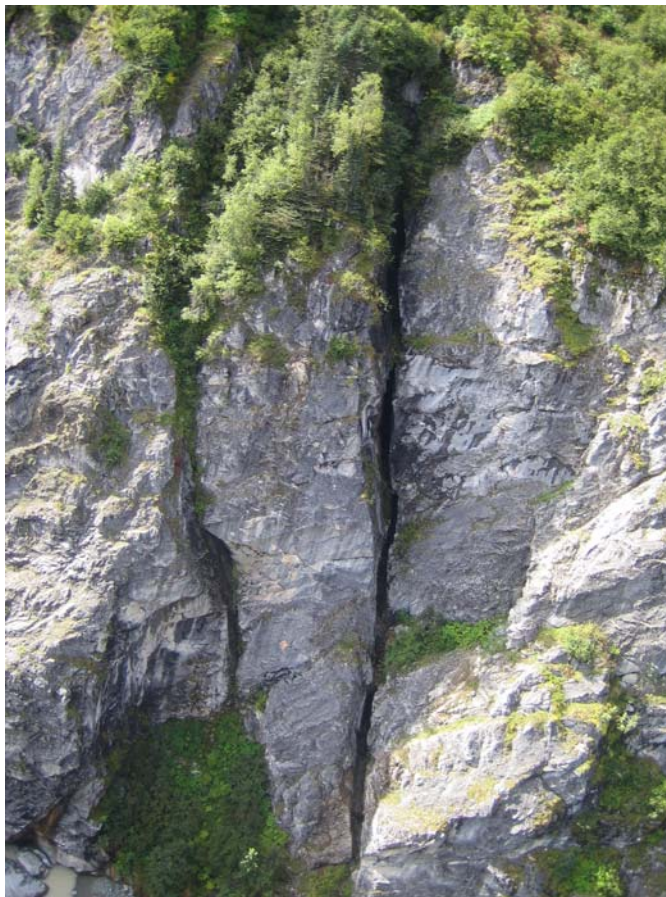
Photo 2. Joint in limestone with solution widening.  
October 2006

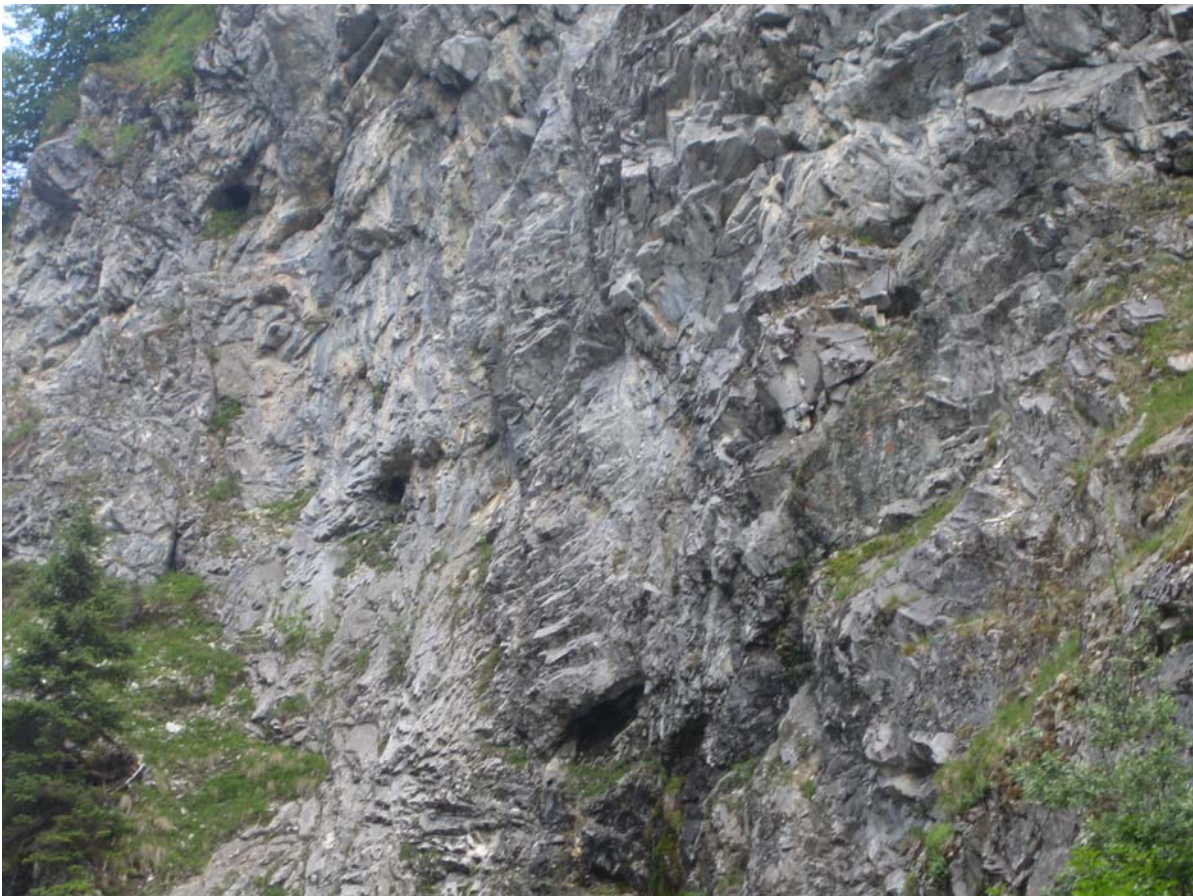
Karst in the form of crevices or small caves has been observed in the canyon downstream of the proposed dam. No large voids or caverns have been identified in the limestone to the north of the dam core during the 2004, 2005 or 2006 investigations. This karst, if it were present under the dam, could allow seepage to escape the impoundment. Although karst can be sealed with grout, NovaGold has chosen to place the impervious core of the tailings dam and grout curtain approximately 100 m upstream of the limestone / volcaniclastic fault contact. This will provide hydraulic closure and prevent water from seeping out of the impoundment through karst.

Photo 3. Karstic voids / cavities in limestone near tailings dam.  
June 13, 2005

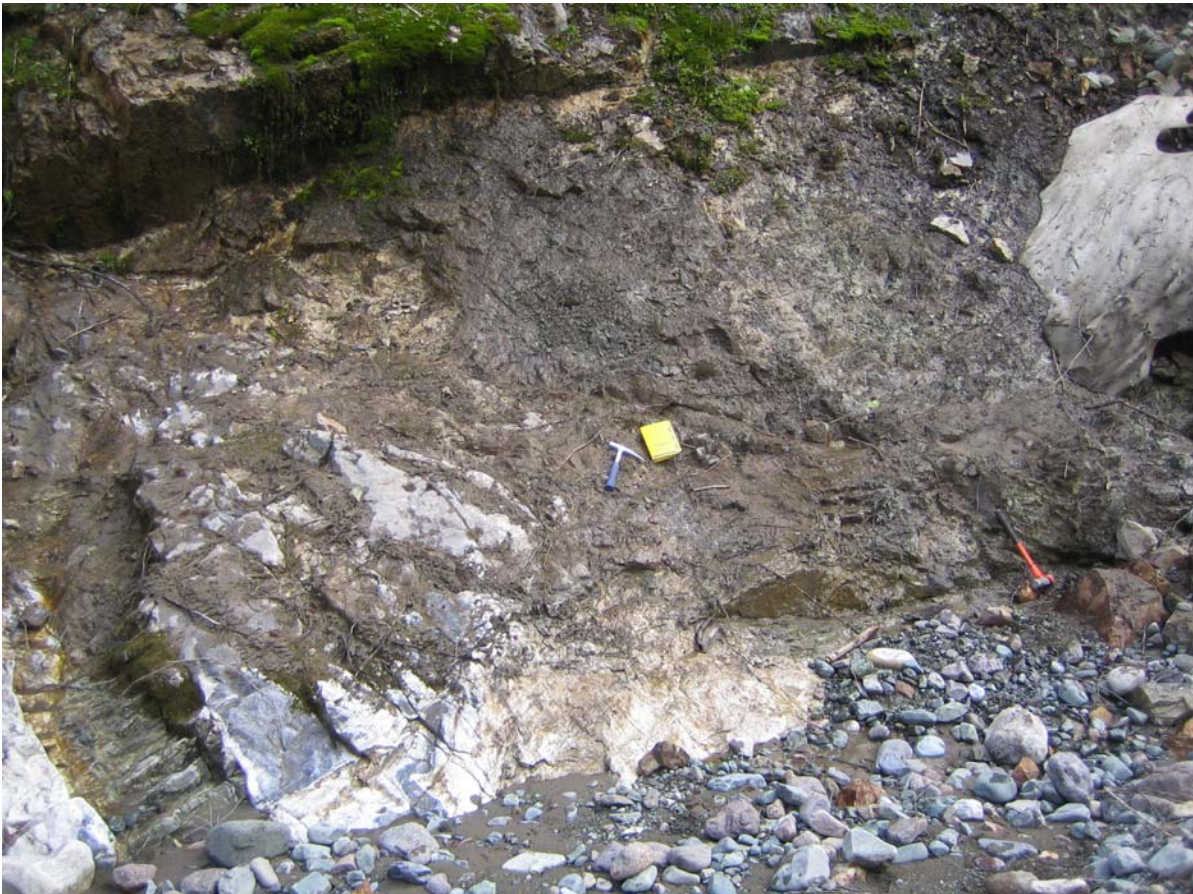
Within this fault zone, the limestone is observed to interfinger with volcanoclastic sediments, metamorphosed argillites, and intense white, heavily garnet altered marble. This interfingering may be due to splay faulting along the contact or the influence of other prominent fault sets in the area. Photo 7 shows an example of interfingering of the limestone / volcanoclastic fault contact in the valley bottom.

Photo 4. Interfingering along limestone - volcanic contact in valley bottom.  
June 2005

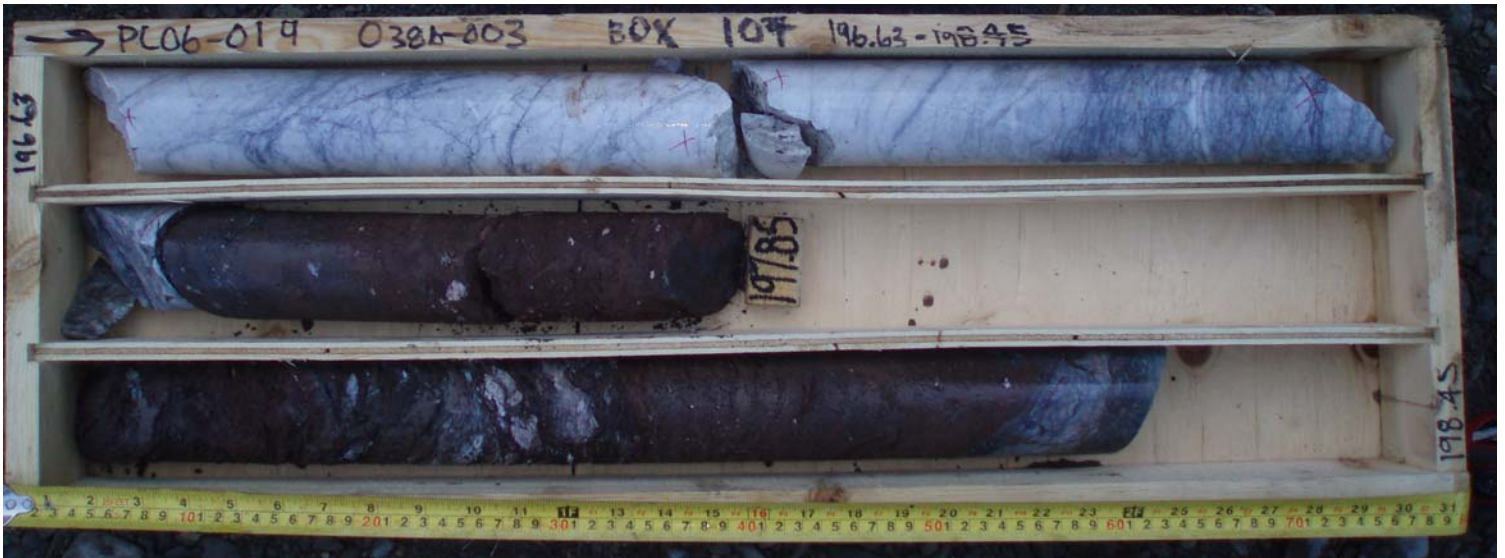
Based on these drillholes and outcrop mapping, this fault trend has been refined so that it has an approximate 45° to 55° dip with a dip direction of 210° orientation in the vicinity of the tailings dam. This fault is 6 m to to 43 m wide based on boreholes DH-BGC06-06 and DH-BGC05-03. It is typically defined by zones of clay-rich gouge up to 1 m thick, overlying weak, intensely sheared rock. The country rock above and below the zones specified in Table 2 shows shear textures and minor faulting also. Photo 4 and Photo 5 show examples of the main fault in core

Photo 5. Gouge in borehole PC06-019. Main Fault.  
June 30, 2006

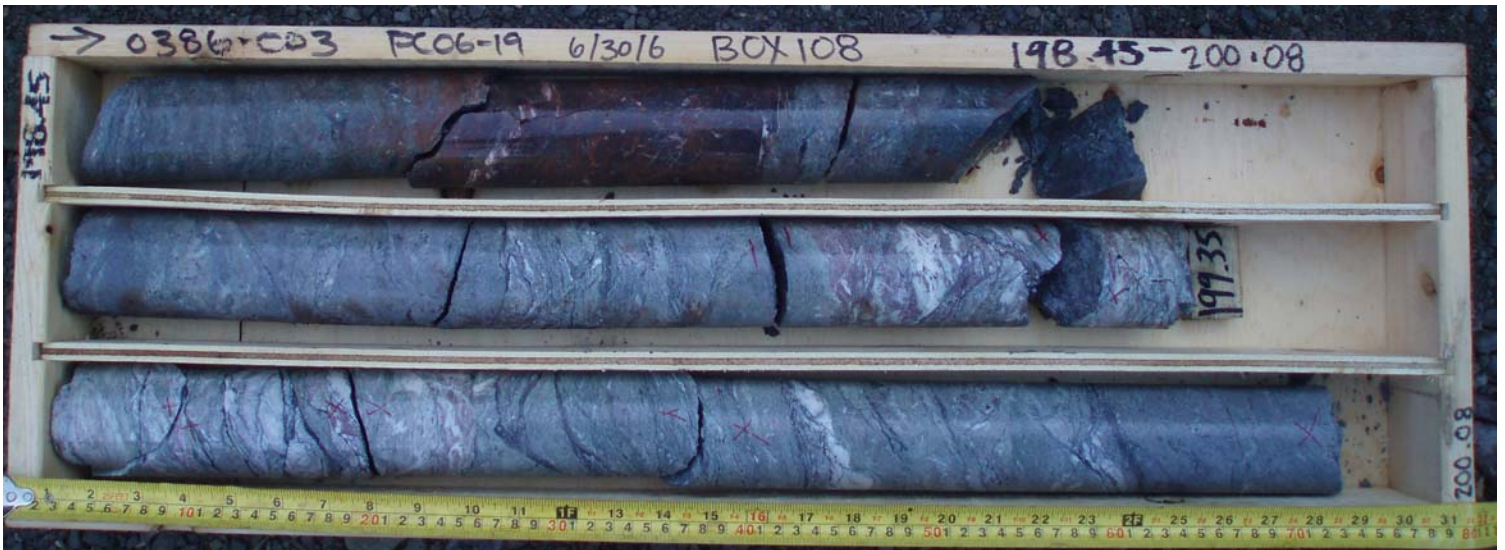
Photo 6. Gouge and shear texture in borehole PC06-019. Main Fault.  
June 30, 2006

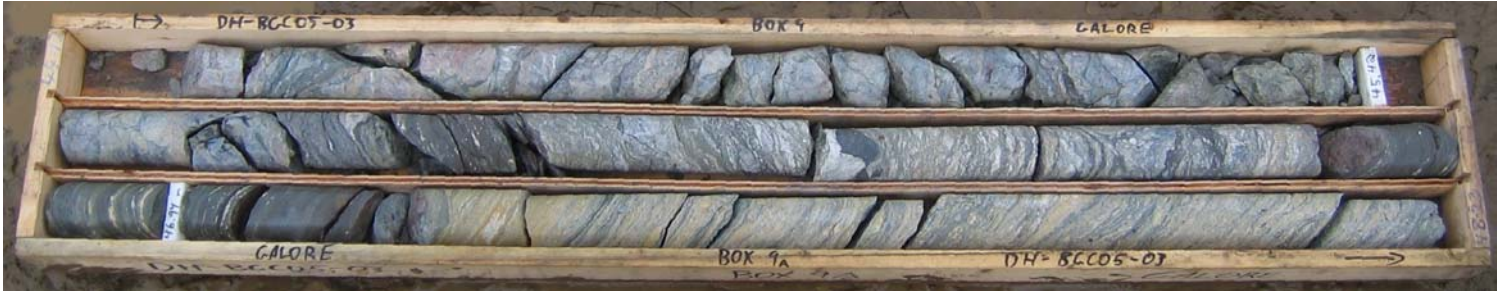
Photo 7. Gouge and shear texture in borehole DH-BGC05-03. Mylonitic Shear Zone.  
June 2005

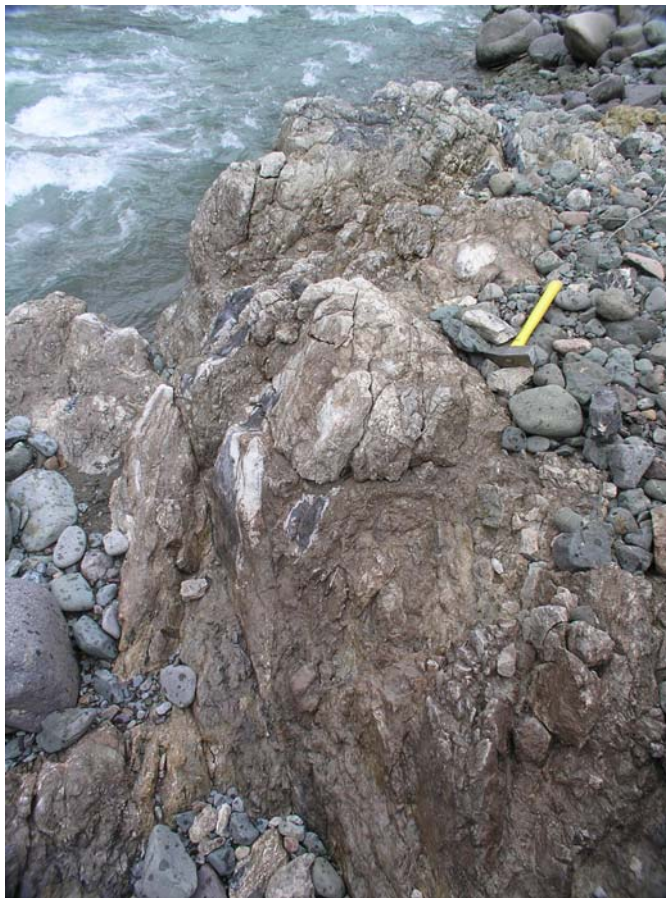
Photo 8. Shear zone contains limestone fragments in gouge - valley bottom  
NovaGold Mapping: P-Dam-6-60; Photo Date: 11 October 2005

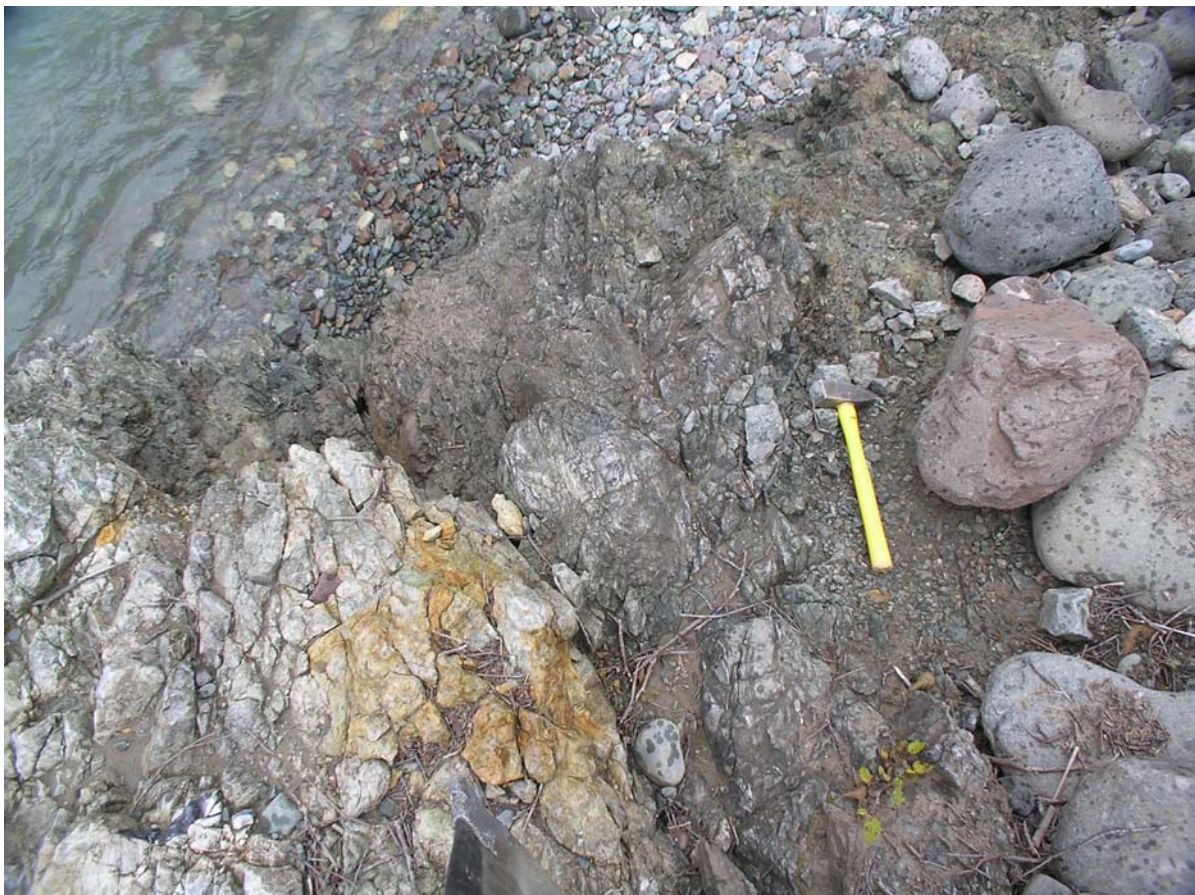
Photo 9. Shear zone contains limestone fragments in gouge - valley bottom  
NovaGold Mapping: P-Dam-6-61; Photo Date: 11 October 2005

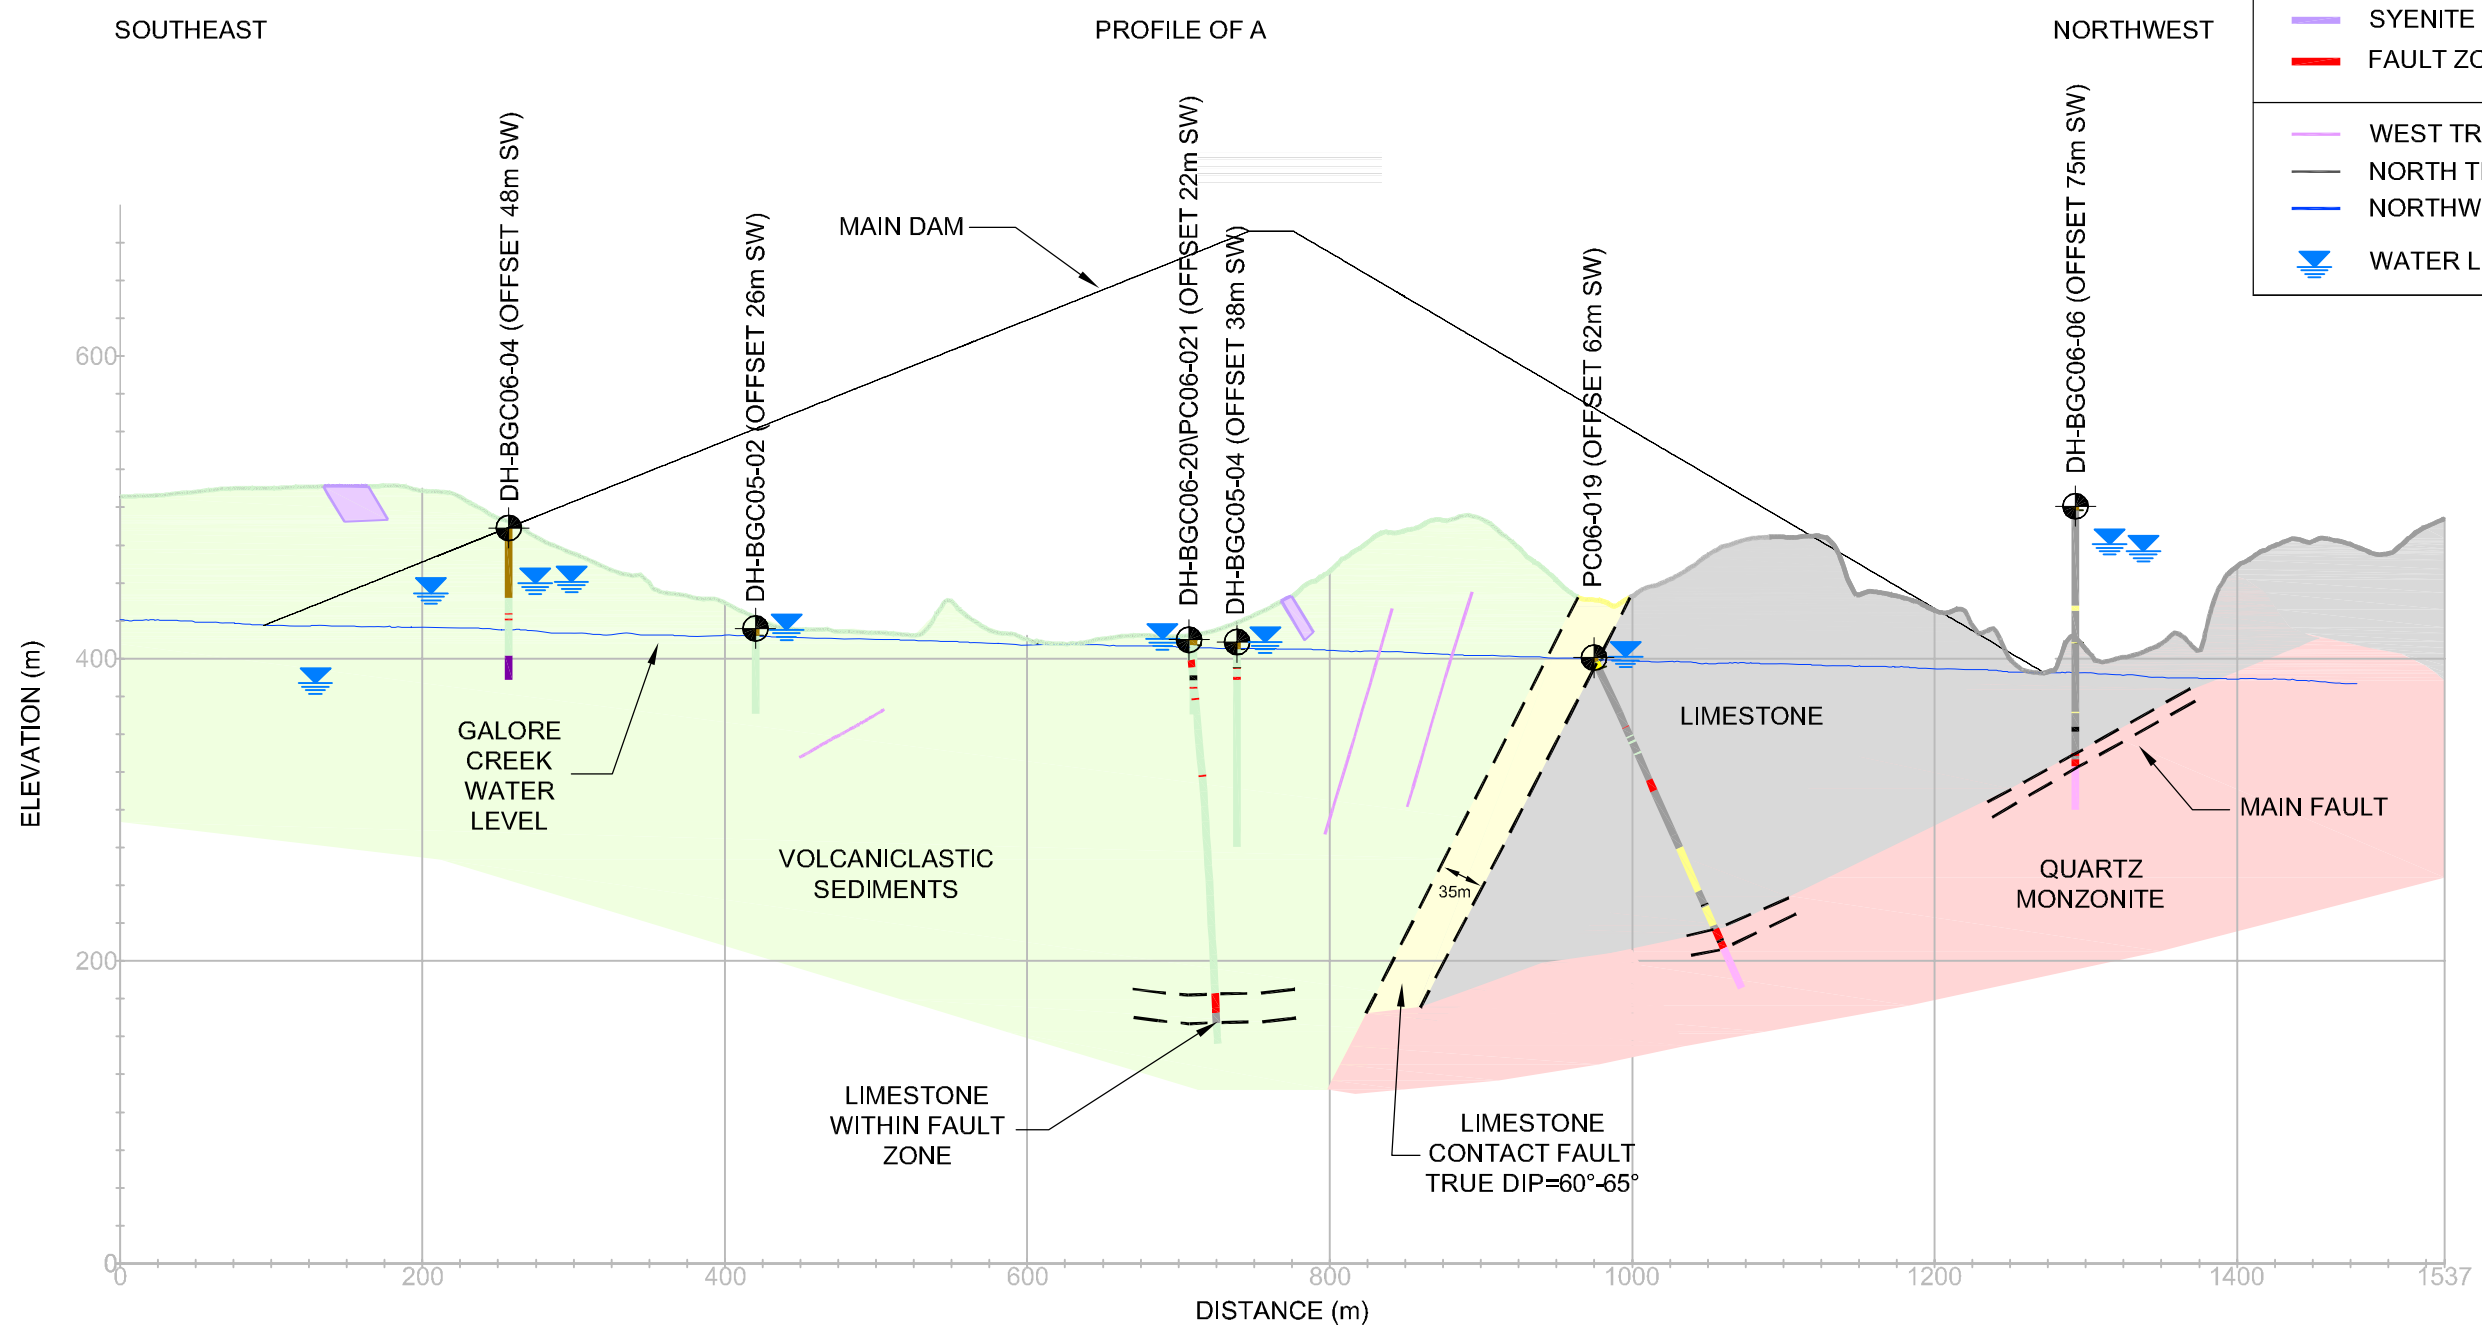
PROJECT: GALORE CREEK - BASIC ENGINEERING		
TITLE: CROSS-SECTION A-A'		
PROJECT No.: 0386-003	DWG No. 08	REV.: 0

As proposed in 2005, the contact is still considered to be a fault, likely normal and dipping to the southeast at approximately 60° to 65° - as shown in Drawing 08. The limestone, volcaniclastic sediments, argillite, and quartzite are observed to interfinger along the contact; based on surface mapping, this contact zone is approximately 35 m wide. A more detailed description of this fault contact is provided in Section 4.2.2.

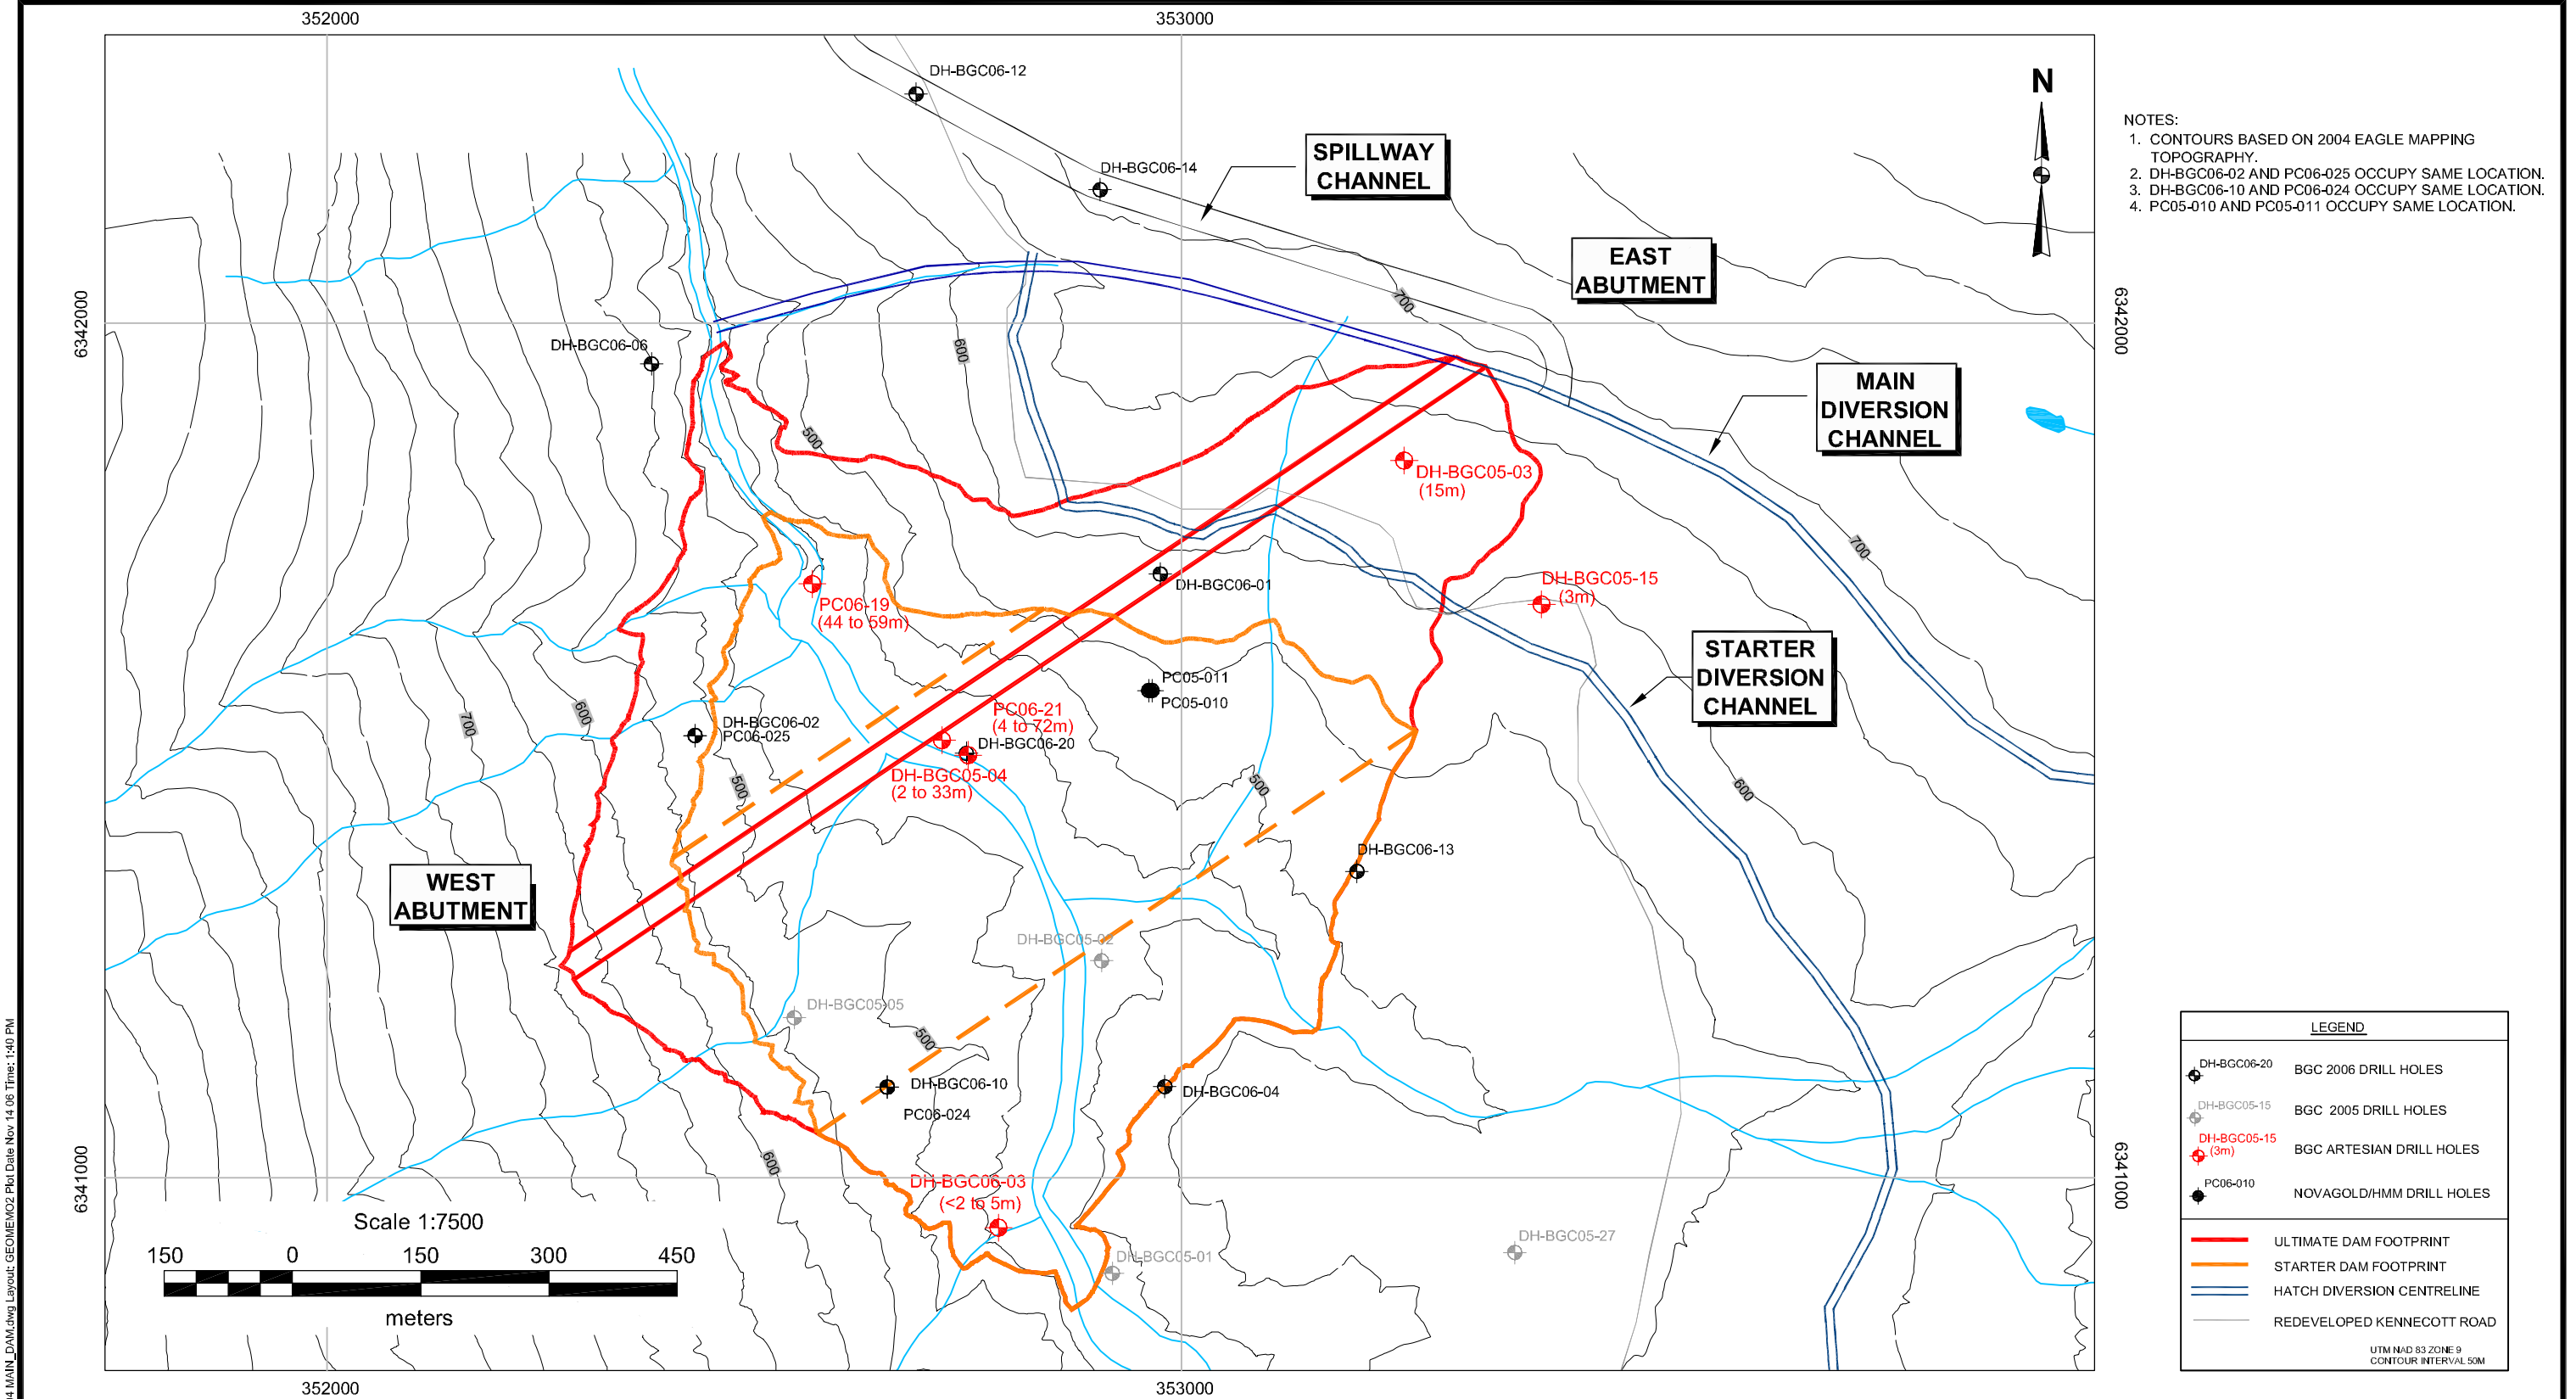
**Drawing 10 Tailings Dam – Artesian Holes**

Artesian conditions exist in a total of six boreholes beneath the main tailings dam footprint: PC06-019, PC06-021, DH-BGC05-03, DH-BGC05-04, DH-BGC05-15, DH-BGC06-03. These are shown with head levels above the ground surface on Drawing 10. In general, artesian head levels between 2 m and 33 m (i.e. meters of water above the ground surface) are measured in the volcanoclastic sediments from 0 to 70 m depth. Below 70 m, artesian head levels from 22 m to 72 m are measured.
