Environmental Assessment Office Inspection Record

Project Name:	Brule Mine	Inspection Status:	Final
Certificate #:	M06-02	Inspection No:	FY 17/18-09
Certificate Status:	Certified	Inspection Date:	2017-06-20
Region:	Peace	Office:	Victoria
Trigger:	Planned	Inspector Name(s):	Justin Carlson (EAO) Mike Olsen (MEM) Victor Marques (MEM) Laurie Meade (MEM)
Location Description:	Approximately 55km South of Chetwynd.	Sector:	Mines
Latitude:	+055.39946 °	Longitude:	-121.83279 °
Incidents of Non-Compliance Observed	Yes		
Non-Compliance Decision Matrix Level:	Choose an item.	Non-Compliance Decision Matrix Category:	Choose an item.
Inspection Summary:	<p>This record details the results of an inspection against the requirements attached to Environmental Assessment Certificate (EAC) # M06-02, that occurred on June 20, 2017. The inspection was conducted by Justin Carlson, Compliance and Enforcement Officer, BC Environmental Assessment Office (C&E Carlson) and the following representatives from the Ministry of Energy and Mines: Mike Olsen, Inspector of Mines - Interagency Coordinator Compliance and Enforcement (MEM Olsen), Victor Marques, Senior Geotechnical Inspector (MEM Marques), and Laurie Mea

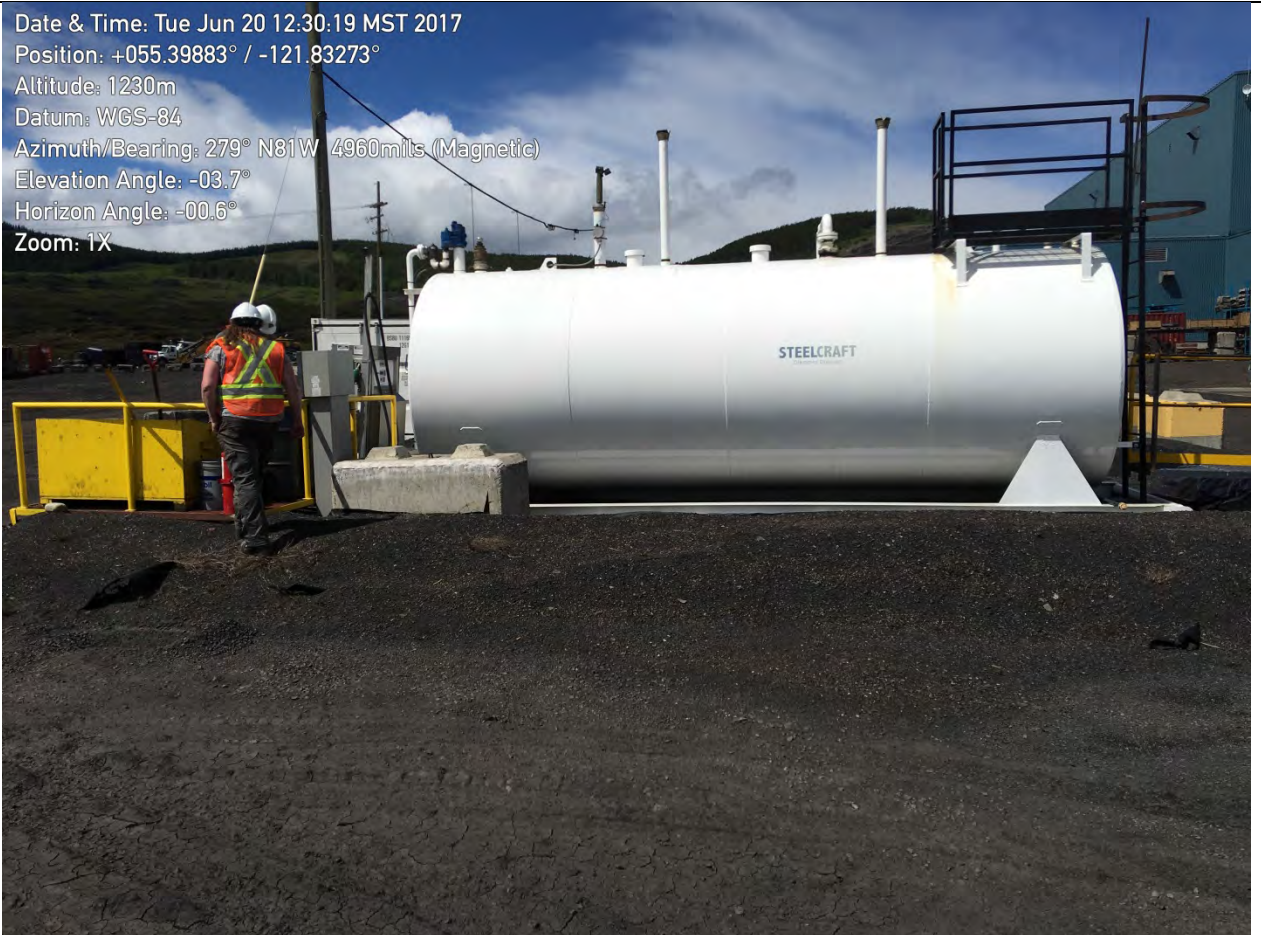
Types of Compliance:	Operations
Requirement Description:	<p>Commitment #4 of Schedule B</p> <p>The Fuel Management Plan</p> <p>Brule Mine Project contractors will be required to comply with the Project Fuel Management Plan</p>
Findings:	<p>EAO C&E had previously conducted an inspection of the Brule Mine on July 21, 2015. At the time of inspection, a bulk fuel tank located near the office trailers was identified on site lacking the required concrete barriers to prevent potential vehicle collisions with the tank. EAO C&E had requested that this non-compliance be remedied prior to the mine starting up again.</p> <p>The same tank was observed on this inspection:</p>

Bulk fuel tank located near the office trailers lacking the required concrete barriers.

The Project resumed operation in late 2016/early 2017 and has not installed the concrete barriers as required.

An update was provided by Conuma representative Dan MCNEIL on August 9, 2017 including the following photo:

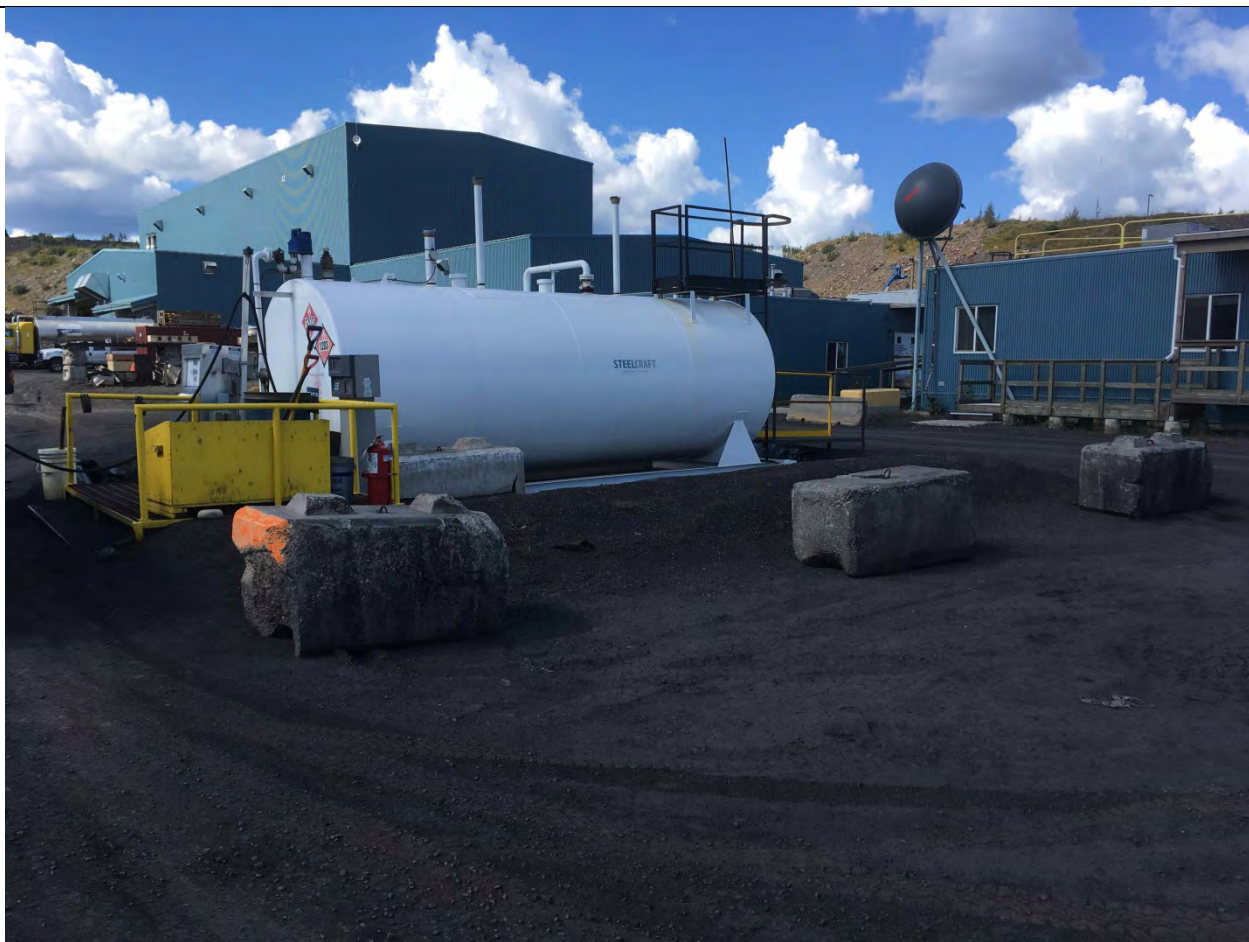
Photo of concrete blocks around the fuel tank provided by Dan MCNEIL on August 9, 2017.

The above image appears to provide a resolution to the non-compliance.

This requirement will be inspected against in a future inspection.

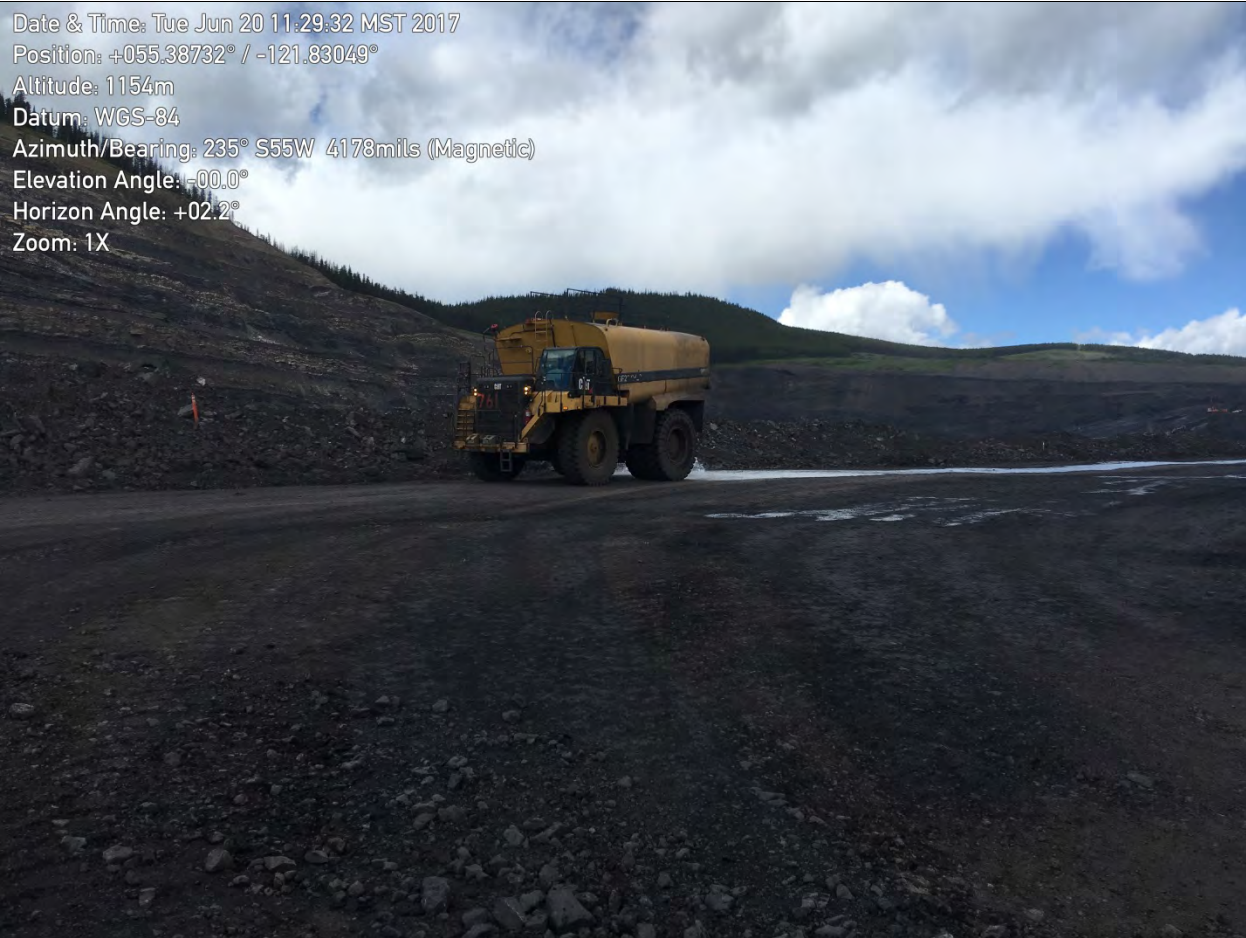
<p>Water truck operating on a mine haul road.</p> <p>The above image provides evidence of compliance with this requirement.</p>
Compliance:	In

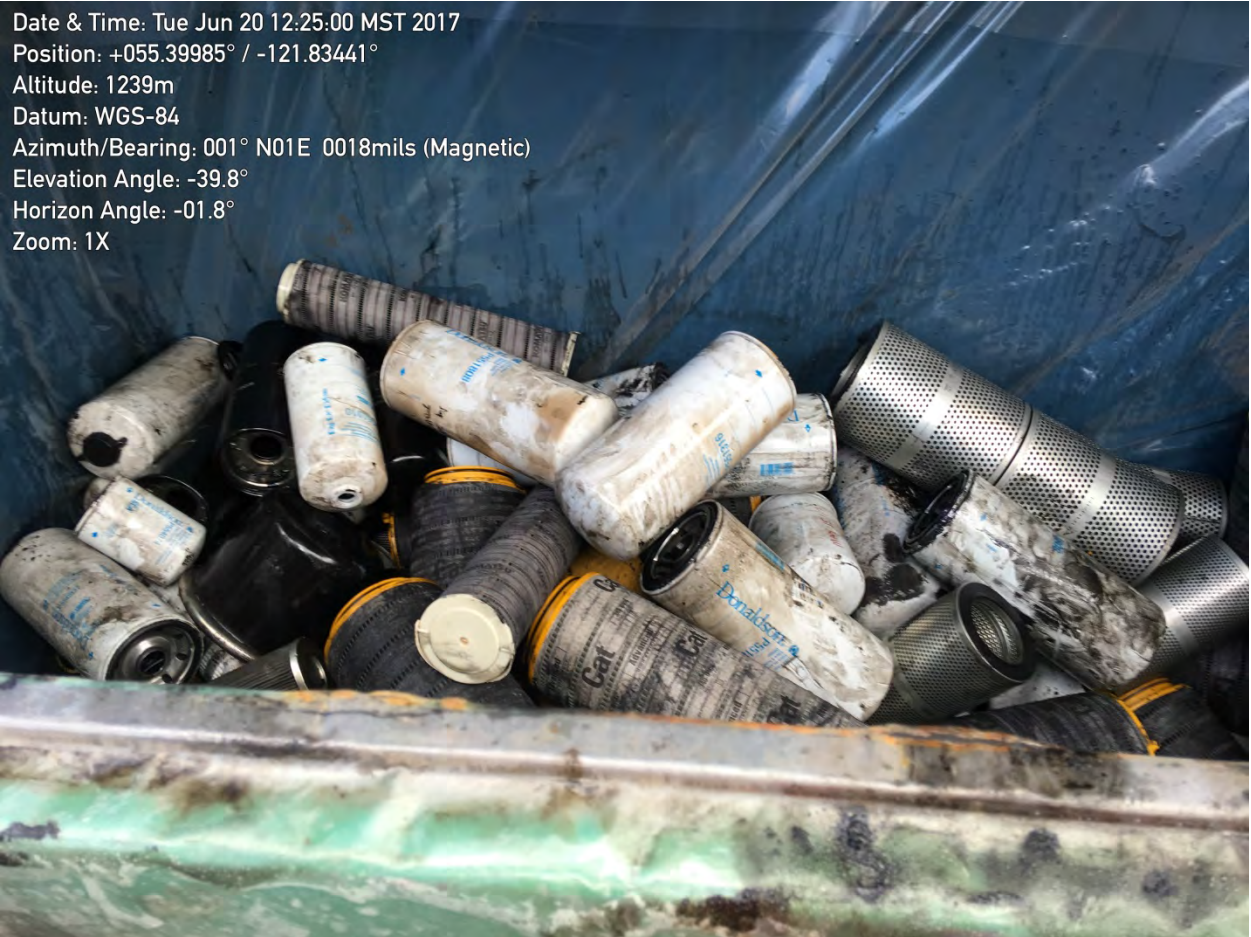
</div> <p>Hazardous waste disposal bin containing oil filters and other used hydrocarbon products.</p>

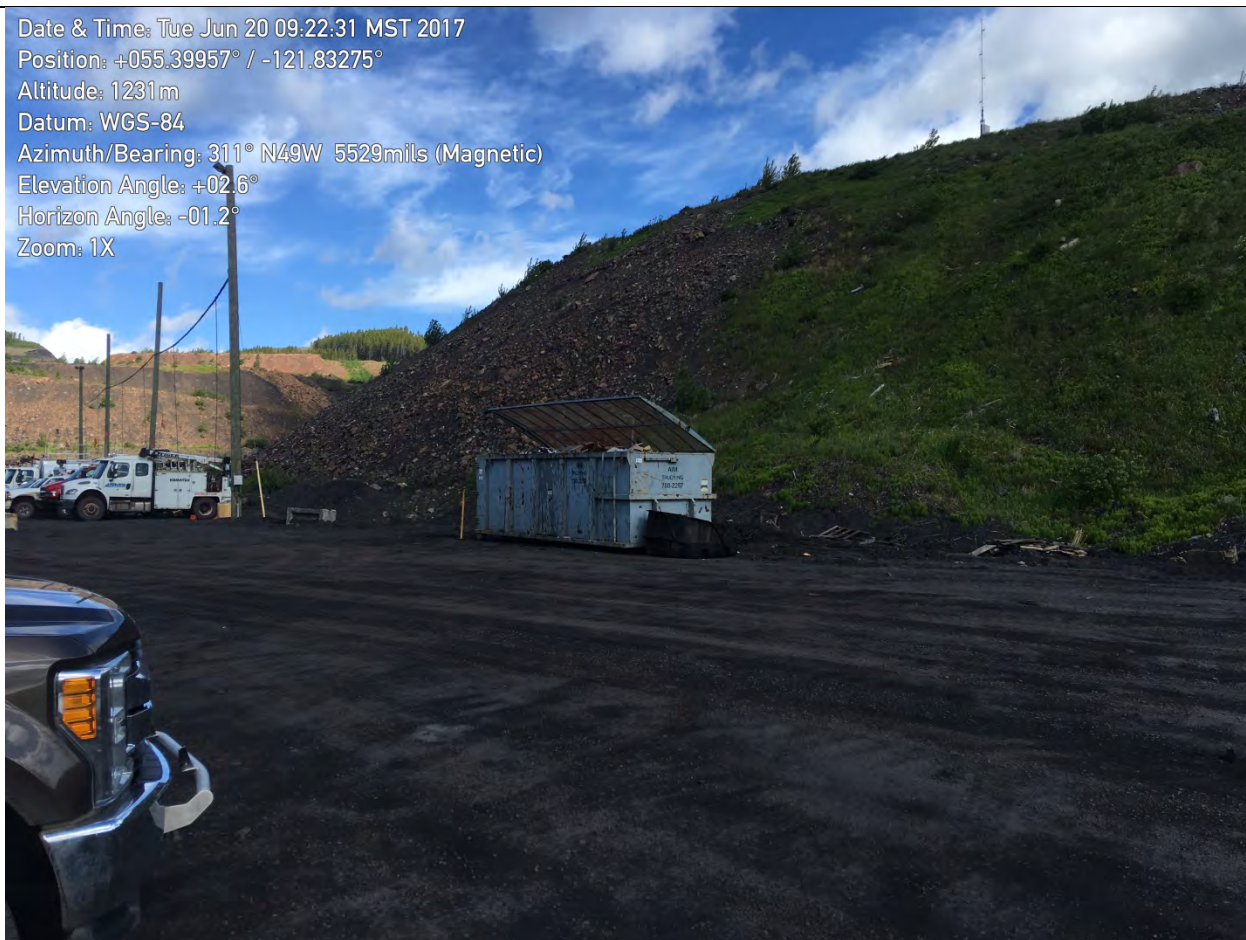
Open construction waste bin containing food and recyclable materials.

The lack of waste segregation in the open bin above is evidence of non-compliance with the requirement to implement a Waste Management Plan.

EAO C&E is unaware of any adverse effects as a result of this non-compliance.

A copy of the newly developed Waste Management Plan was provided to EAO C&E (Appendix F). Section 4.0 of The Waste Management Plan states:

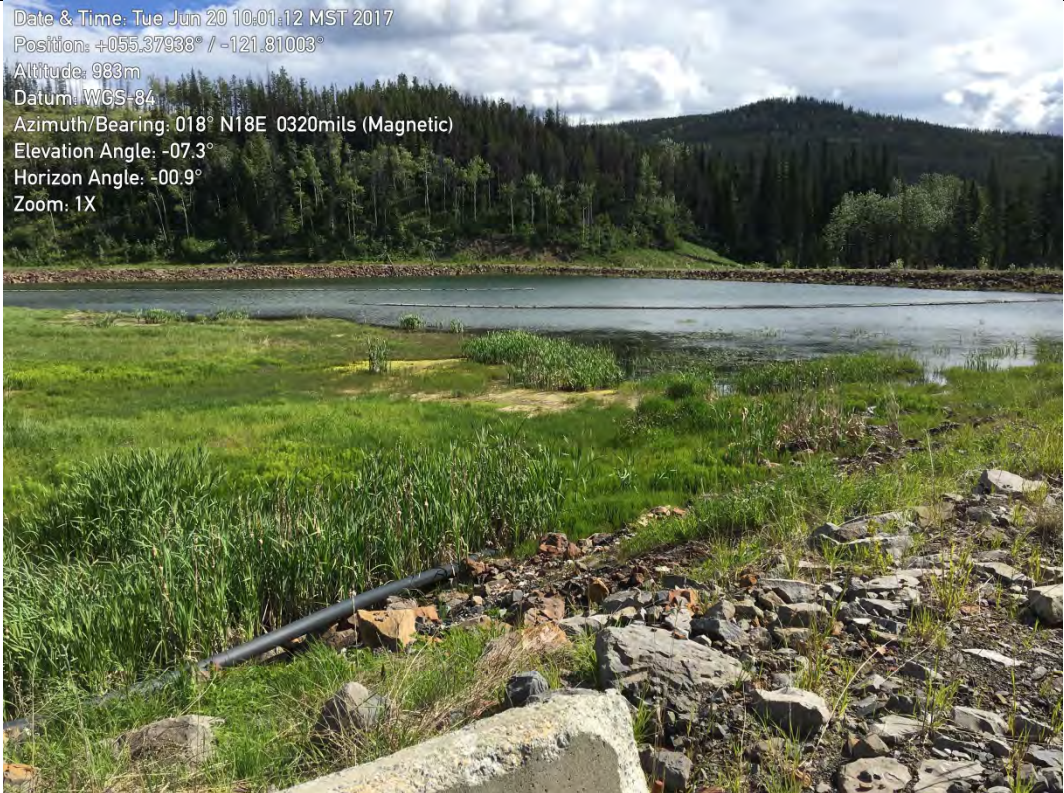
SP 2 with riprap.

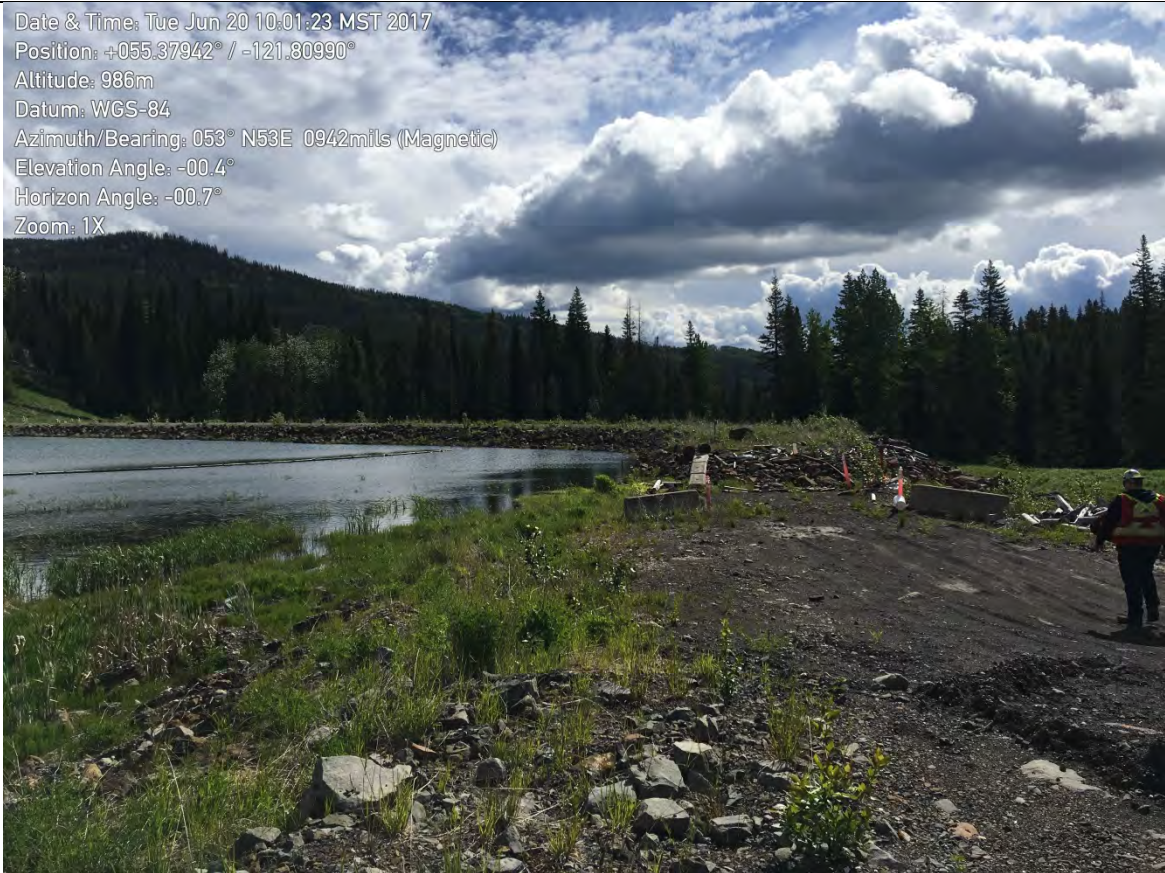
<p>SP2 with riprap.</p> <p>SP2 has been riprapped. According to CALDWELL, rip rap was completed prior to influent flow.</p> <p>The above evidence provides evidence of compliance with this requirement.</p>
Compliance:	In
