Project Name	Coastal GasLink Pipeline Project	Inspection Status	Final
EA Certificate #	E14-03	Inspection No.	20230027_IR003
Project Status	Certified - construction	Inspection Start	2023-05-26
Officer	Lombardi	UTM	9U 600010 E 6007241 N to 9U 589850 E 6007975 N
Trigger	Unplanned Inspection	Inspection Type	Field
Project Description	The Coastal GasLink Pipeline Project (Project) is an approximately 650-kilometre (km) natural gas pipeline connecting facilities in northeast British Columbia to the LNG Canada facility near Kitimat.		
Location Description	The Project initiates near the community of Groundbirch and terminates near Kitimat. This inspection covered works in Sections 7.		
Inspection Summary	<p>The Officer inspected the Project right-of-way (ROW) between kilometre post (KP) 565+400 to 576+500. At the time of the inspection, this area of the Project was under Order 20230027_OR001 (Appendix 1), which requires that all activities that advance the completion of the Project, except for those activities specific to erosion and sediment control and those necessary for the watercourse crossing of Gosnell Creek, cease until EAO Compliance and Enforcement Branch (CEB) has conducted a sit

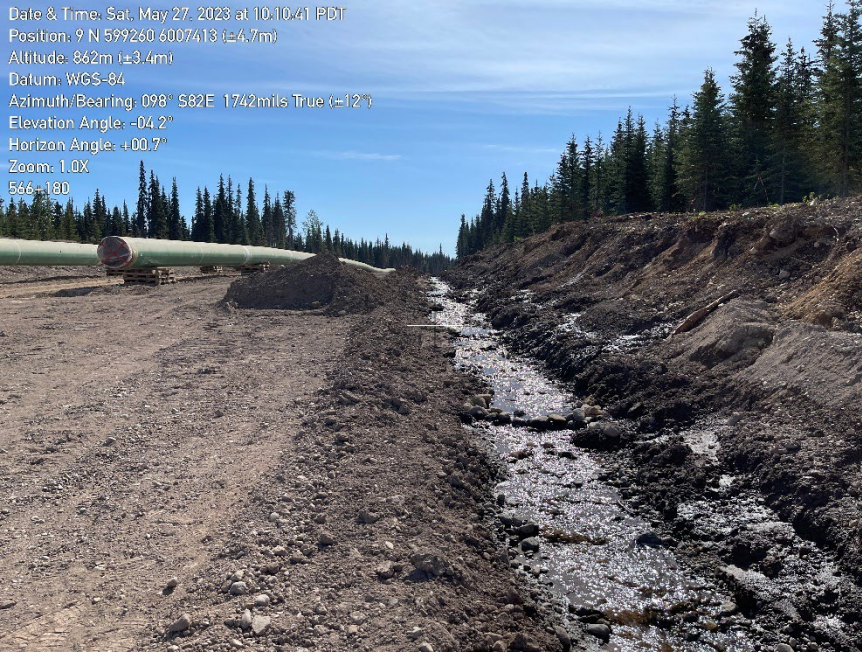
- Lined ditch at KP 566+000 was not present. The OJ Pipelines Erosion and Sediment Control Specialist identified that the feature had been deactivated to allow non-classified drainage (NCD) J430.02 to flow into an unlined ditch on the south side of the ROW, and that the change was documented in a field fit submission. The May 11, 2023 field fit submission identifies that the NCD was captured in a non-contact perimeter ditch (Appendix 4), yet erosion on the grade cut above the ditch was evident and exposed soils were observed to be stored adjacent to the ditch (Photo 1).

Photo 1. Unlined ditch at KP 566+180 directing NCD J430.02 to cleared wetland area.

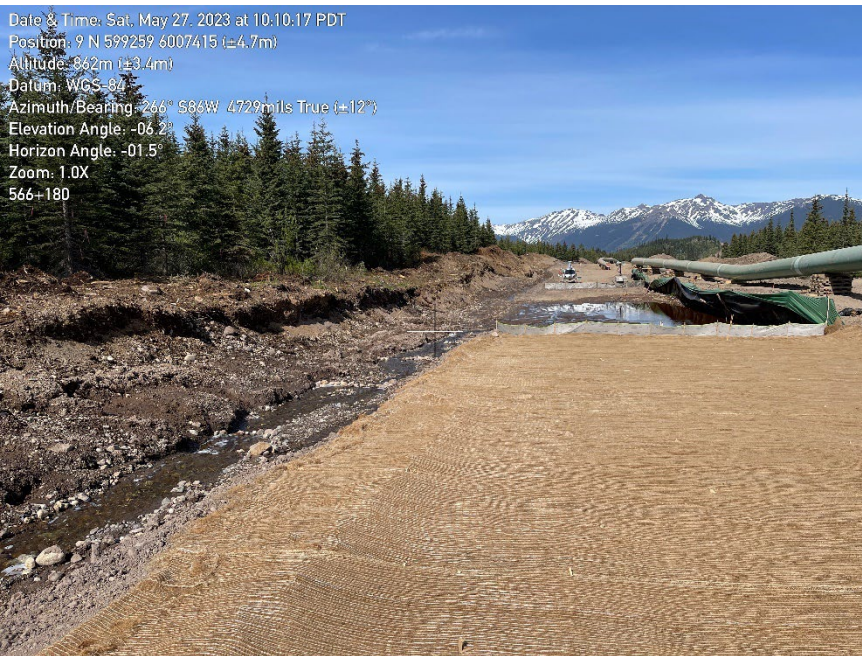
- Rather than delineating the margin of Ecologically and Socio-Economically Important Wetland (ESIW) WET-566.3 at KP 566+200 to the edge of the ROW with sediment fencing, as specified in the WEP, the cleared wetland area was observed to be utilized as a catchment pond for water from unlined ditches running along the south side of the ROW from both the upchain and downchain directions (Photo 1 and 2). A pump was in place to discharge collected water off the ROW, but a culvert maintained connectivity of the catchment to the undisturbed portion of the wetland on the north side of the ROW.

Photo 2. Cleared portion of ESIW WET-566.3 utilized as a catchment area for unlined ditches at KP 566+200. The WEP specifies that the wetland be delineated from the ROW.

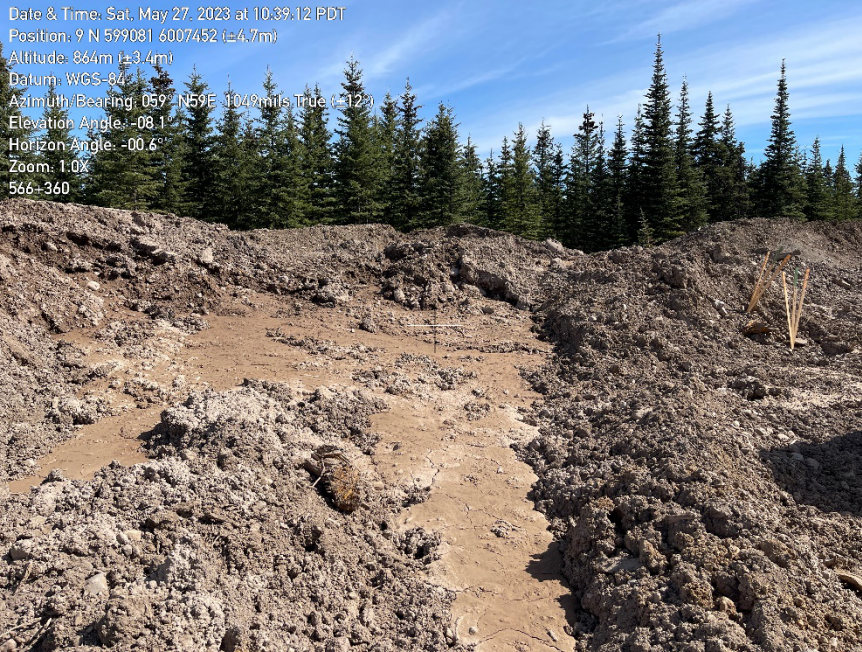
- Water bar at KP 566+360 was not present and no alternate measures were observed to be in place (Photo 3). The OJ Pipelines Erosion and Sediment Control Specialist identified that grade was completed in this area in March and that the feature had been deactivated since April 6, 2023, due to saturated soils. The WEP specifies that “features should not be deactivated unless temporarily required to facilitate safe travel and work activities during favourable weather/site conditions”. There was not evidence that the deactivation criteria had been met.

Photo 3. Location of deactivated water bar on ROW at KP 566+350.

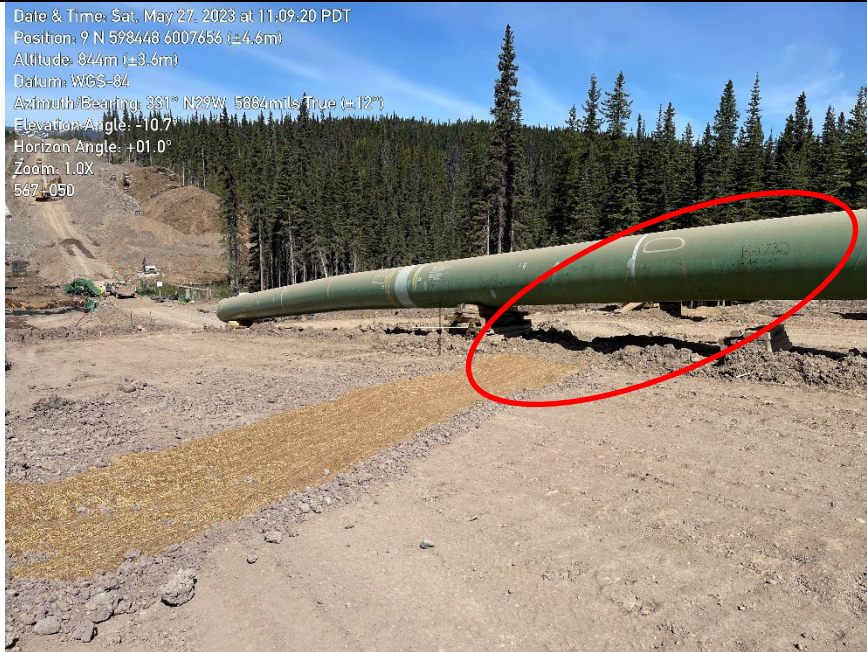
- The lined ditch across the ROW at KP 567+050 was not installed per the ESC Mitigation Package (Appendix 5). The specification for a lined ditch is a minimum of 0.5 metres (m) and the ditch did not meet this specification (Photo 4). In addition, the lining of this ditch was interrupted across the travel lane.
- The lined ditch on the south side of the ROW between KP 567+000 and 567+080 specified in the WEP was observed to be unlined (Photo 5).
- Gap observed at the corner between the silt saver and sediment fence at KP 567+150 (Photo 6). Evidence of previous sediment movement through this gap was observed.
- Soil storage at KP 567+160 to 260 observed to not be hydromulched, as specified in the WEP (Photo 7).

Photo 4. Lined ditch at KP 567+050 not installed to depth specification and unlined across a portion of the ROW.

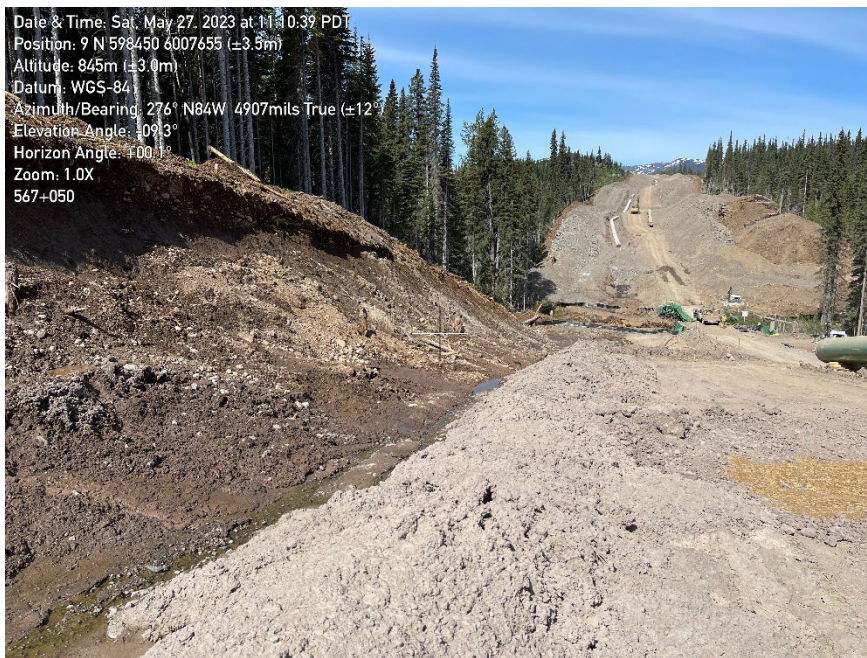
Photo 5. Ditch at KP 567+000 and 567+080 not lined as specified in WEP.

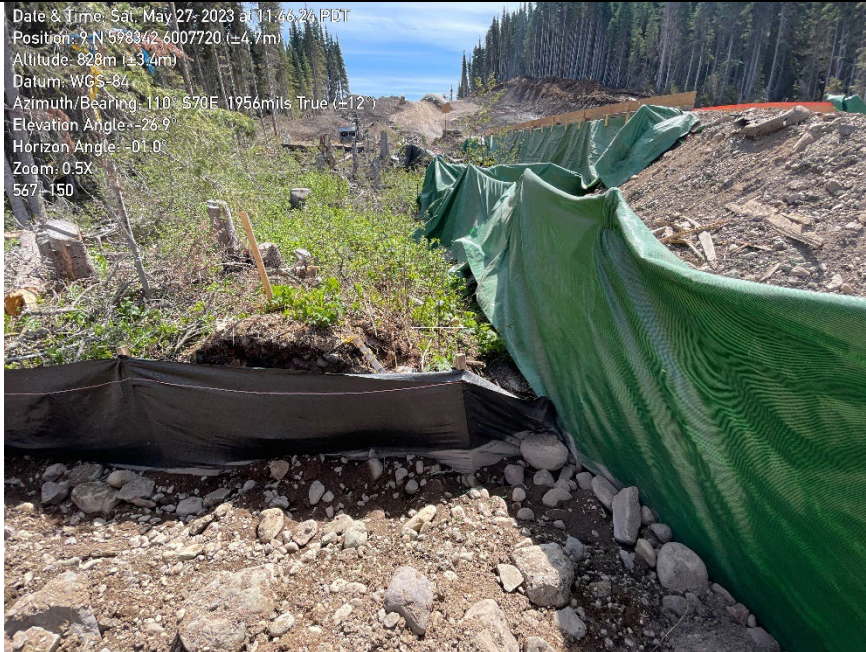
Photo 6. Gap in the corner of sediment fencing at KP 567+150 where evidence of sediment movement was observed.

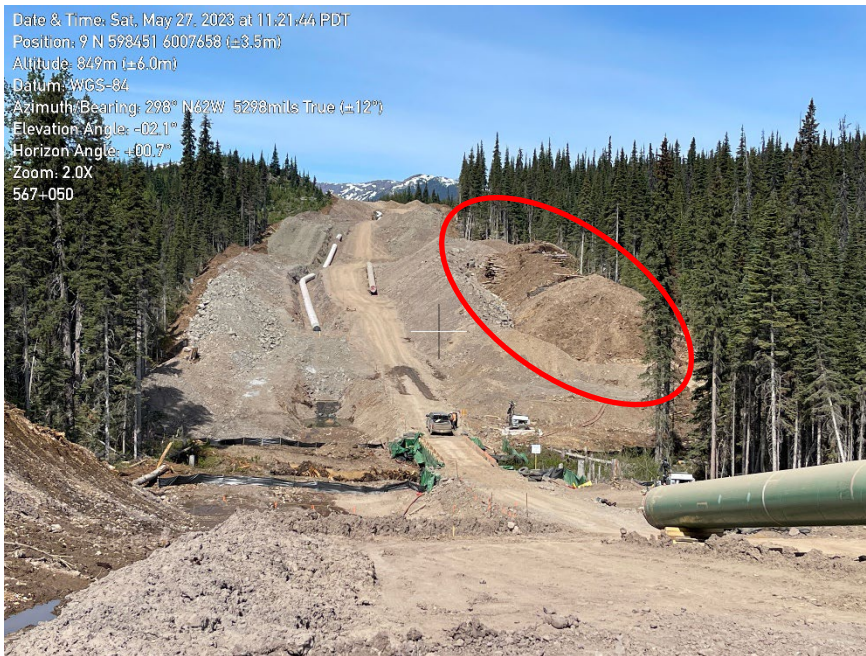
Photo 7. Soil storage at KP 567+160 to 260 not hydromulched.

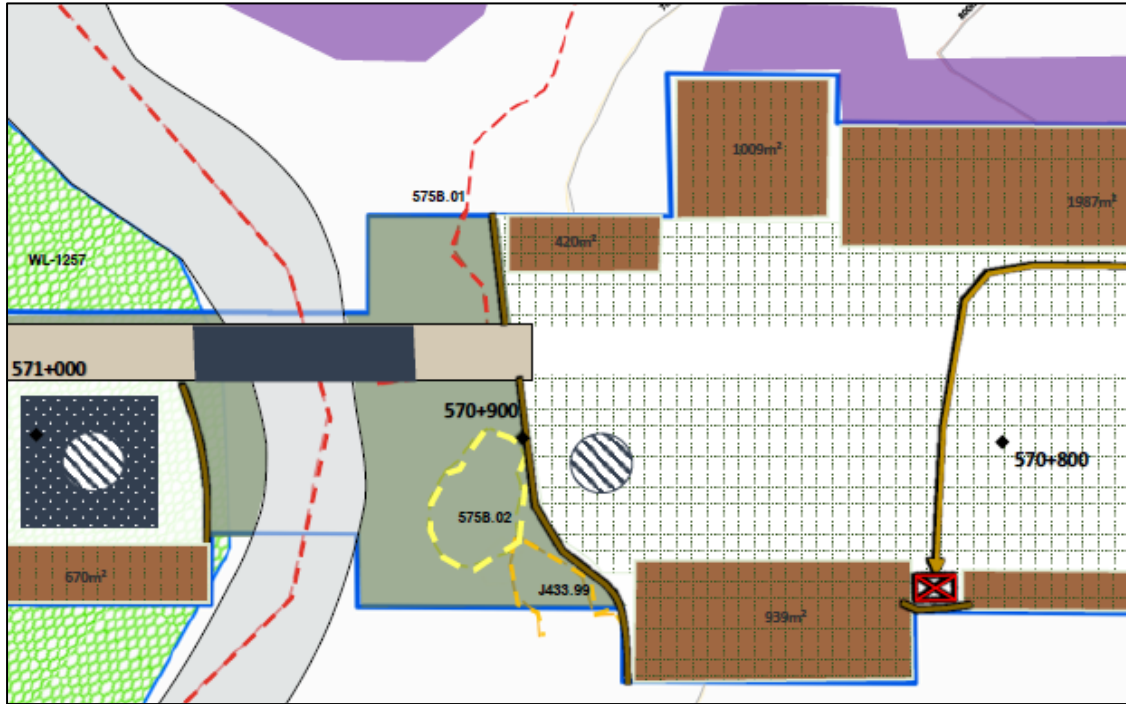
- The WEP specifies a berm across the ROW on the lowchain side of the crossing at KP 570+900 to separate the ROW from the vegetated area adjacent to Gosnell Creek, including lake 575B.02. The WEP depicts the bore bay as outside of the vegetated area. The Officer observed both the bore bay and a flocculant tank (not

specified in the WEP) to be located inside of the vegetated area, metres from the bank of Gosnell Creek, with no containment measures between these features and Gosnell Creek. Figure 1 and Photo 8 present the planned and actual site conditions.

Figure 1. Excerpt from the KP 565+400 to 576+500 for the Gosnell Creek crossing (bore bays indicated with lined circles).

- The Gosnell Creek crossing structure at KP 590+900 has been moved from the north side of the ROW to the south resulting in lake 575B.02 being pumped out and filled in to accommodate the configuration. As illustrated by Figure 1 and Photo 8 above, this approach is not reflected in the WEP.

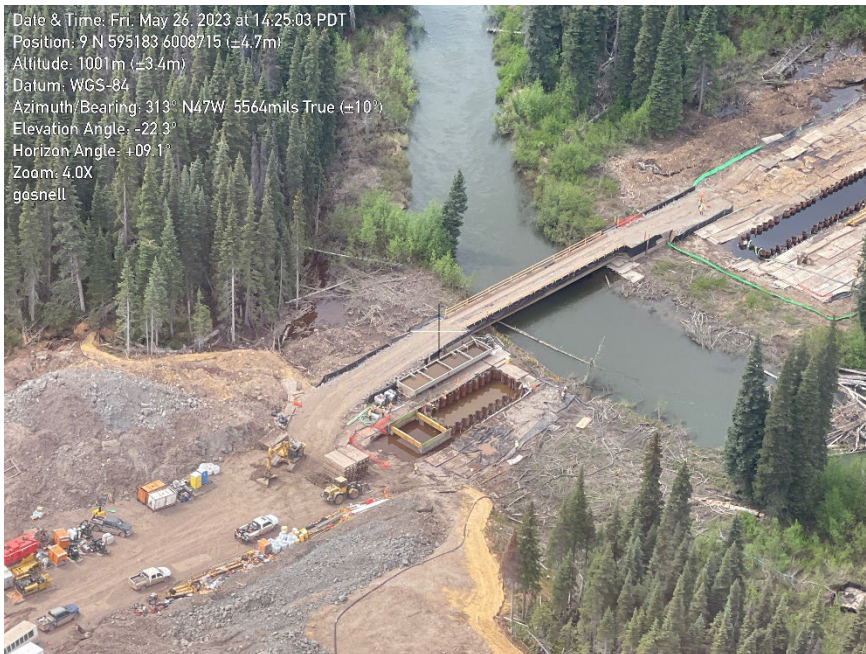
Photo 8. Aerial view of Gosnell Creek crossing site facing the highchain (west) direction.

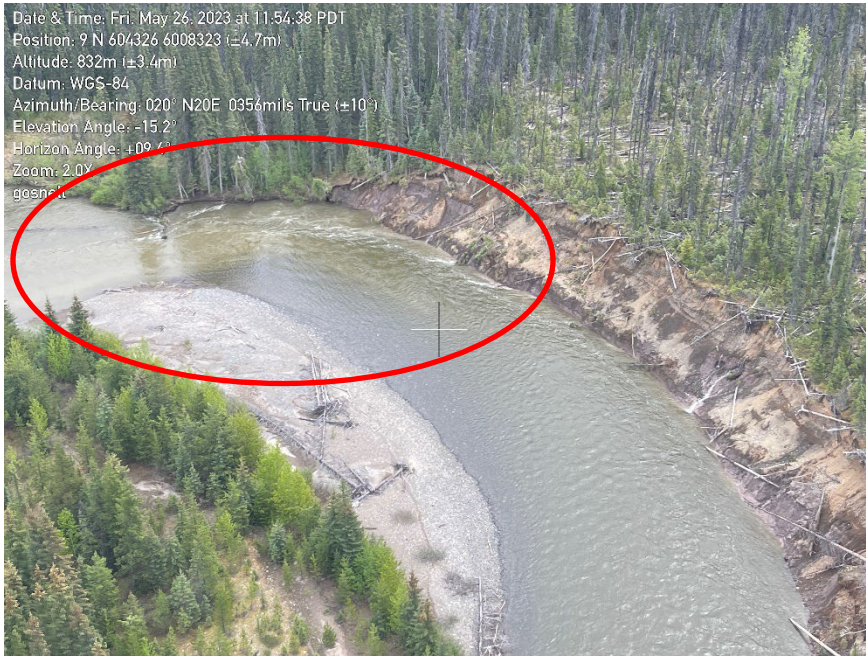
At the time of the inspection, the water level at the highchain side Gosnell Creek crossing site had receded significantly, but the ROW was still flooded. No evidence of mass sediment movement offsite was observed. Aerial observations were made of Gosnell Creek both upstream of the Project ROW and downstream to the Morice River. No difference in water quality was observed in Gosnell Creek upstream and immediately downstream of the Project. An eroding bank downstream of the Project, approximately 5 km upstream of its confluence with the

Morice River, was observed to be impacting water quality in Gosnell Creek (Photo 9). At this location, a sediment plume was observed in Gosnell Creek and the water downstream was visibly more turbid. Other minor inputs from eroding banks were observed both upstream and downstream of the Project ROW, which increased the turbidity of Gosnell Creek.

Photo 9. Eroding bank depositing sediment into Gosnell Creek downstream of the Project ROW.

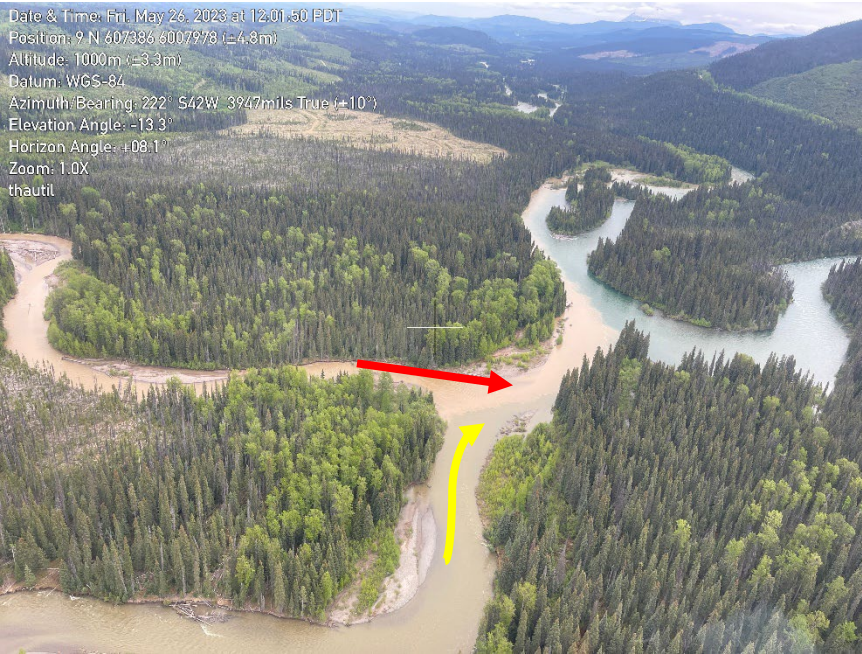
More significantly, approximately 200 m before the confluence of Gosnell Creek and the Morice River, the Thautil River was observed to flow into Gosnell Creek heavily loaded with sediment that was subsequently discharged into the Morice River (Photo 10). This observation is consistent with a 2002 publication by David Bustard and Associates titled *Conserving Morice Watershed Fish Populations and Their Habitat*, which notes Gosnell Creek and the Thautil River as the main sources of sediment into the Morice River (Appendix 7 and Figure 2). The Thautil River flows south toward Gosnell Creek from the opposite direction of the ROW, so its condition is independent of Project activities.

Photo 10. Inputs to the Morice River from the Thautil River (red) and Gosnell Creek (yellow).

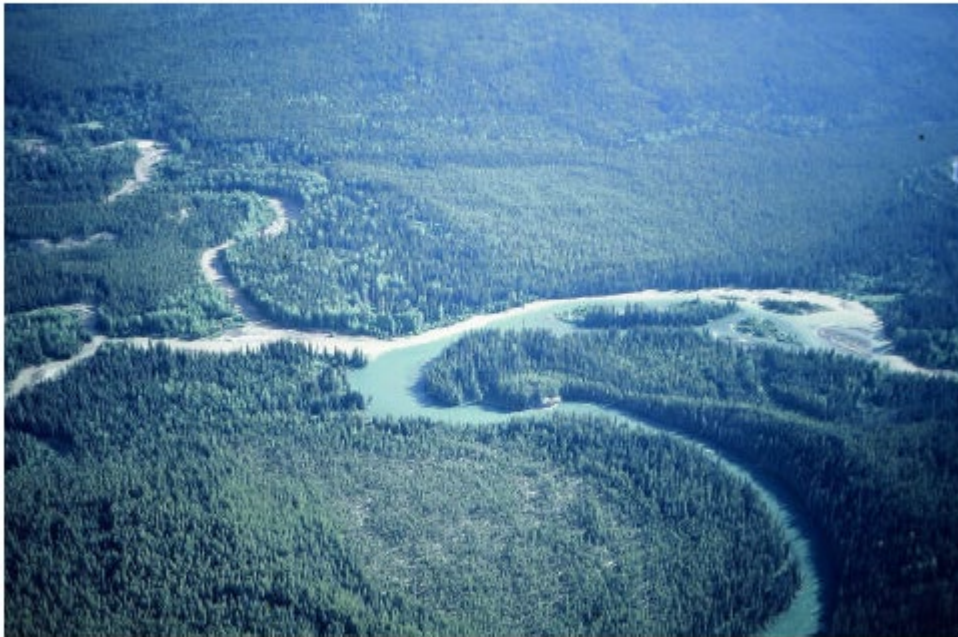
Photo 1. Gosnell Creek (lower left) and Thautil River (top of photo) are main sources of sediment into the Morice River at a point located 13 km downstream from Morice Lake. This photo was taken in June 1982 prior to any significant road or logging development in these drainages.

Figure 2. Excerpt from *Conserving Morice Watershed Fish Populations and their Habitat* (Appendix 7) documenting pre-Project sediment input to the Morice River from Gosnell Creek and Thautil Creek.
