<b>Project Name</b>	Coastal GasLink Project	<b>Inspection Status</b>	Final
<b>EA Certificate #</b>	E14-03	<b>Inspection No.</b>	IR2020-057
<b>Project Status</b>	Certified	<b>Inspection Start</b>	2020-11-13
<b>Sector</b>	Energy	<b>UTM</b>	n/a
<b>Trigger</b>	Planned Inspection	<b>Inspection Type</b>	Administrative
<b>Project Description</b>	The Coastal GasLink Project (Project) is an approximately 650-kilometre natural gas pipeline.		
<b>Location Description</b>	The Project initiates near the community of Groundbirch in northeast BC and terminates at the LNG Canada facility near Kitimat.		
<b>Inspection Summary</b>	<p>On November 13, 2020, Shayla Frechette, Environmental Assessment Office (EAO) Compliance and Enforcement Officer (EAO C&amp;E) initiated an administrative inspection of the Project against the requirements of EAC E14-03 (Appendix 1-4).</p> <p>The Project was in Construction at the time of inspection.</p> <p>After review of observations and information obtained during the inspection, the following compliance determinations have been made:</p> <ol style="list-style-type: none"> <li>1. NON-COMPLIANT with Condition 26 with respect to the Environmental Management Plan – Appe

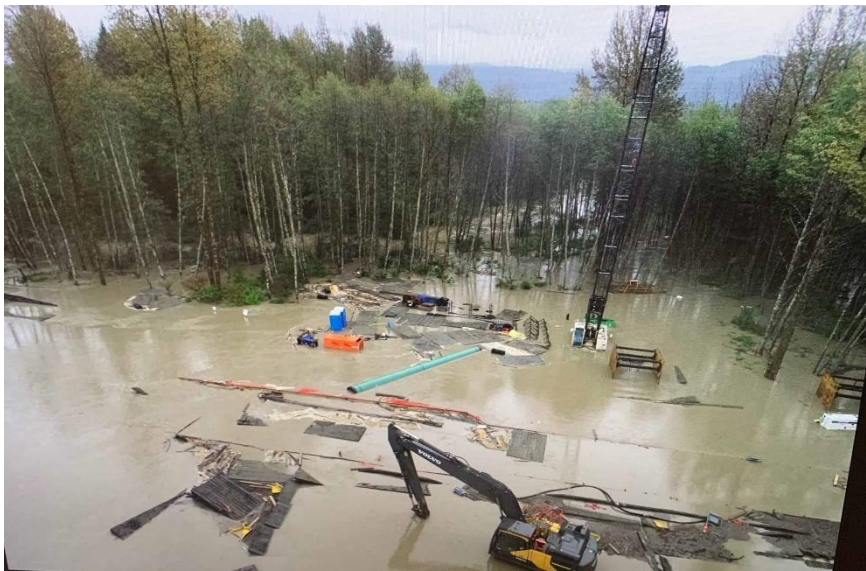
On October 3, 2020 EAO C&E received an anonymous complaint which included a photograph of Coastal GasLink's right of way (ROW) at approximately Kilometre point 666+667, north of the Kitimat River (Photo 1).

September 28, 2020: *"Heavy rain event has stopped and there are multiple areas of severe flooding, especially at the DPI pad and LNC Canada site. The Kitimat River has completely flooded and covered the work site. 700 meeting with MSJV environment to discuss the plan to assess the RoW near the Kitimat River and the current flooding"* (Appendix 10).

Photo 1: Flooding of CGL ROW provided by anonymous complainant.

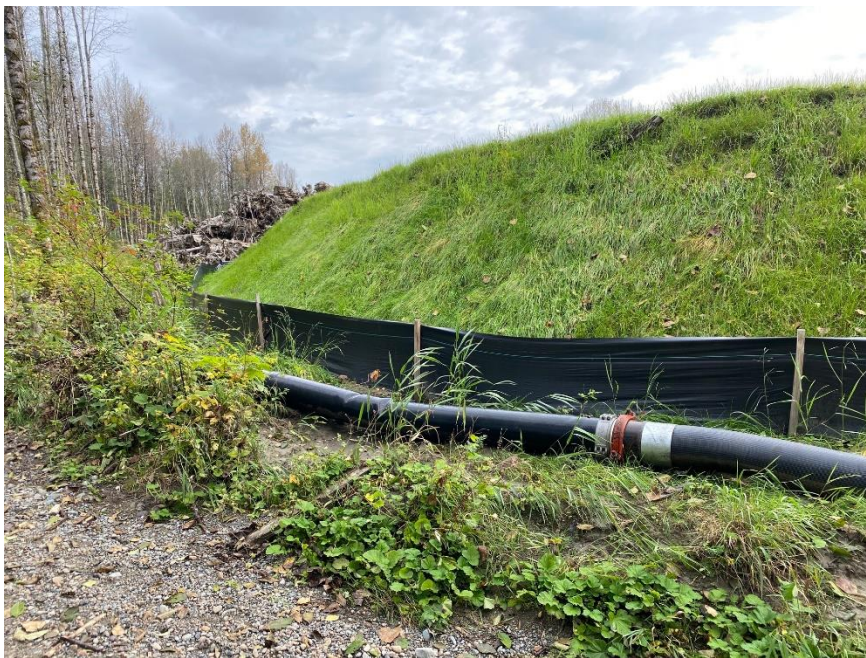
WYMAN also provided photographs which were taken on October 6, 2020 of the site after the water had receded (Photos 2-4).

Photo 2: Photo provided by WYMAN of site condition after flooding.

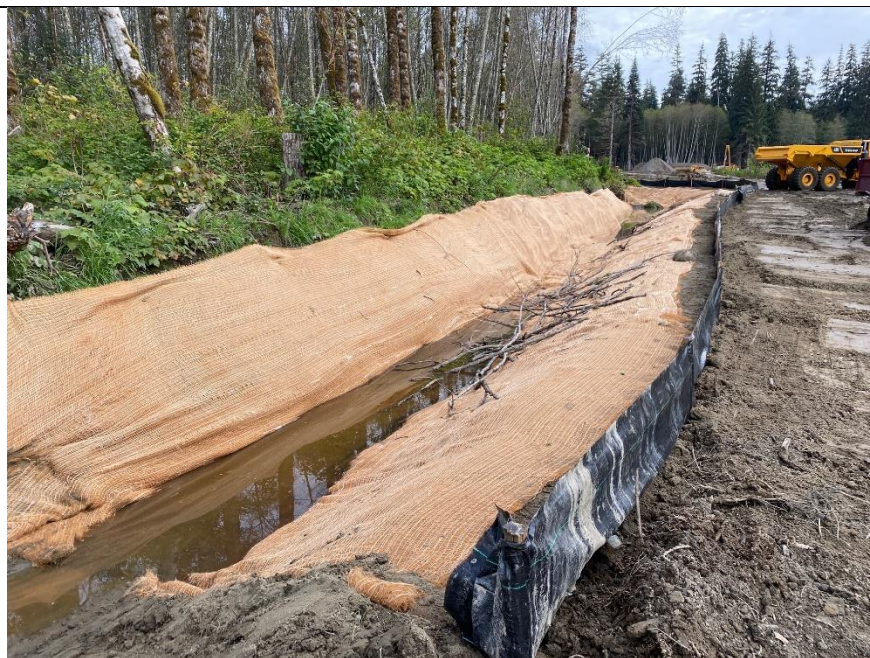
Photo 3: Photo provided by WYMAN of site condition after flooding.

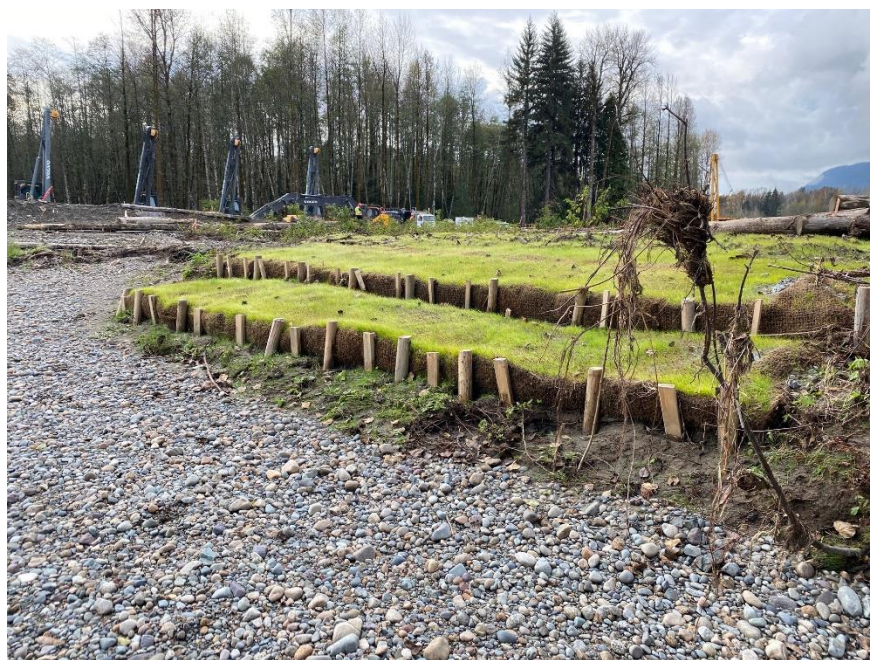
Photo 4: Photo provided by WYMAN of site condition after flooding.
