Project Name	Coastal GasLink Pipeline Project	Inspection Status	Final
EA Certificate #	E14-03	Inspection No.	IR2022-040
Project Status	Certified	Inspection Start	2022-07-19
Sector	Energy	UTM	10U 405148 E 6003644 N to 375878 E 5996479 N
Trigger	Planned Inspection	Inspection Type	Field and Administrative
Project Description	The Coastal GasLink Pipeline Project (Project) is an approximately 650-kilometre natural gas pipeline connecting facilities in northeast British Columbia (BC) to the LNG Canada facility near Kitimat.		
Location Description	The Project initiates near the community of Groundbirch, BC and terminates near Kitimat, BC. This inspection covered works in Section 5 in the vicinity of Fraser Lake, BC.		
Inspection Summary	<p>On July 19 to 20, 2022, Environmental Assessment Office Senior Compliance and Enforcement Officer Christie Lombardi (EAO C&E) inspected the Project against the requirements of Environmental Assessment Certificate (EAC) # E14-03 (Appendix 1).</p> <p>The Project was in Construction at the time of inspection.</p> <p>Project areas inspected include right-of-way (ROW) locations between kilometre post (KP) 351+600 and 383+500 (approximately), as well as the L

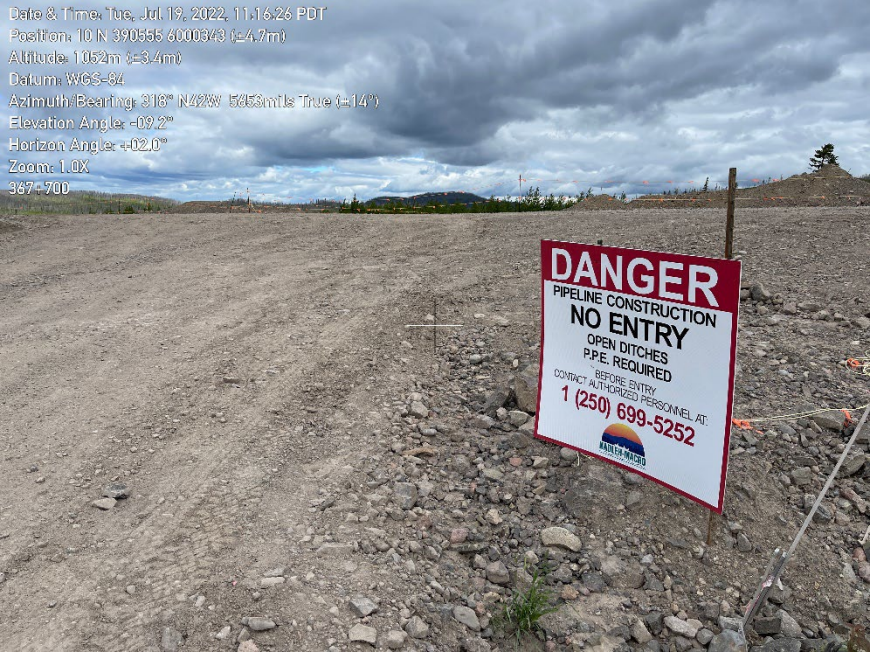
<p>Requirement 1: Condition 15 of EAC# 14-03 Schedule B (Appendix 2)</p> <p>The Holder must develop and implement an Access Control Management Plan to meet the objectives stated in the Application Appendix 2-A, Appendix D.3:</p> <ul style="list-style-type: none"> control public access along the pipeline ROW, especially where new access is created or existing access is improved; <p><i>Refer to Appendix 2 for the full text of Condition 15.</i></p> <p>Access Control Management Plan (Appendix 3) Section 4.4.1 Construction Phase – Existing Access</p> <ul style="list-style-type: none"> Where existing access intersects with the project ROW, flagging and signage will be used to discourage public use. <p>Findings:</p> <p>Over the course of the inspection, EAO C&E observed multiple locations where the Project right-of-way (ROW) intersected existing resource roads. At these locations, EAO observed that flagging, fencing and signage were employed to discourage public access (Photos 1, 2).</p>

Photo 1. Signage and flagging at ROW intersection with Turtle Forest Service Road.

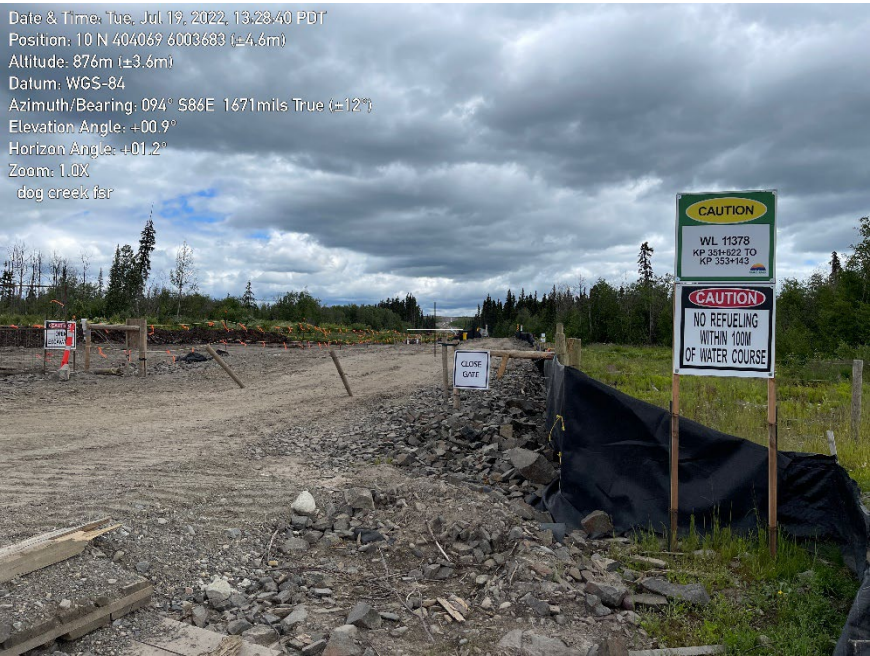
Photo 2. Gate and signage at ROW intersection with Dog Creek Trail Road.

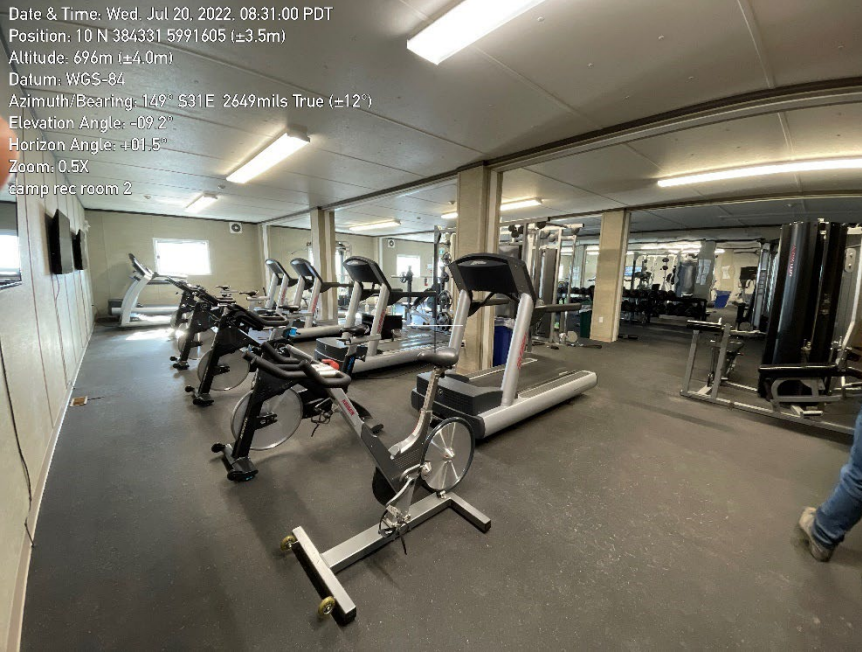
Photo 4. Second gym at Little Rock Lake Lodge accommodation camp.

EAO C&E inspected the Little Rock Lake Lodge workforce accommodation site in Lejac on July 20, 2022. While onsite, EAO C&E observed two gyms (Photos 3, 4) and a recreation room (Photo 5). An open Wi-Fi network was readily accessible at the camp and workers questioned onsite verified that network connectivity was generally fast and reliable. A landline telephone was available for use at the camp’s front desk.

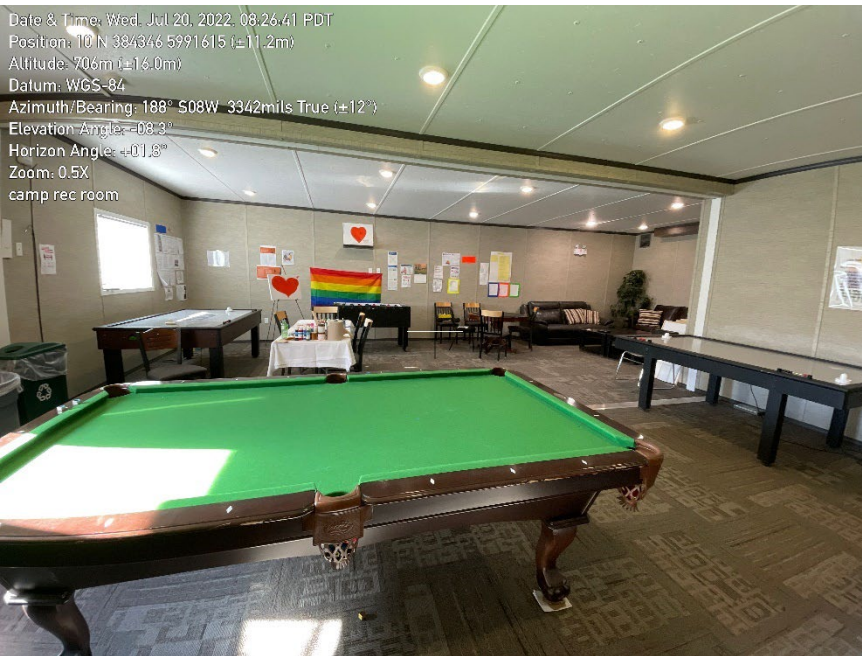
Photo 5. Recreation room at Little Rock Lake Lodge accommodation camp.

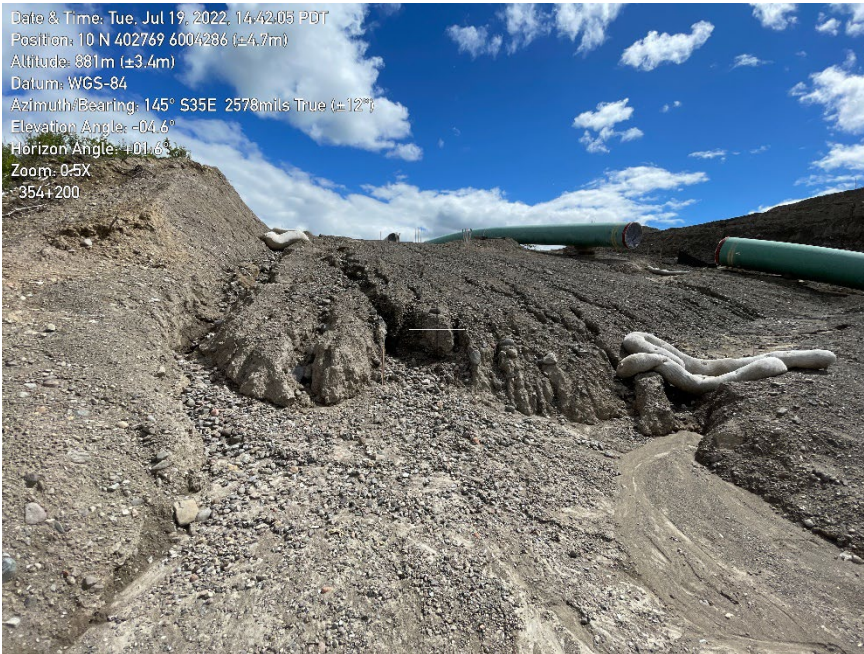
- KP354+150. Rills and gullies observed on unstabilized ROW upslope of ecologically and socio-economically important wetland (ESIW) WL-0662 (Photo 6). The single sediment fence protecting the wetland at the bottom of the slope had previously overtopped, depositing sediment into the wetland (Photo 7).

Photo 6. Rills and gullies on exposed ROW soils at KP354+150, upslope of wetland WL-0662 (ESIW).

These findings provide evidence that the Project is not compliant with Condition 26 and Enforcement Order EN2020-011 with respect to stabilizing exposed surface material and subsoil and planning and installing erosion and sediment control measures in order to control the risk of sediment transport to environmentally sensitive receptors.

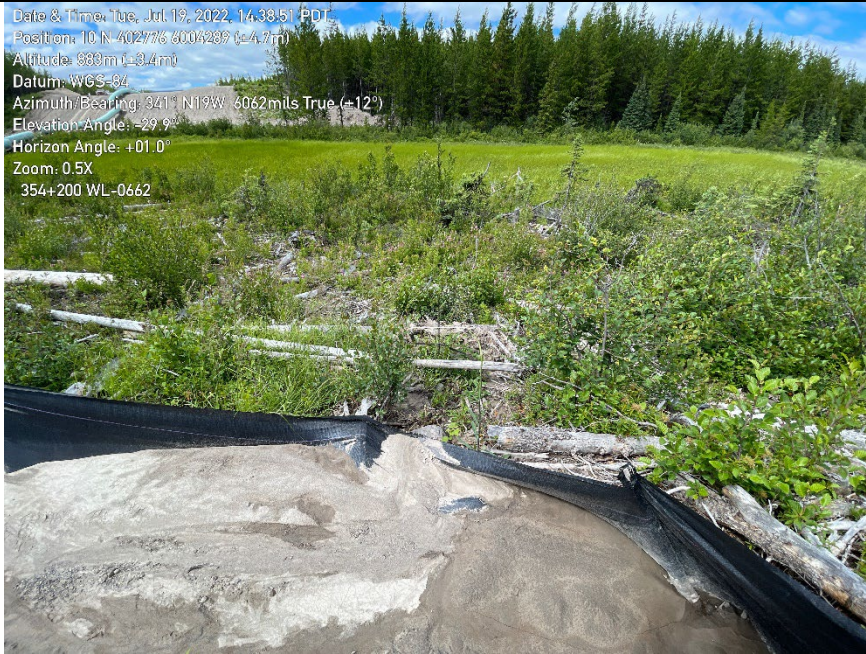
Photo 7. Overtopped sediment fence at KP354+150 with evidence of sediment deposition into wetland WL-0662 (ESIW).

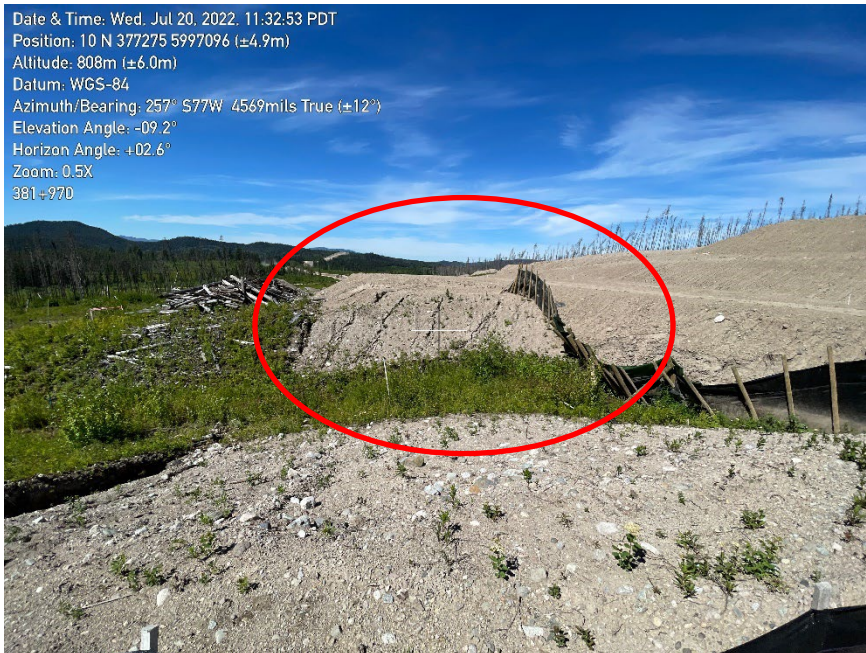
- 381+960. Absence of erosion and sediment controls on the lowchain side of non-classified drainage (NCD) 64C1 crossing on the north side of the ROW, with rills and gullies on slope face observed (Photo 8). Evidence of previous sediment deposition into the watercourse was observed from the north highchain side of the crossing where gully erosion beyond the sediment fence was observed (Photo 9). On the south side of the crossing, a sediment fence, which had received previous flow over exposed soil on the ROW on the highchain side of the crossing (Photo 10), was observed to have overtopped, with evidence of sediment deposition (Photo 11).

Photo 8. Rills and gullies on unprotected slope on the north lowchain side of watercourse 64C1 (NCD) at KP381+960.

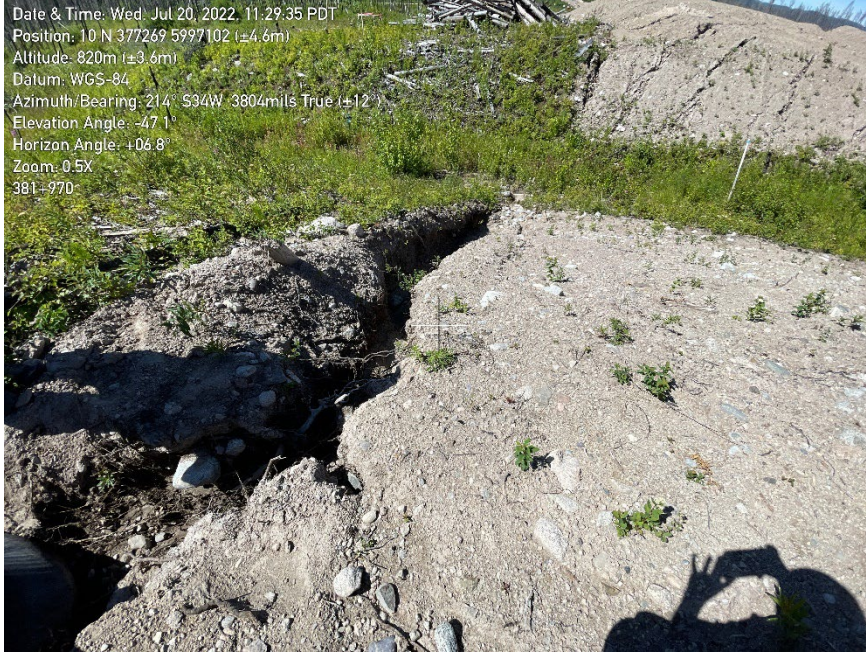
Photo 9. Eroded gully upslope of watercourse 64C1 (NCD) at KP381+960 beyond the sediment fence on the north highchain side of the the crossing where sediment deposition was observed.

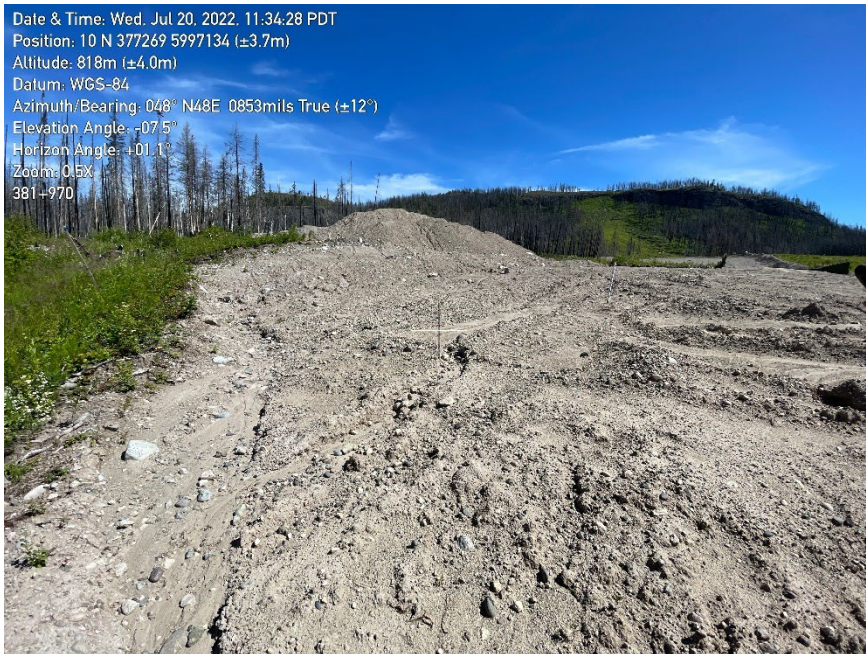
Photo 10. Exposed ROW soils on south highchain approach to watercourse 64C1 (NCD) at KP381+960.

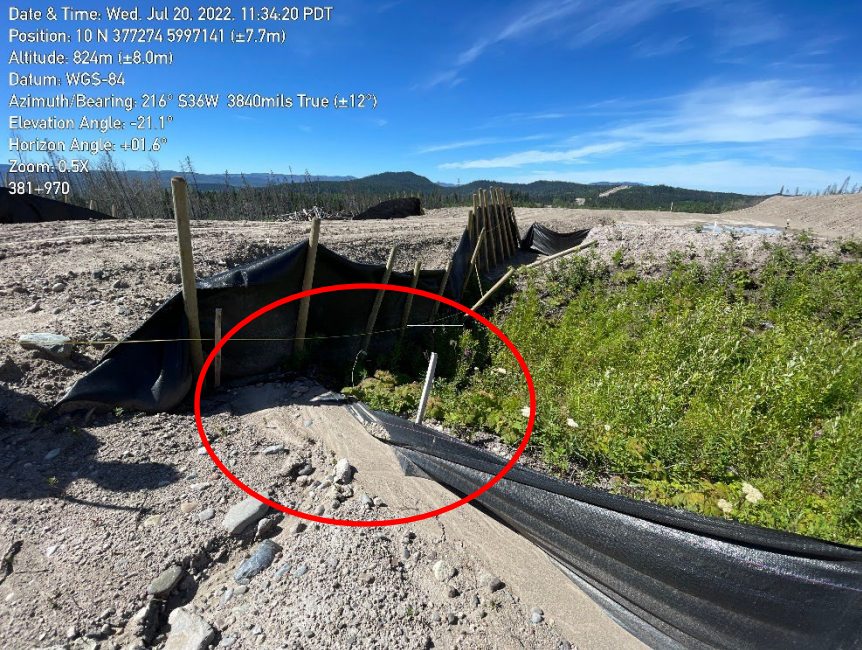
Photo 11. Overtopped sediment fence at watercourse 64C1 (NCD) at KP381+960.

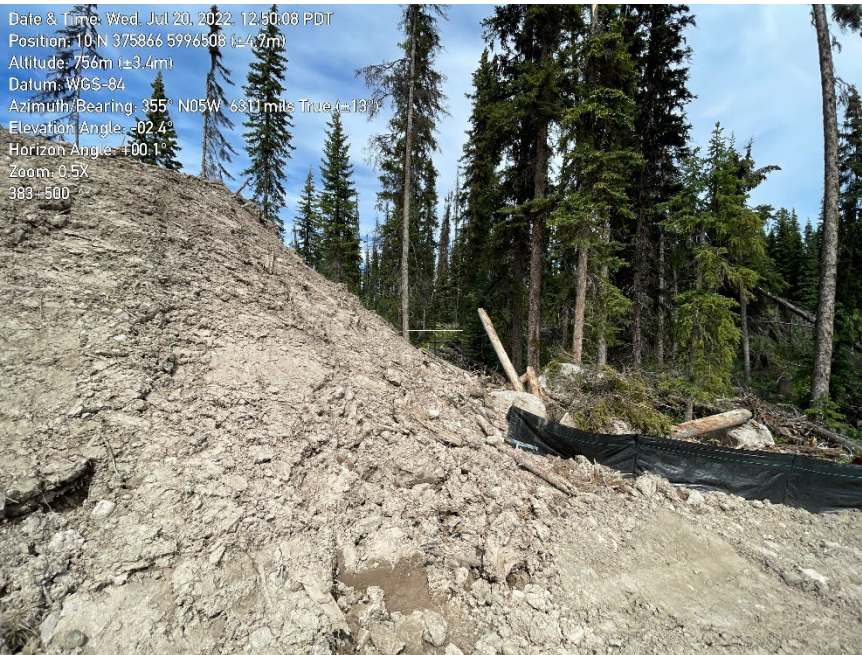
- KP383+500. Spoil pile adjacent to ESIW WL-0684 without erosion control measures to prevent sediment transport to the wetland (Photo 12).

Photo 12. Spoil pile without erosion control measures adjacent to wetland WL-0684 (ESIW) at KP383+500.

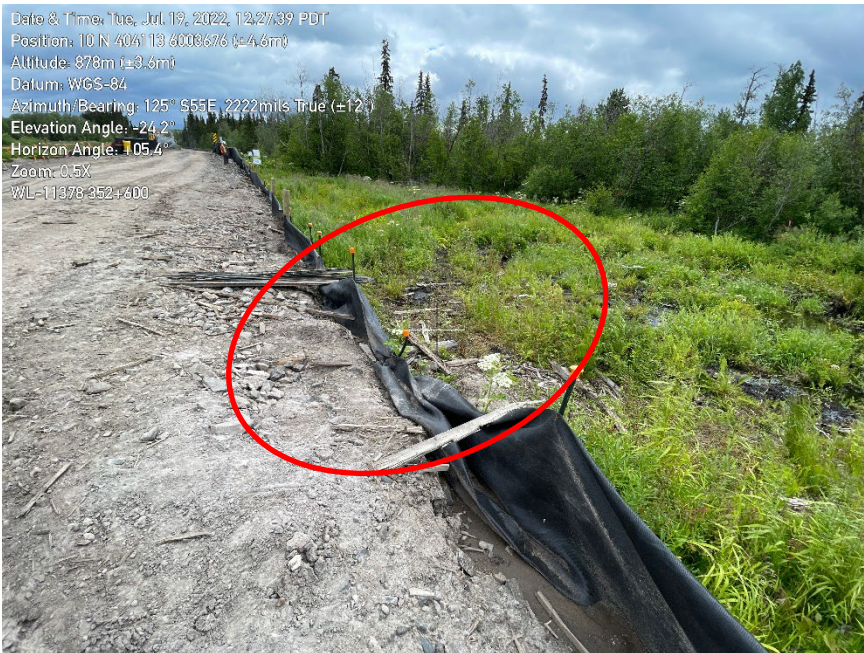
Photo 13. Collapsed sediment fence between travel lane and wetland WL-11378 (ESIW) at KP352+620.

These observations provide evidence that the Project is not compliant with Condition 26 and Enforcement Order EN2020-011 with respect to maintaining erosion and sediment control measures in order to control the risk of sediment transport to environmentally sensitive receptors.

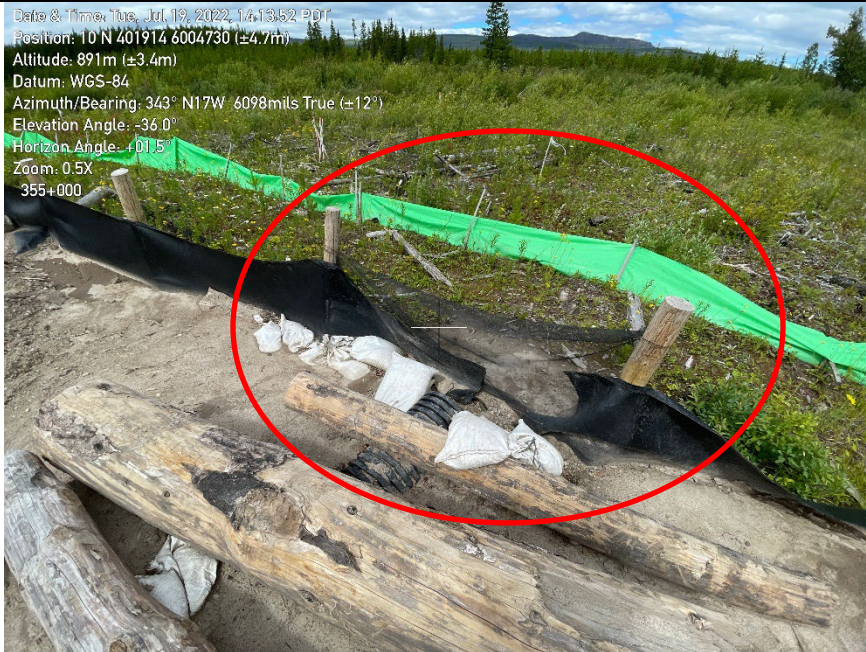
Photo 14. Gap in sediment fence between ROW and wetland WL-11401 (ESIW) at KP355+110.

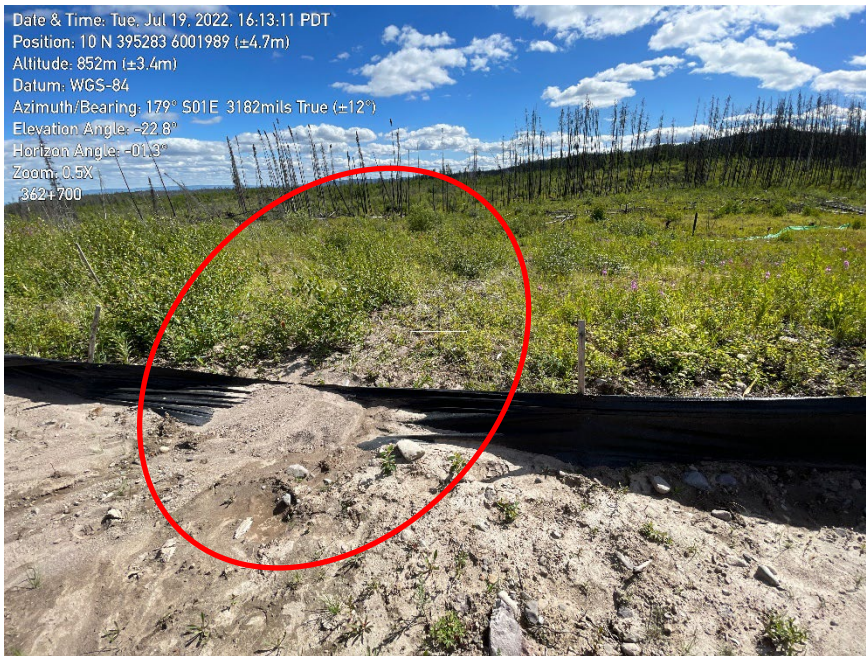
Photo 15. Overwhelmed sediment fence upslope of wetland WL-11251 (ESIW), with evidence of previous sediment flow off the ROW at KP362+610.

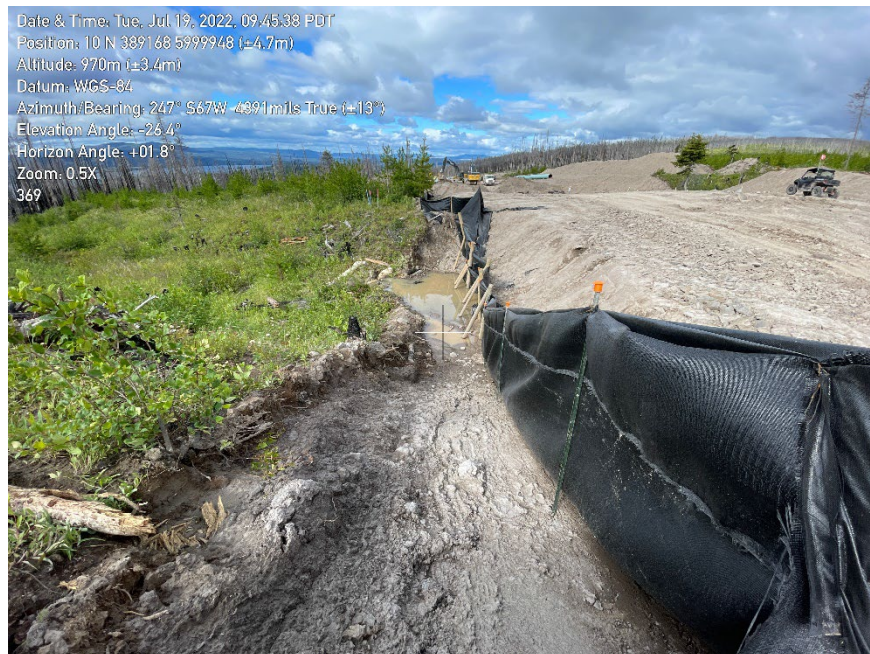
Photo 16. Erosion rills beyond gap in sediment fence on the downstream side of watercourse 32C2A (NCD) at KP369+200, with pooled sediment-laden water at the culvert under the ROW.

These findings provide evidence of noncompliance with Enforcement Order EN2022-009 with respect to implementing erosion and sediment control measures at watercourses between KP369+070 and 369+915 in accordance with professional standards and to the satisfaction of EAO C&E.

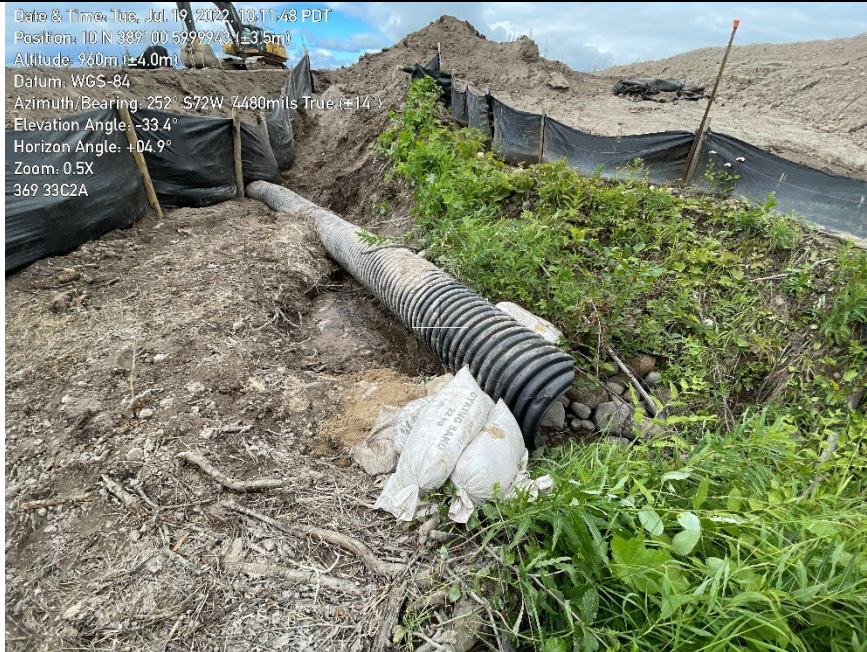
Photo 17. Culvert directing S6 watercourse 33C2A under the ROW at 369+280 non-functional as inlet was observed to be six inches above ground level.

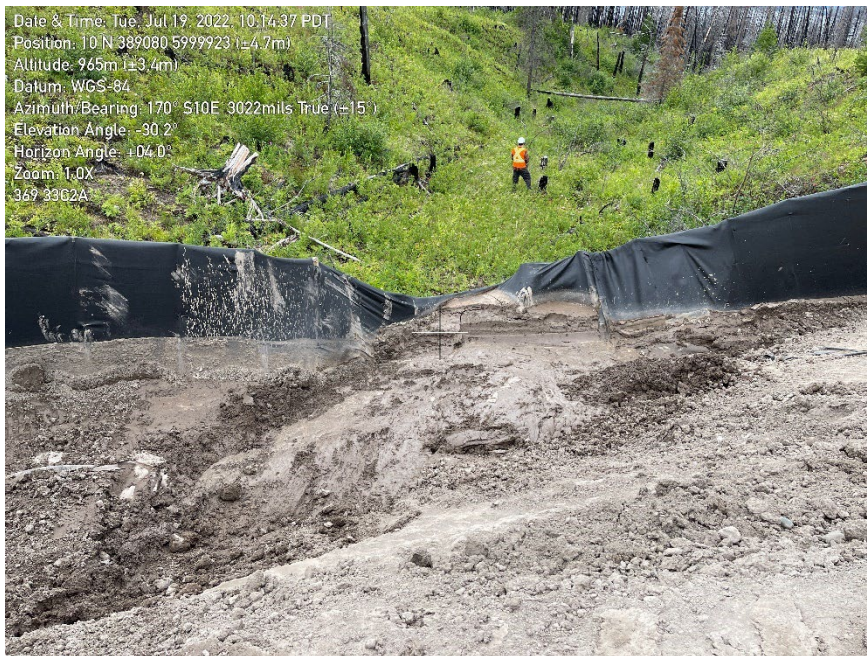
Photo 18. Minimal repairs to bulging and previously overtopped sediment fence at S6 watercourse 33C2A at KP369+295.

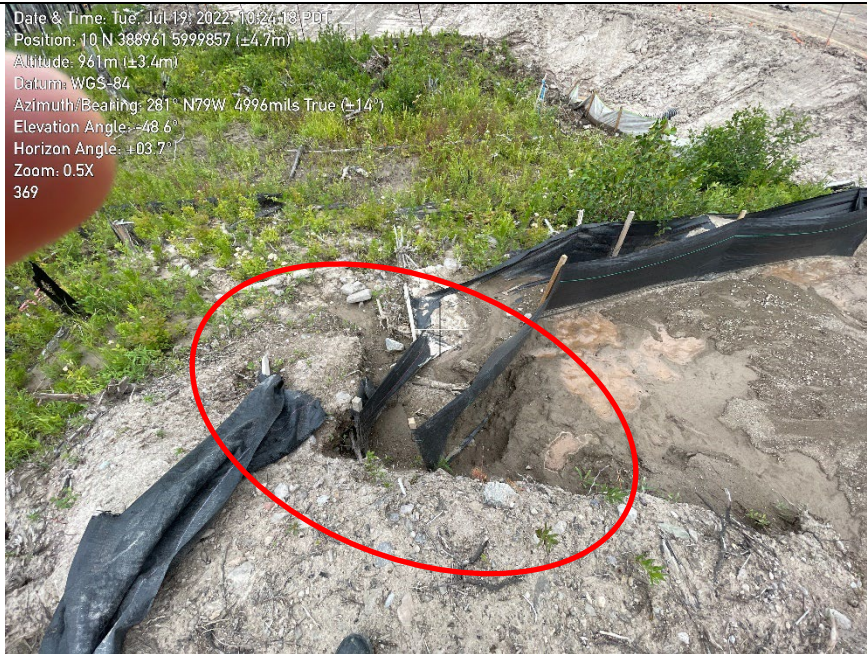
Photo 19. Newly installed sediment fence at watercourse 34C2A (NCD) at KP369+440 with gap at edge that will allow water to bypass.

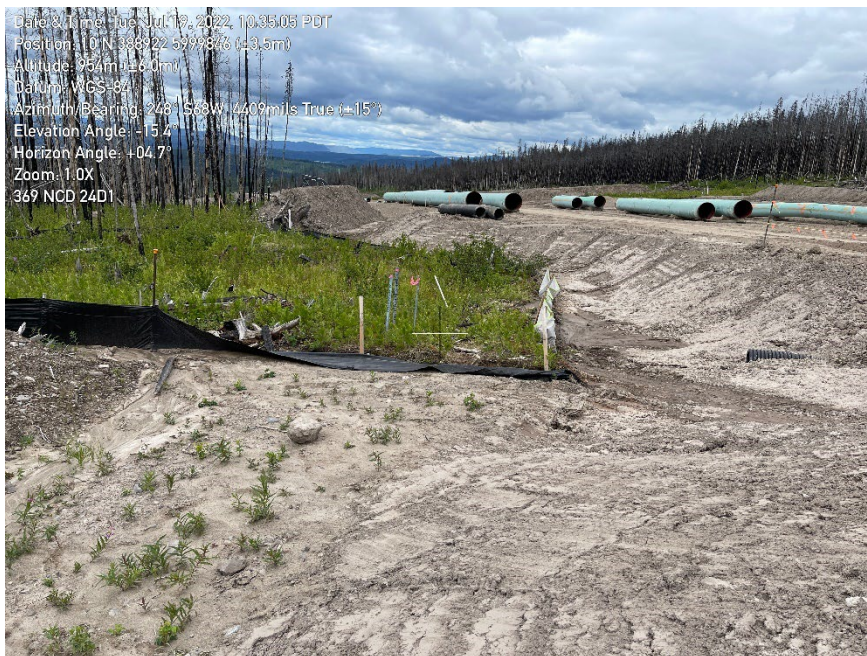
Photo 20. Non-functional sediment fence laying on the ground at watercourse 24D1 (NCD) crossing at KP369+480.

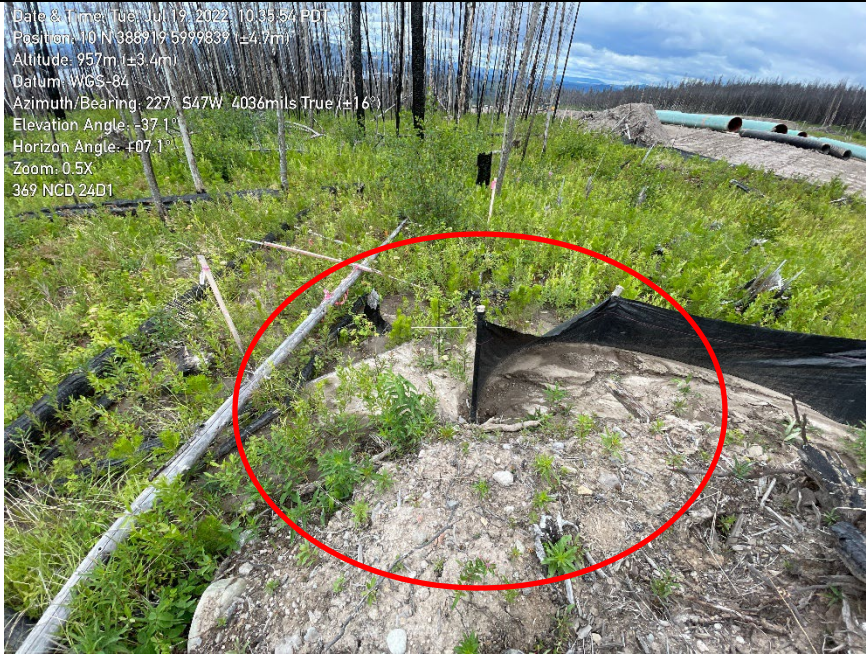
Photo 21. Evidence of sediment-laden water flowing around edge of sediment fence at watercourse 24D1 (NCD) crossing at KP369+480.

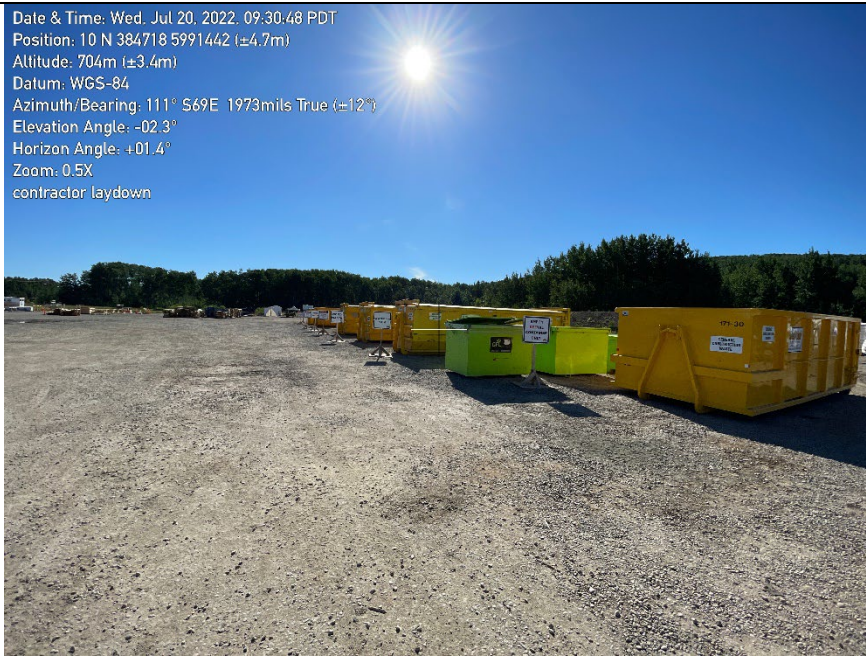
On July 20, 2022, EAO C&E inspected the Lejac contractor laydown yard. While onsite, EAO C&E observed hazardous and non-hazardous waste to be segregated into labeled receptacles (Photo 22).

Photo 22. Segregated waste as contractor laydown yard across the road from the Little Rock Lake Lodge accommodation camp.

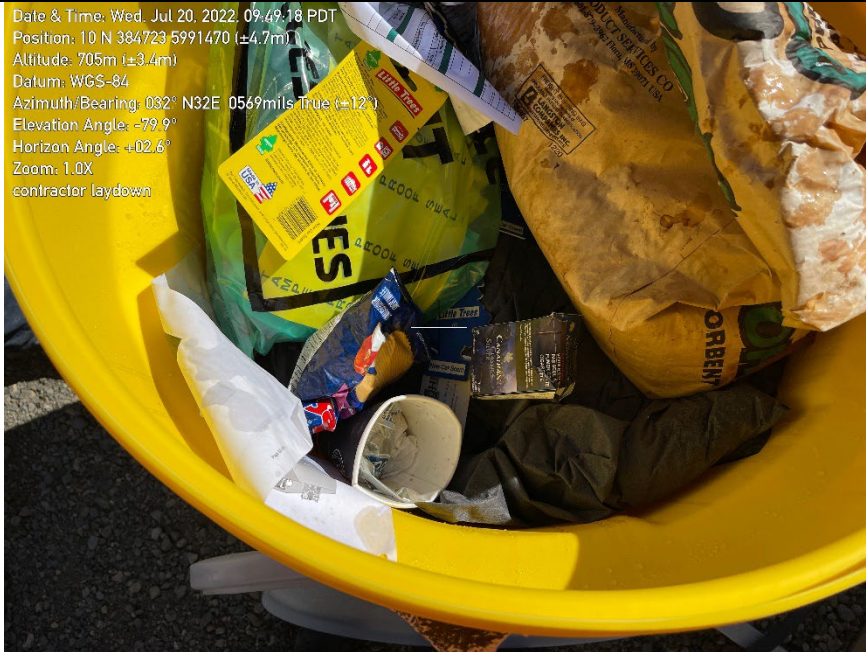
During EAO C&E’s inspection of the Lejac contractor laydown yard on July 20, 2022, EAO C&E observed non-hazardous waste (cigarette pack, chip bag, coffee cup, air freshener and packaging) in one of the three screw-top spill kits at the fuel island (Photo 23).

Photo 23. Spill kit at Lejac contractor laydown containing non-hazardous waste.

Photo 23 of Requirement 8 above, a chip bag was also observed in a spill kit at the Lejac contractor laydown yard fuel island.

These observations provide evidence that the Project is not compliant with Condition 26 with respect to maintaining spill kits and disposing of non-hazardous waste in appropriate receptacles.

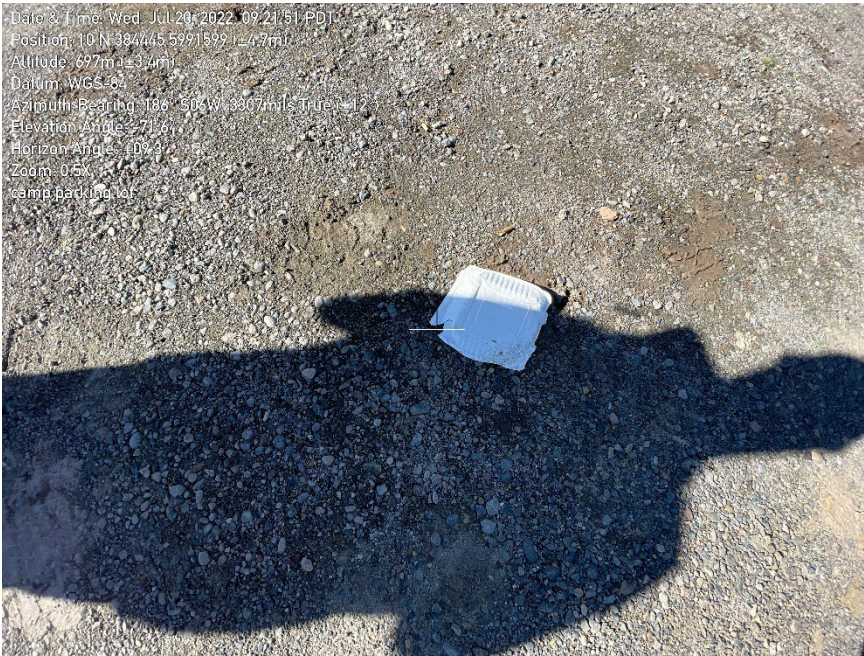
During EAO C&E’s inspection of Project locations between KP351+600 and 383+500 on July 19 and 20, 2022, no animal attractants were observed on the ROW work areas inspected. At Little Rock Lake Lodge accommodation camp a food takeaway container was observed on the ground in the parking lot (Photo 24) and at the Lejac contractor laydown yard a pineapple can was observed in the back of a pickup truck (Photo 25). As depicted in

Photo 24. Takeaway container on the ground in the Little Rock Lake Lodge working accommodation camp parking lot.

These observations provide evidence that the Project is not compliant with Condition 26 and Enforcement Order EN2019-003 with respect to wildlife attractants. While these observations of non-compliance may be considered to be relatively minor, these findings are being referred to a decision maker for an administrative penalty due to

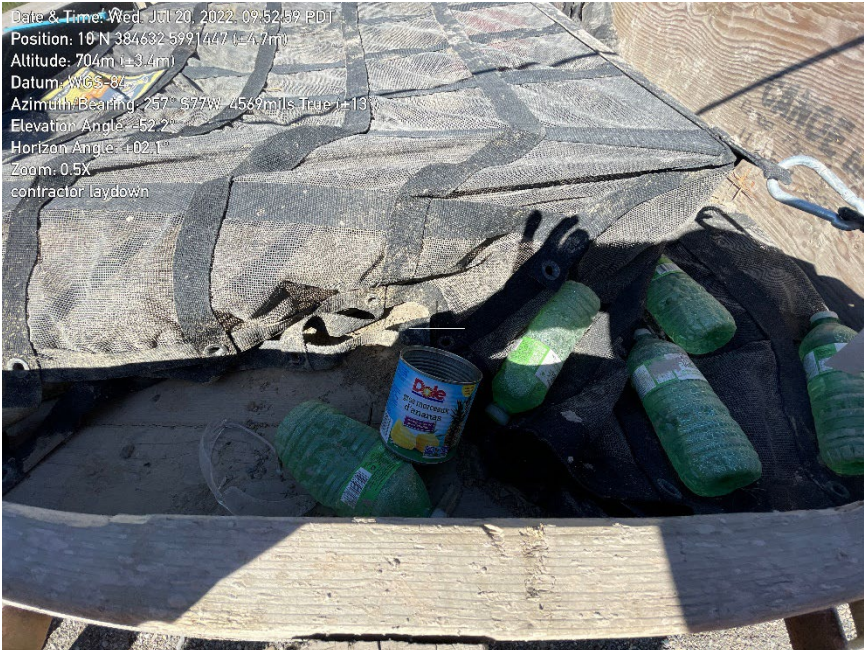
Photo 25. Pineapple can observed in the back of a work truck at the Lejac contractor laydown.

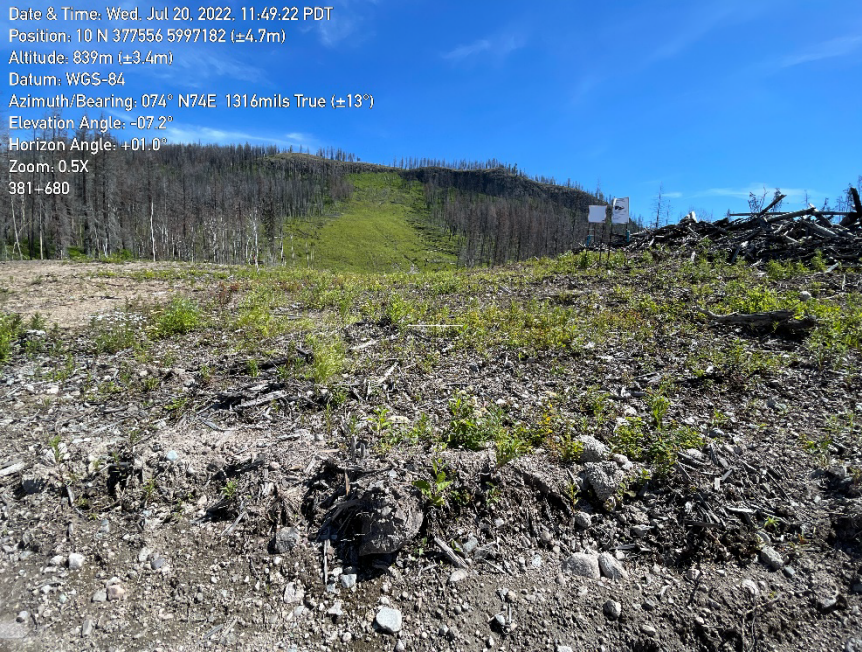
On July 20, 2022, EAO C&E made observations at KP361+680, the western (highchain) boundary of the Identified Area between KP 381+320 to 381+690. At the time of the inspection, no active works were observed on foot or by drone in the previously cleared section Project ROW (Photo 26).

Photo 26. KP381+665 looking east (lowchain) into the Identified Area in KP range 381+320 to 381+690.
