Re: Environmental Assessment Certificate (EAC) #E14-02: Schedule A (Project Description) – Request to Amend Condition #4 regarding Removal of Temporary Structures

Appendix A: Overview of Temporary Structures within the reservoir

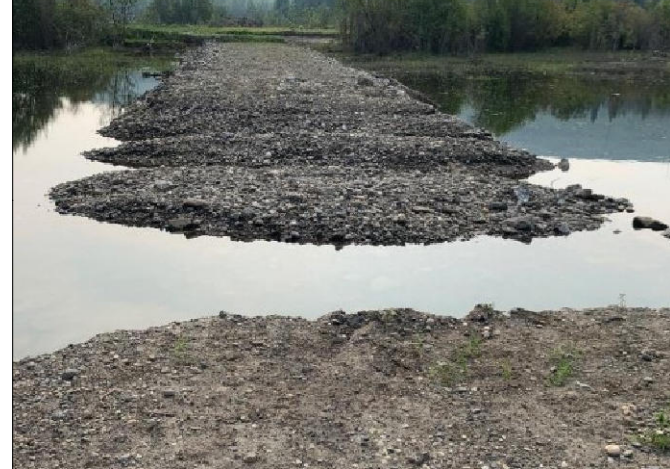
1 - Temporary Causeway for Reservoir Clearing (causeway example)

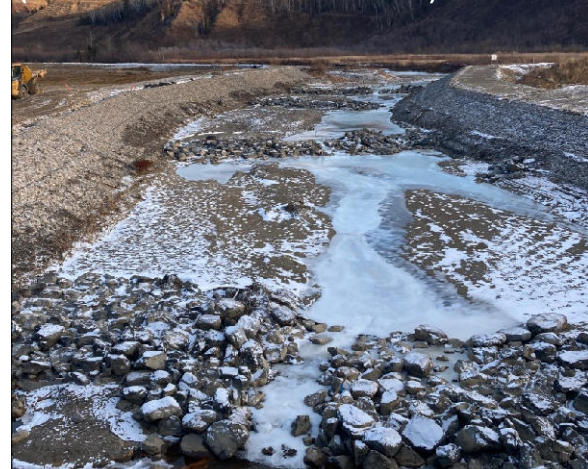
2 - Temporary Diversion at Cache Creek (similar diversion at Farrell Creek)

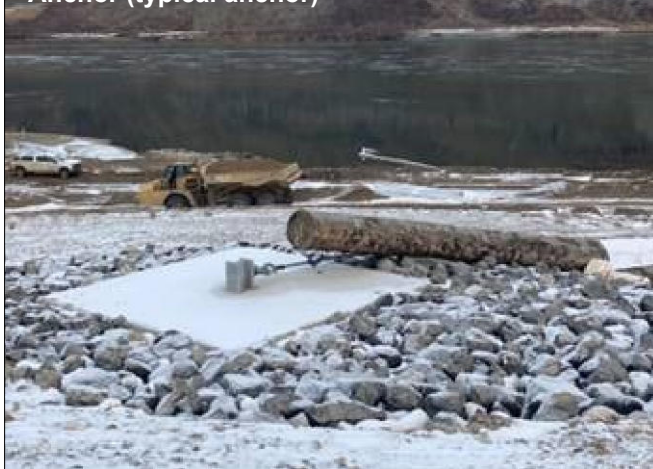
3 - Temporary Peace River Debris Boom Anchor (typical anchor)
