<b>Project Name</b>	Coastal GasLink Pipeline Project	<b>Inspection Status</b>	Final
<b>EA Certificate #</b>	E14-03	<b>Inspection No.</b>	20230076_IR001
<b>Project Status</b>	Certified - construction	<b>Inspection Start</b>	2023-11-07
<b>Officer</b>	Smith	<b>UTM</b>	10U 556797 6105580 to 9U 592948 6009169
<b>Trigger</b>	Planned Inspection	<b>Inspection Type</b>	Field
<b>Project Description</b>	The Coastal GasLink Pipeline Project (Project) is an approximately 650-kilometre natural gas pipeline connecting facilities in northeast British Columbia to the LNG Canada facility near Kitimat.		
<b>Location Description</b>	The Project initiates near the community of Groundbirch and terminates near Kitimat. This inspection covered activities between approximately Kilometre Post (KP)140 and KP 573 of the pipeline.		
<b>Inspection Summary</b>	<p>From November 7 to 9, 2023, the Officer and the Deputy Director of the Compliance and Enforcement Branch (CEB) inspected the Project right-of-way (RoW) between KP 140+100 to 573+000. The primary focus was to assess the implementation of the Work Execution Plans (WEP) prior to the winter season. The inspection included a debrief of observations at the en

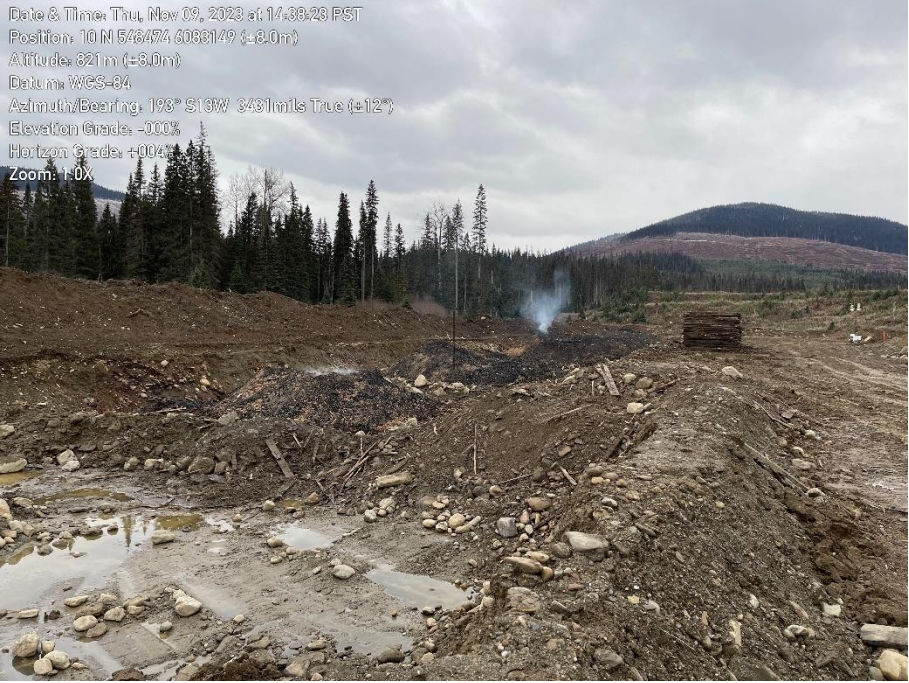
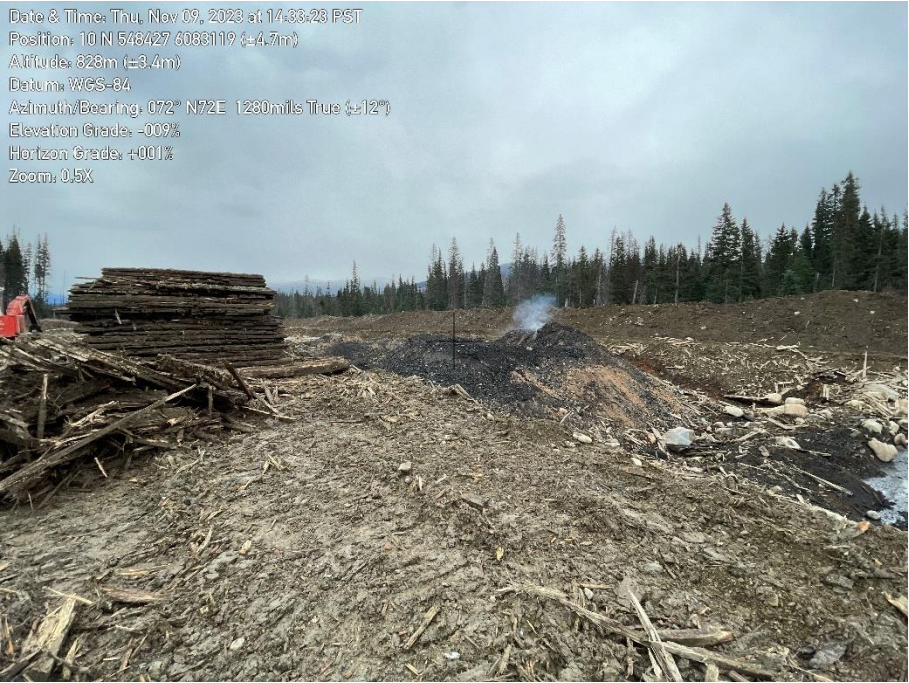
During the inspection on November 9, 2023, EAO CEB observed the disposal of construction related wood waste including rig-mats through burning adjacent to the pipe-storage yard near KP 166+100. Following the inspection, EAO CEB requested the Certificate Holder provide documentation (*Environmental Management Act* (EMA) Authorization (#AA-11548)) that allows for the disposal of rig-mats through burning.

On November 28, 2023, the Certificate Holder responded to EAO CEB’s request and provided waste discharge Approvals issued under the EMA for the “discharge of contaminants from burn piles located along the pipeline corridor of sections 3 & 4 of the Coastal GasLink Pipeline project”. The Authorization was provided to the Project by the relevant regulatory authority and covers the area of the Project where waste discharge through burning was observed by EAO CEB; Section 3. The Authorization allows for the following material to be combusted: wood based materials, untreated SPF construction wood debris consisting of damaged skids, beams, blocks, wooden spools, pallets, access mats and rig mats.

Photo 1. Burn piles observed by EAO CEB on November 9, 2023, near KP 166+100.

Photo 2. Burn piles observed by EAO CEB on November 9, 2023, near KP 166+100.

The documentation provided by the Certificate Holder through the information request process provides evidence of compliance with the requirement to dispose of all waste materials in accordance with federal and provincial legislation and municipal/regional regulations as required, at the pipe-storage area adjacent to roughly KP 166+100.

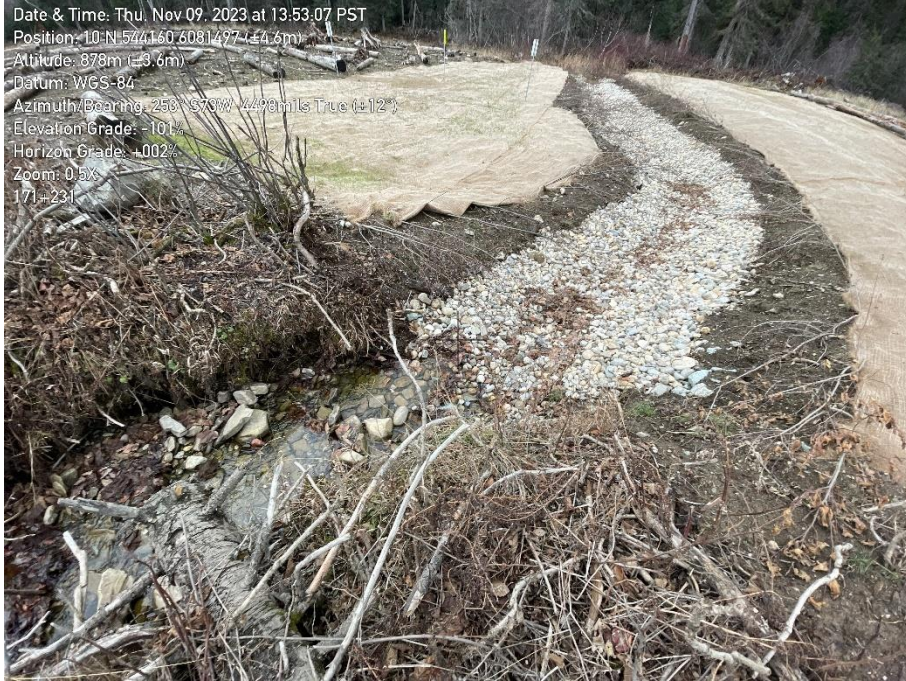
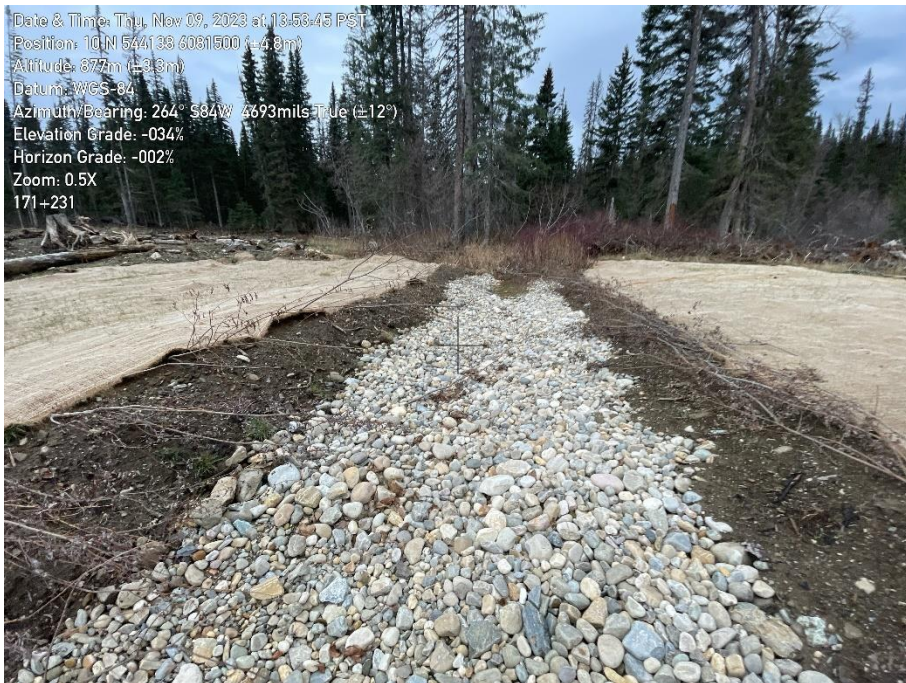
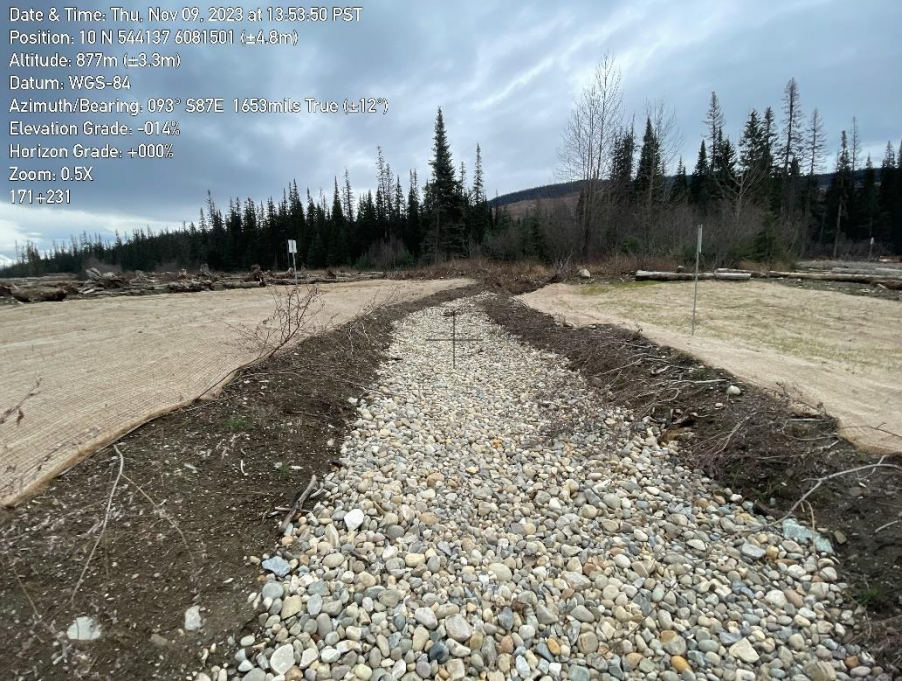
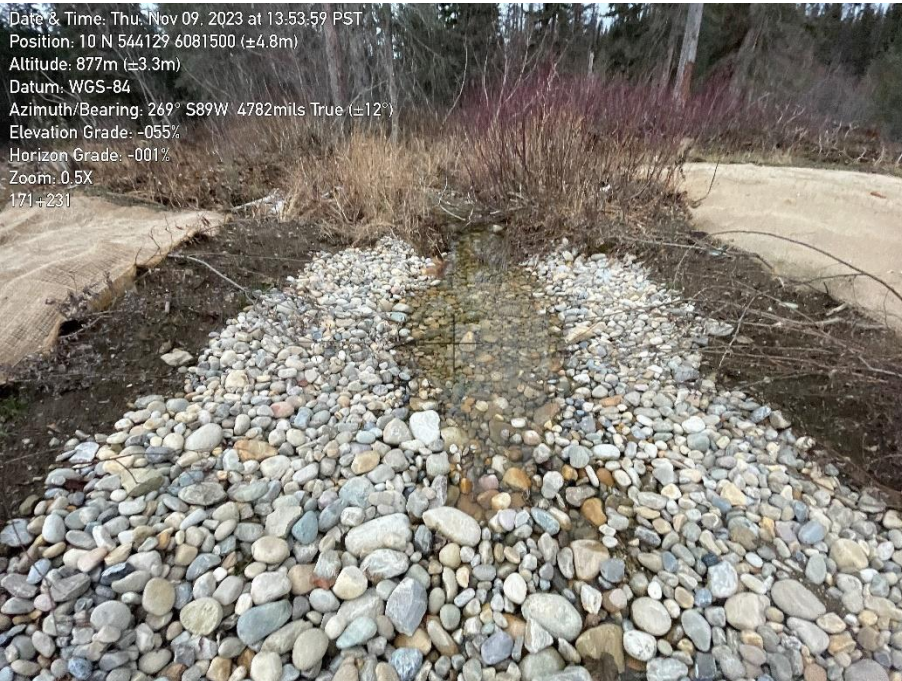
EAO CEB's observations at KP 171+231, which is labeled as a fish-bearing stream with a watercourse crossing number of J234.99, document that the pipe has been installed through the crossing, the travel lane has been removed and streambanks adjacent to the channel have been reinstated.

The re-constructed channel has large substrate consisting primarily of cobble placed in a manner that limits the channel's profile. Flow through this area of the channel was observed to be within the spaces between the cobble itself; the lack of a defined channel profile limited the channel's depth through the portion of the stream that crosses the Project RoW. Flowing water was noted within the channel immediately upstream and downstream of the pipeline RoW. However, open flowing water was not observed at the crossing itself. The lack of a channel profile and channel depth through the re-established portion of the feature may cause fish passage restrictions.

Photo 3. Watercourse number J234.99 looking upstream to downstream - overview.

Photo 4. Watercourse number J234.99 looking upstream to downstream – mid crossing channel.

Photo 5. Watercourse number J234.99 looking downstream to upstream.

Photo 6. Watercourse number J234.99 looking downstream at the bottom end of the crossing.

The observations made by EAO CEB on November 9, 2023, at KP 171, 231 (watercourse number J234.99) appear to provide evidence of non-compliance with the requirements referenced above regarding drainage patterns and bank protection and reclamation.

**Compliance Determination:** Out - Warning - Refer to Enforcement Summary

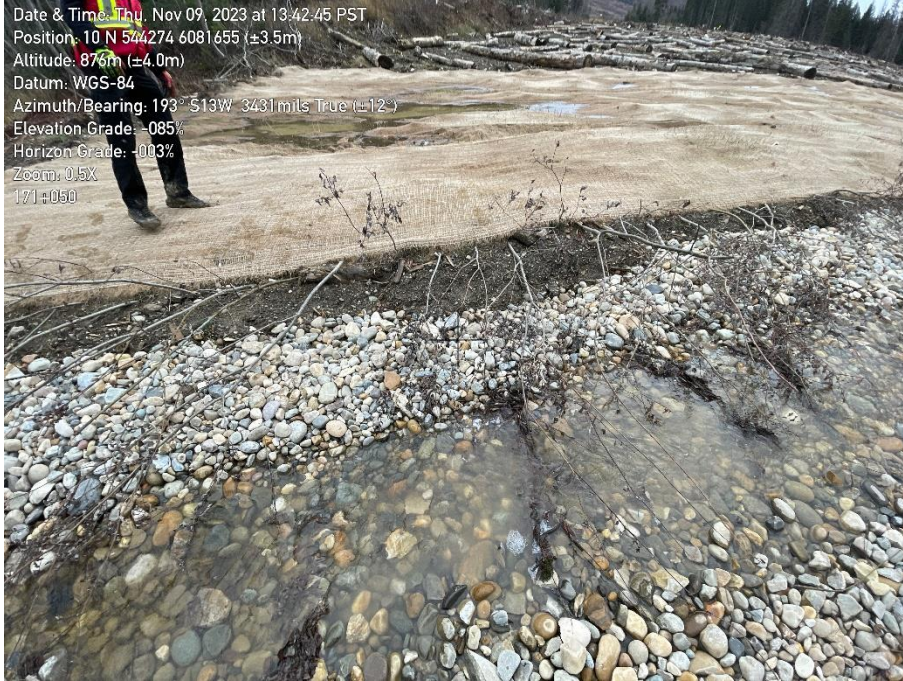
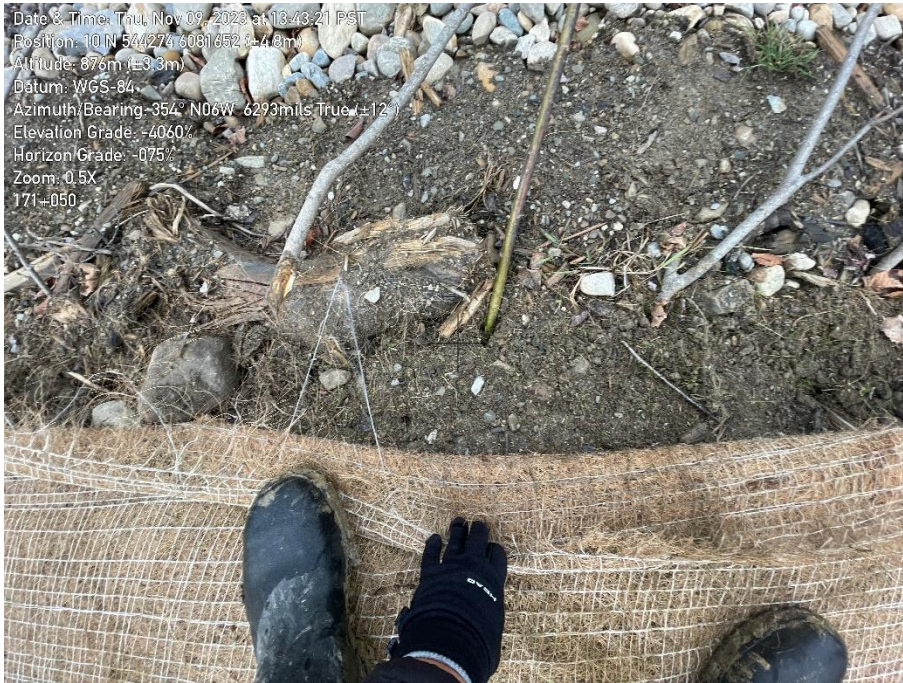
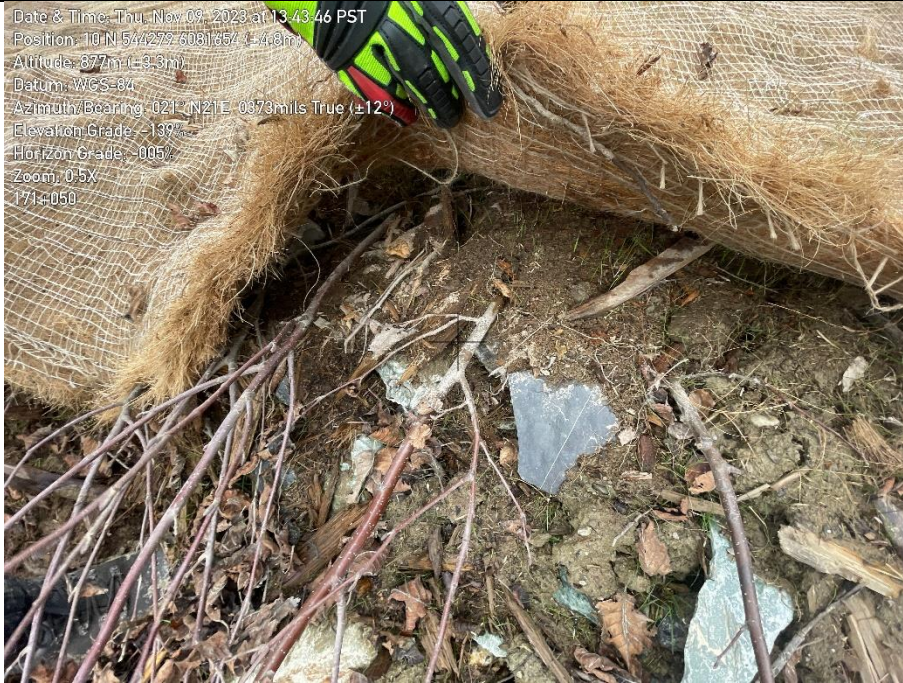
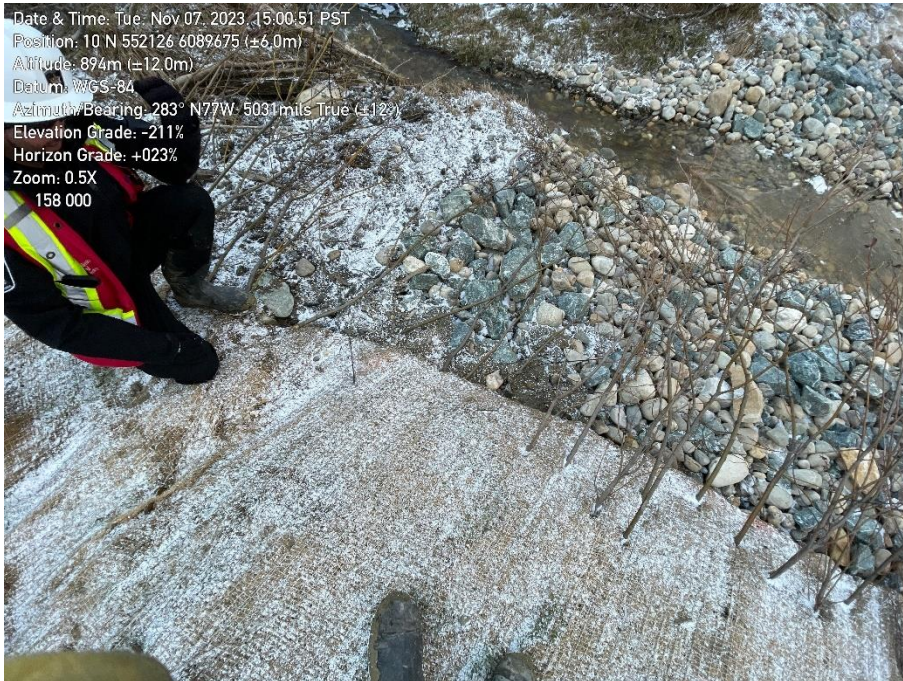
During the inspection, EAO CEB viewed the willow installation used for bank reclamation at select crossings. The willow stakes inspected were primarily less than 1.5 to 2.5 centimeters (cm) in diameter, were less than 2 to 3 metres (m) long and most often had more than 25 cm of the stake left exposed. See the below photos for examples at the crossings located at roughly KP 158+300 and 171+050.

Photo 7. Overview of willow staking at the watercourse crossing at KP 171+050.

Photo 8. Close-up of willow staking at the watercourse crossing at KP 171+050.

Photo 9. Close-up of willow staking at the watercourse crossing at KP 171+050.

Photo 10. Willow staking at the watercourse crossing of KP 158+300 (approximately).

The above observations provide evidence of non-compliance with the bank protection and reclamation requirement within the Environmental Management Plan specific to willow staking.

**Compliance Determination:** Out - Warning - Refer to Enforcement Summary

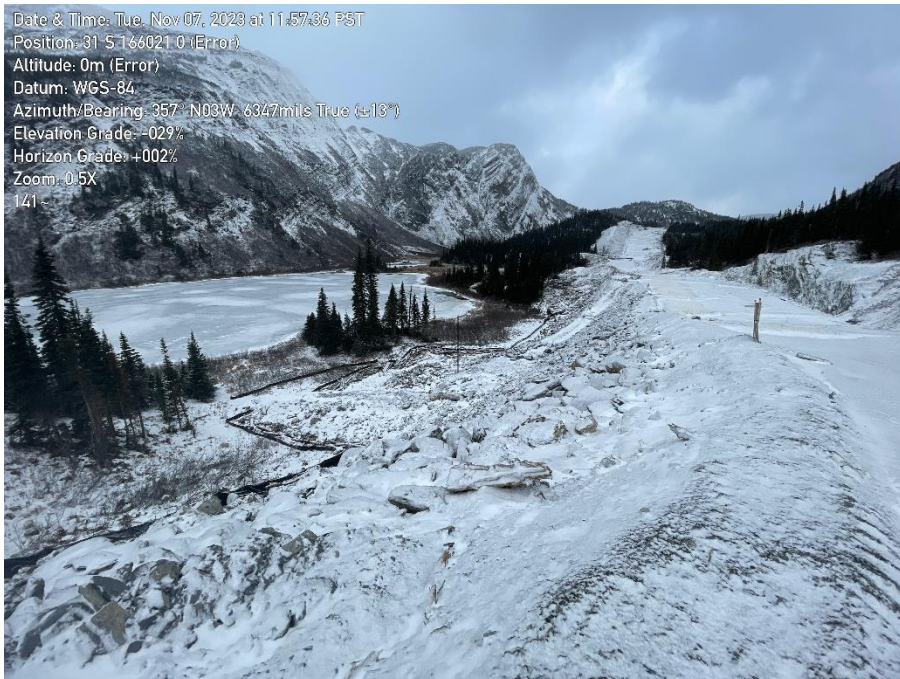
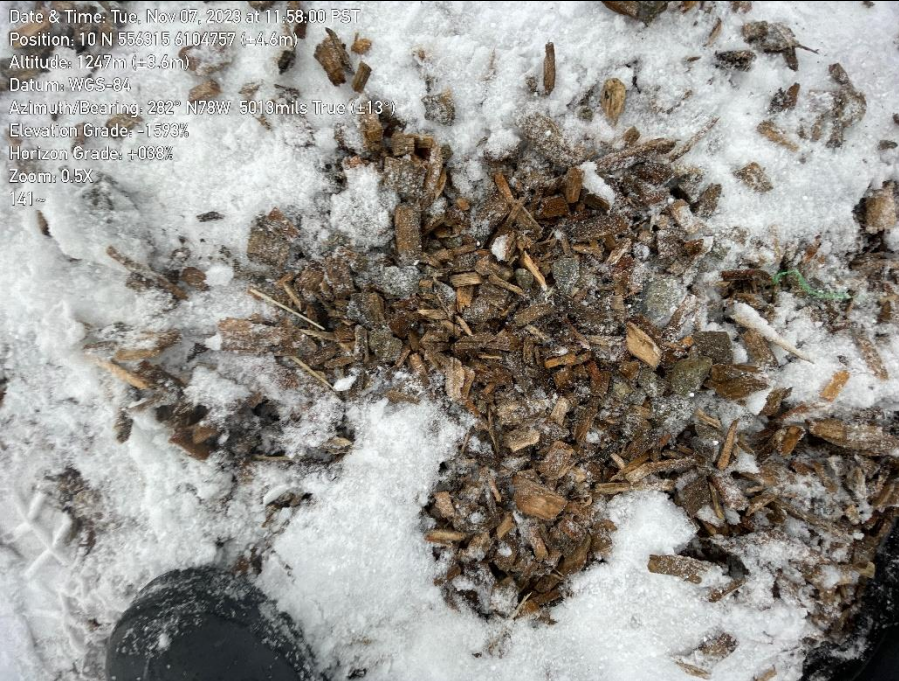
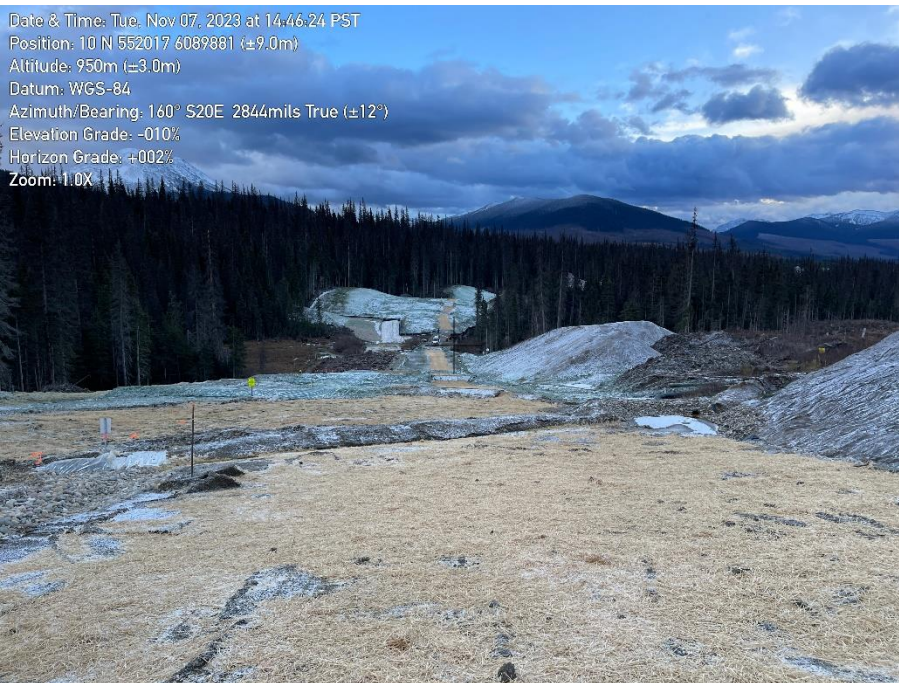
Erosion and sediment control measures observed include cover management, diversion berms, sediment fence and perimeter controls such as rock lined ditching. See the below photos for examples of the observations made on November 7, 2023.

Photo 11. KP 141+100 approximately. Perimeter controls and cover management per the WEP.

Photo 12. KP141+100 approximately. Close up of wood mulch used as cover management.

Photo 13. KP 151+100 approximately. Overview of RoW looking towards high-chain. Measures installed per the WEP.

The observations and findings provide evidence that the Project is compliant with Section 2.4(2) of the Compliance Agreement with respect to implementation of ESC measures specified in the WEPs for KP 140+200 to 143+200 and KP 149+200 to 154+000.

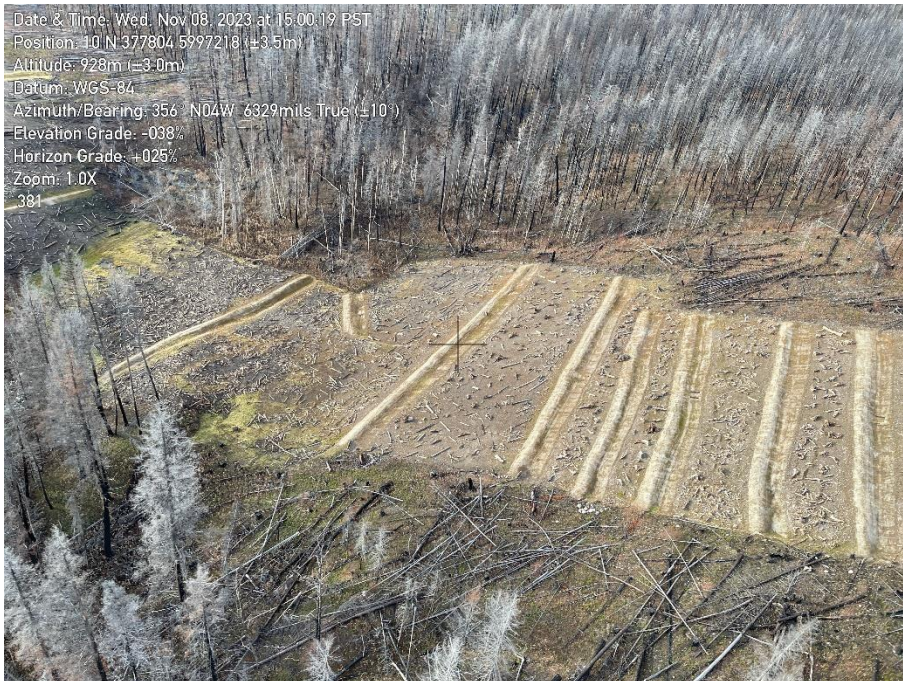
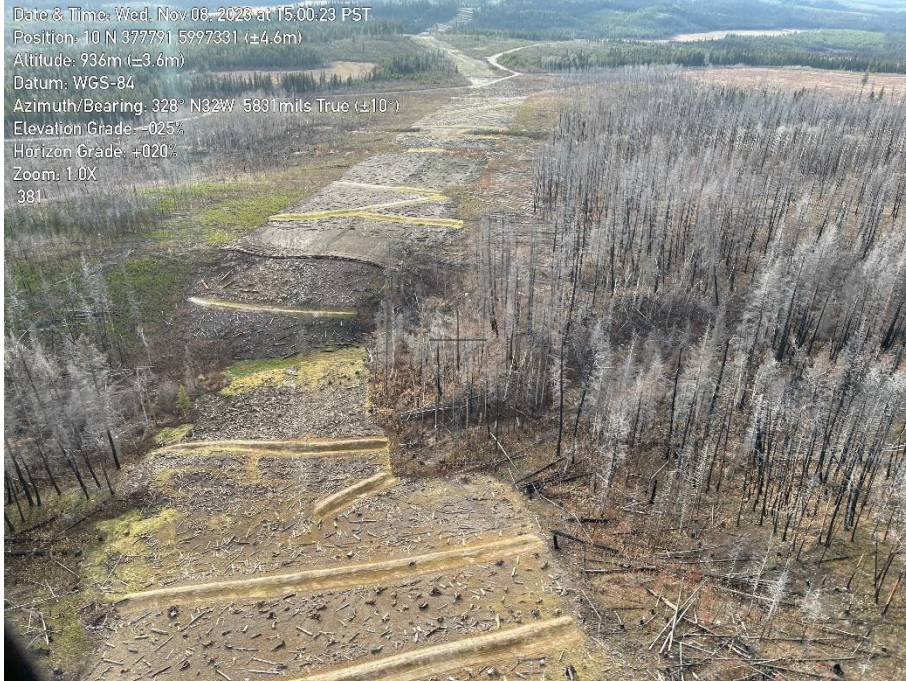
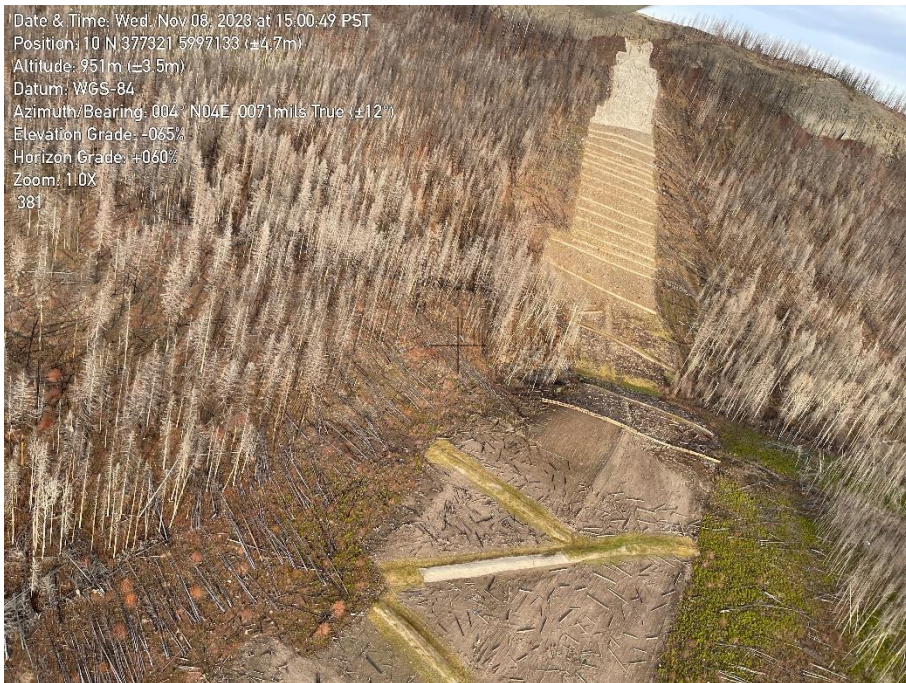
EAO CEB observed measures in the field installed as per the final clean-up portion of the WEP. These measures included a series of offtake diversion berms, which are lined with erosion control product, rollback using woody debris and cover management using seed. See the below photos for examples of the observations made on November 8, 2023, near KP 381.

Photo 14. Overview of KP 381 as seen from the air on November 8, 2023. Final clean-up completed.

Photo 15. Overview of KP 381 as seen from the air on November 8, 2023. Final clean-up completed.

Photo 16. Overview of KP 381 as seen from the air on November 8, 2023. Final clean-up completed.

The observations and findings provide evidence that the Project is compliant with Section 2.4(2) of the Compliance Agreement with respect to implementation of erosion and sediment control measures specified in the WEP for KP 381+200 to 381+600.

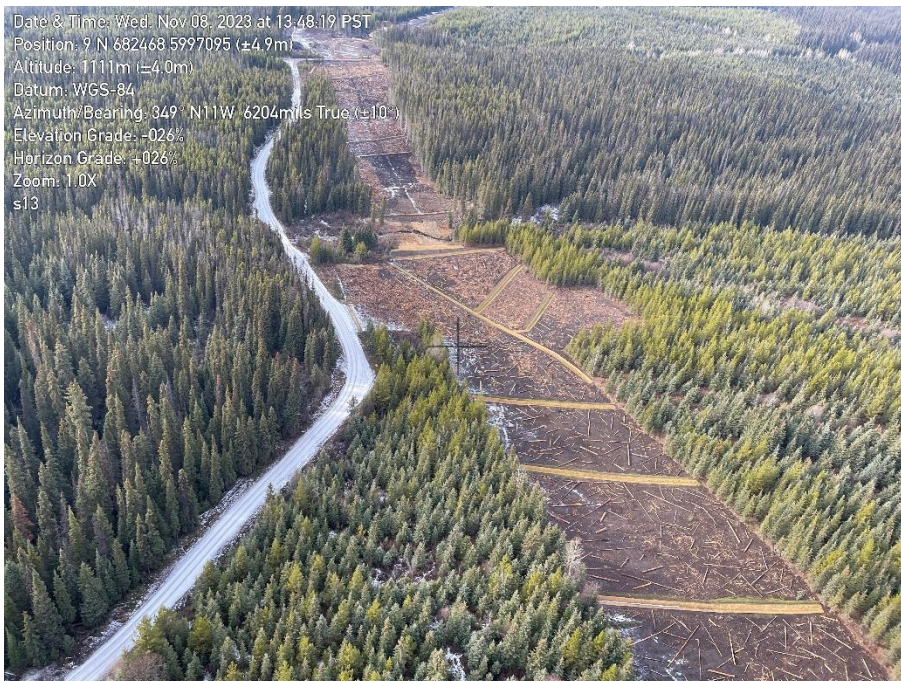
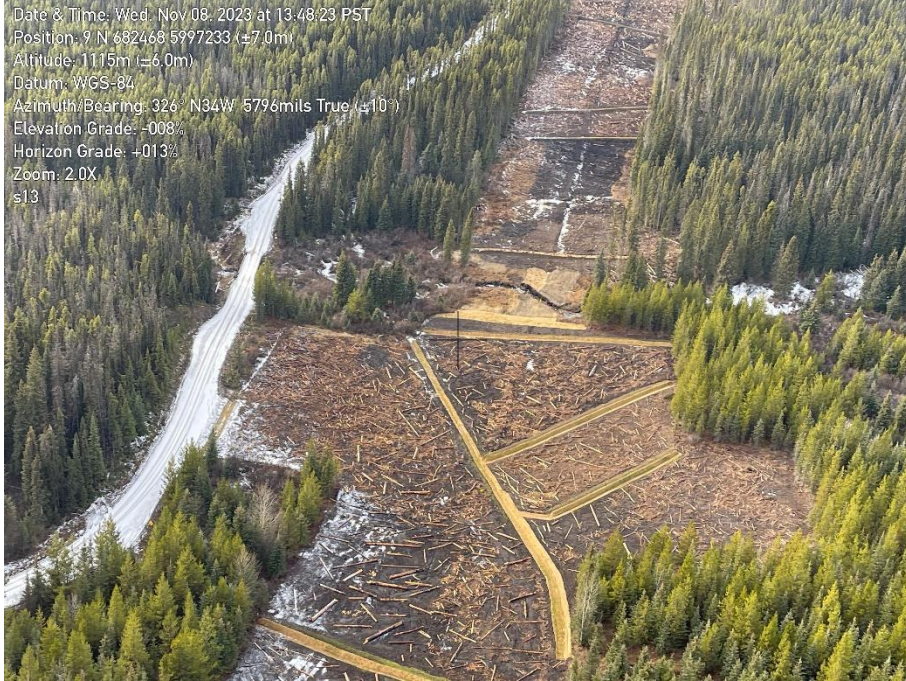
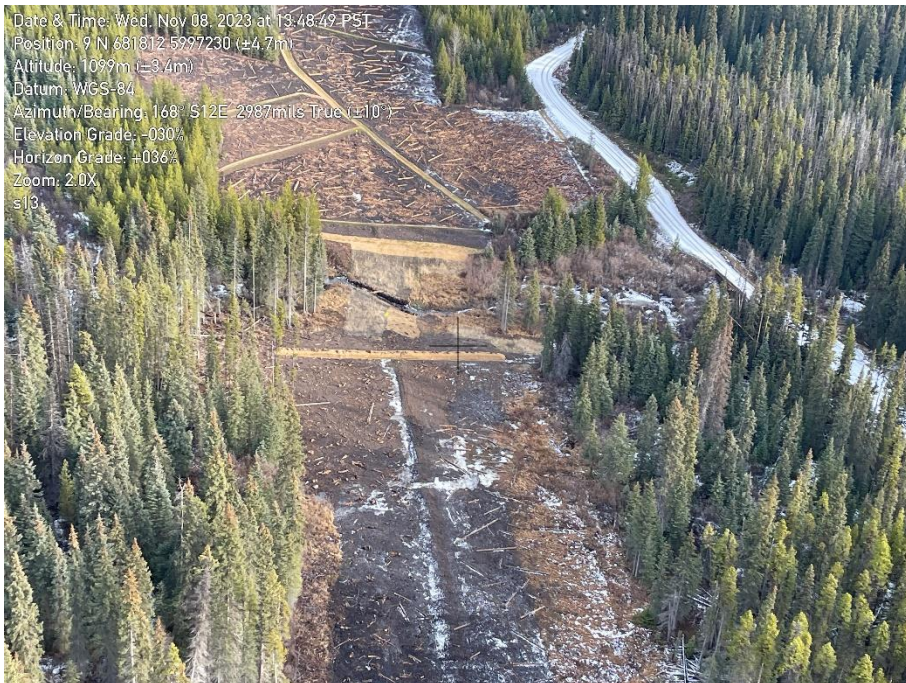
EAO CEB observed measures in the field installed as per the phase 2 WEP, which covers final clean-up. These measures included diversion berms, which are lined with erosion control product, rollback using woody debris and cover management at the watercourse crossing. See the below photos for examples of the observations made on November 8, 2023, near KP S\_13.

Photo 17. Overview of KP S\_13 as seen from the air on November 8, 2023. Looking high chain towards KP S\_13+050 watercourse crossing. Final clean-up completed.

Photo 18. Overview of KP S\_13 as seen from the air on November 8, 2023. Looking at the watercourse crossing at KP S\_13+050. Final clean-up completed.

Photo 19. Overview of KP S\_13 as seen from the air on November 8, 2023. Looking low chain at the watercourse crossing at KP S\_13+050. Final clean-up completed.

The observations and findings provide evidence that the Project is compliant with Section 2.4(2) of the Compliance Agreement with respect to implementation of ESC measures specified in the WEP for KP S\_13+020 to S\_13+120.
