Project Name	Prince Rupert Gas Transmission Project	Inspection Status	Final
EA Certificate #	E14-06	Inspection No.	20240051_IR001
Project Status	Certified - construction	Inspection Start	2024-10-02
Inspection Type	Field and Administrative	Initiation	Planned Inspection
UTM	497060 E 6121905 N to 463791 E 6094970 N		
Project Description	The Prince Rupert Gas Transmission Project (Project) is a natural gas transmission pipeline and associated infrastructure. The Project includes up to 780 kilometres of land-based pipeline and up to 120 kilometres of twin marine pipelines.		
Location Description	The Project extends from the Hudson’s Hope area in northeast BC to Lelu Island, near Prince Rupert. This inspection covered Project activities in the Nass Area, northwest of Terrace. The UTM range listed above correspond to the extent of the right-of-way (ROW) inspected.		
Inspection Summary	<p>The Officer inspected the pipeline ROW and access development activities between kilometre-post (KP) 674 and 729. The inspection included a debrief of observations with Project staff on October 2, 2024.</p> <p>The following requirements were inspected against:</p> <ol style="list-style-type: none"> 1. EAC

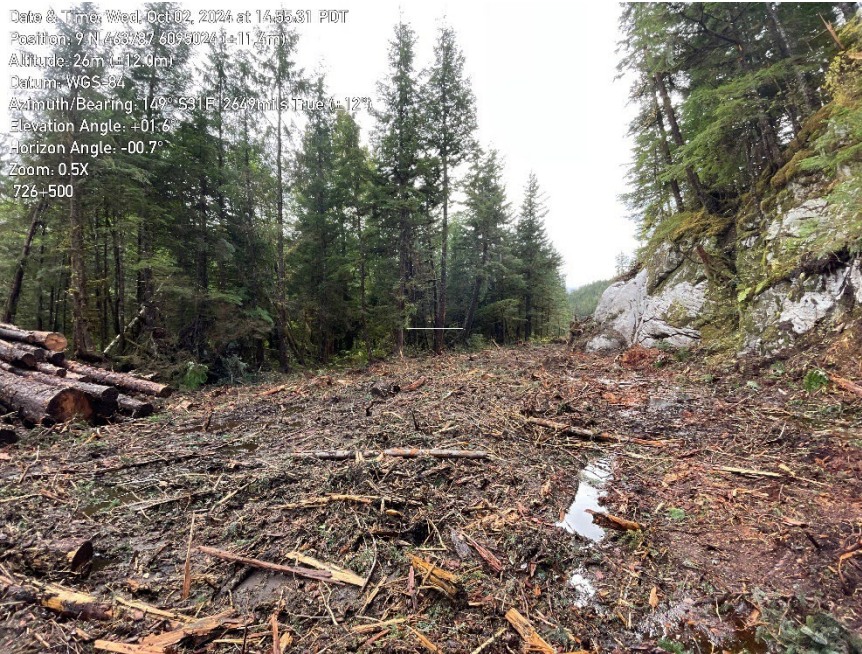
On October 2, 2024, the Officer inspected the Project ROW at KP 726+500 (Photo 2, 3), which had been cleared.

Photo 2. Cleared Project ROW at KP 726+500 in highchain direction.

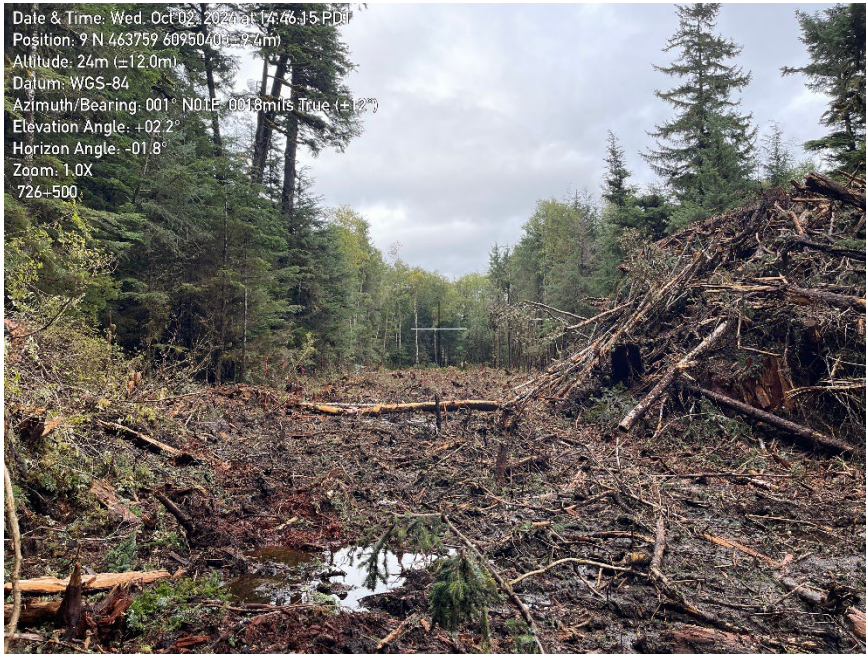
Photo 3. Cleared Project ROW at KP 726+500 in lowchain direction

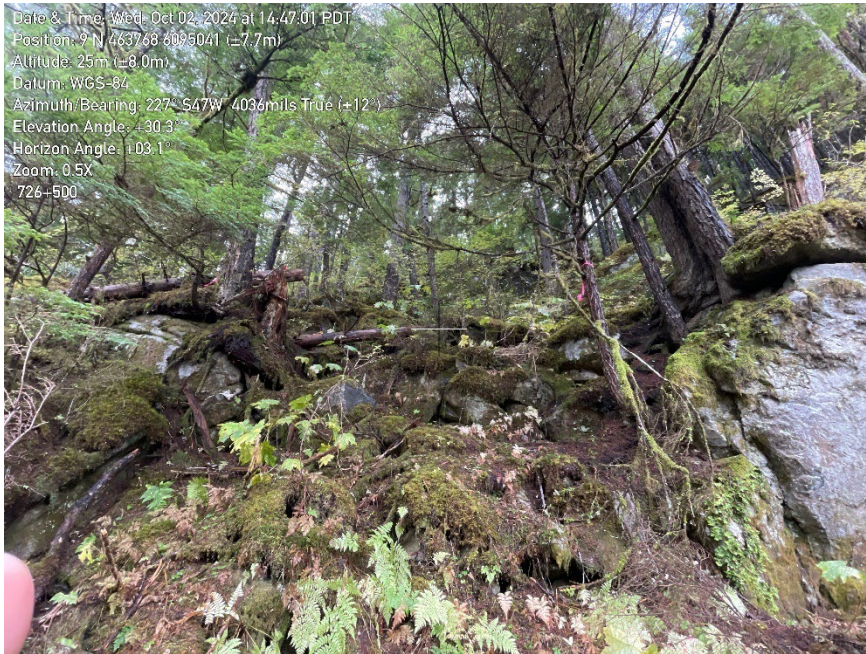
Table 7-1a of the Construction Environmental Management Plan (Appendix 15), provided to the Officer by the Certificate Holder on October 1, 2024 and an excerpt of which is presented in Requirement 7 below, identifies a potential bat hibernaculum or roost located between approximately KP 726+359 to 608 with feature number W_262. This feature is also indicated on the Environmental Alignment Sheets the Certificate Holder provided to the Officer on January 22, 2025 (Appendix 14).

The Officer observed feature W_262 at the edge of the cleared ROW, approximately in the centre of the Certified Pipeline Corridor. The feature was not delineated and there was no signage the ROW, only a few pieces of pink flagging tape were observed (Photo 4). Signage associated with a buffer and speed limit mitigation for the potential hibernaculum was observed on the road adjacent to the ROW (Road 24/Iskheenickh Road), which is on the opposite of the ROW from the potential hibernaculum and separated from the ROW by a vegetation buffer. This sign was not visible from the ROW or while in the direct vicinity of the potential hibernaculum (Photo 5).

Photo 4. Location of potential bat hibernaculum W_262 on the Project ROW, marked only with flagging tape.

These observations provide evidence of non-compliance with Condition 36 with respect to delineation and signage of environmentally sensitive features.

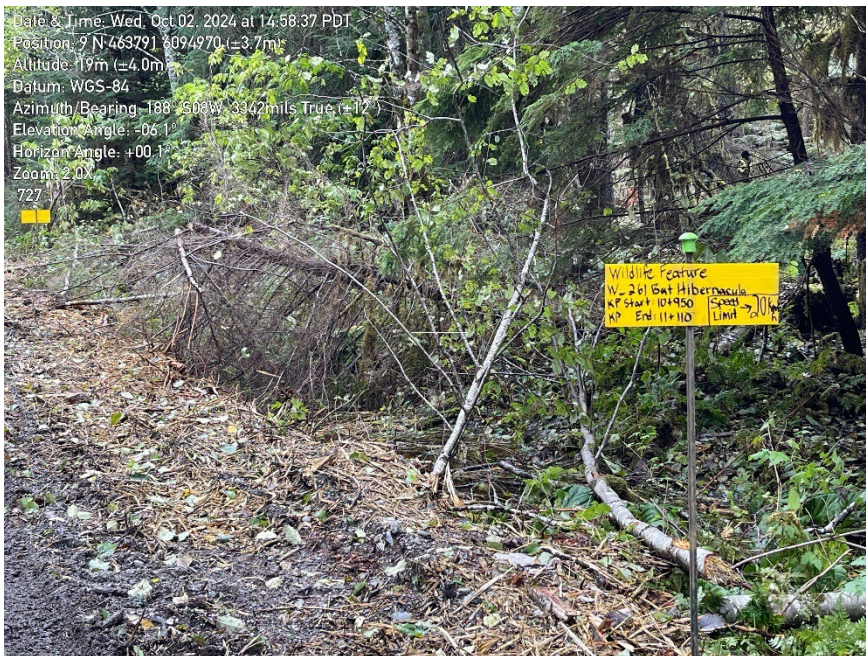
Photo 5. Road signage for potential bat hibernaculum W_262, not visible from the Project ROW.

Further observations by the Officer during the inspection in the vicinity of KP 726 identified that the placement of signage for environmental features on the road, rather than the ROW, as a common practice in the area.

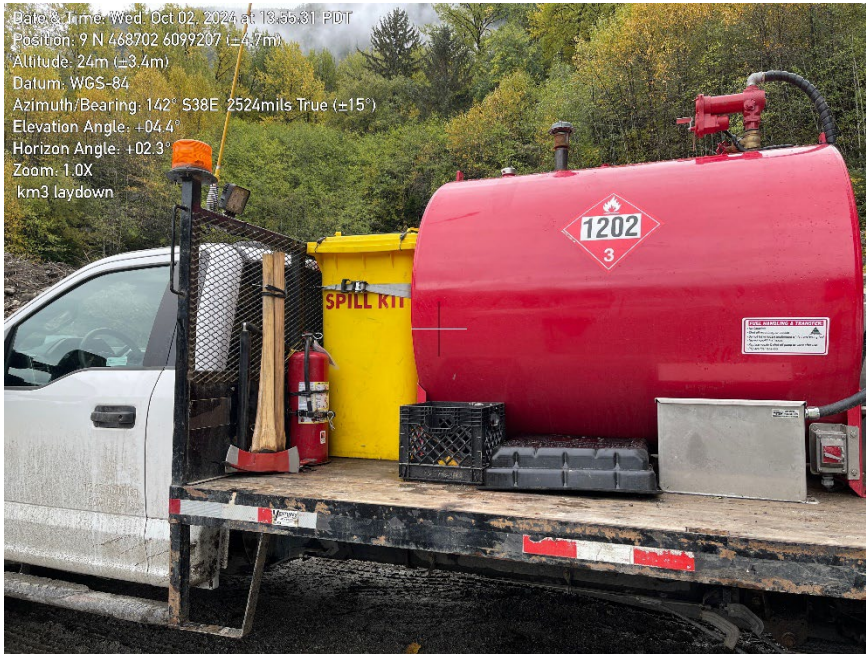
During the field inspection on October 2, 2024, the Officer inspected a Project service vehicle at the Road 24 laydown for the spill prevention equipment noted in Section 3.3.1 of the Chemical and Waste Management Plan (Photo 6). All of the required stand-by equipment was observed to be present.

Photo 6. Project service vehicle inspected for spill prevention equipment.
