Project Name	Coastal GasLink Pipeline Project	Inspection Status	Final
EA Certificate #	#E14-03	Inspection No.	IR2020-055
Project Status	Certified	Inspection Start	2020-10-19
Sector	Energy	UTM	10U 533697 E 6071620 N
Trigger	Planned Inspection	Inspection Type	Field
Project Description	The Coastal GasLink Pipeline Project (Project) is an approximately 650 kilometer (km) long natural gas pipeline connecting facilities in northeast British Columbia (BC) to the LNG Canada facility near Kitimat.		
Location Description	The Project is near Groundbirch (40 km west of Dawson Creek) in northeast BC to the LNG Canada facility near Kitimat. This inspection focused on work being carried out in Sections 1 through 5 of the Project.		
Inspection Summary	<p>From October 19 to 23, 2020 Environmental Assessment Office (EAO) Director of Compliance and Enforcement Chris Parks and Compliance and Enforcement Officer Clayton Smith (collectively EAO C&E) inspected the Coastal GasLink Pipeline Project (Project) against requirements of the Environmental Assessment Certificate (EAC) #E14-03 (Appendix 1). On November 2, 2020 EAO C&E conducted a follow up inspection in Section 4 of the Project near KP 244, north

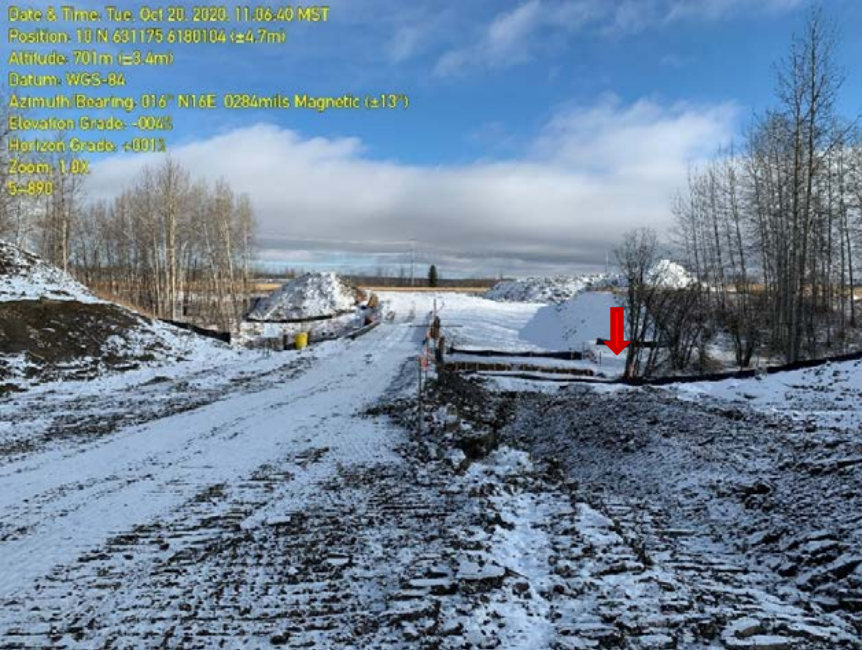
- KP_5+818_CPESC_Site-Specific ESC Plan_Rev1. Temporary measures have been installed at this bridge crossing site; however, the installation is not per the site-specific plan. Notably, on the left bank downstream side of the crossing the site is sloped towards the channel and a gap in the sediment fence may allow for the passage of water from exposed upslope area to mobilize into the fish-bearing stream. See photos 9 & 10 below; and,

Photo 10: KP 5+890. ESC not installed to site-specific plan. Risk of sediment mobilizing to watercourse.

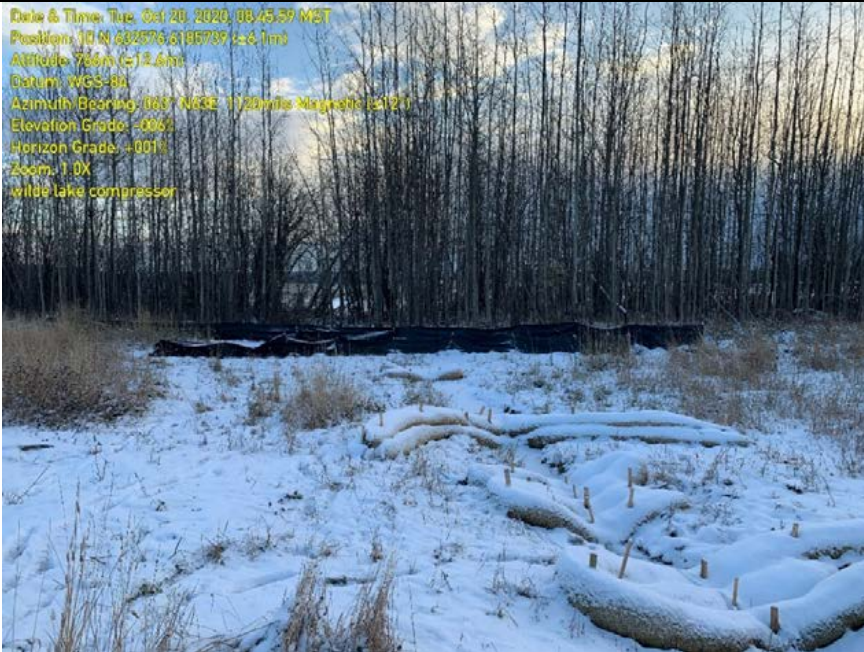
Photo 15: Sediment fence across outlet channel at Wilde Lake Compressor Site.

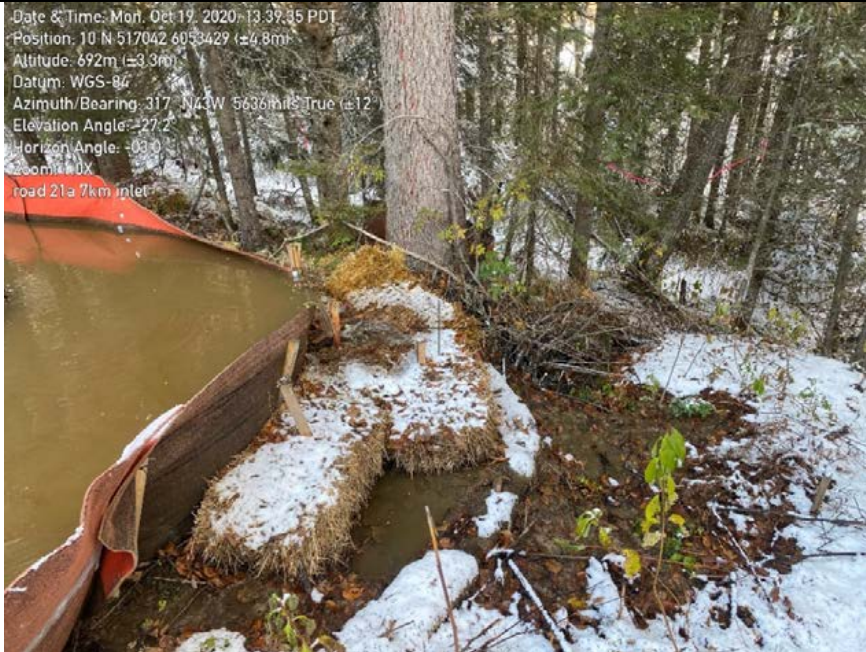
Photo 23: Sediment fence installed across water feature and overwhelmed. Straw bails installed incorrectly. Sediment laden water discharging towards Crooked River downslope of site.

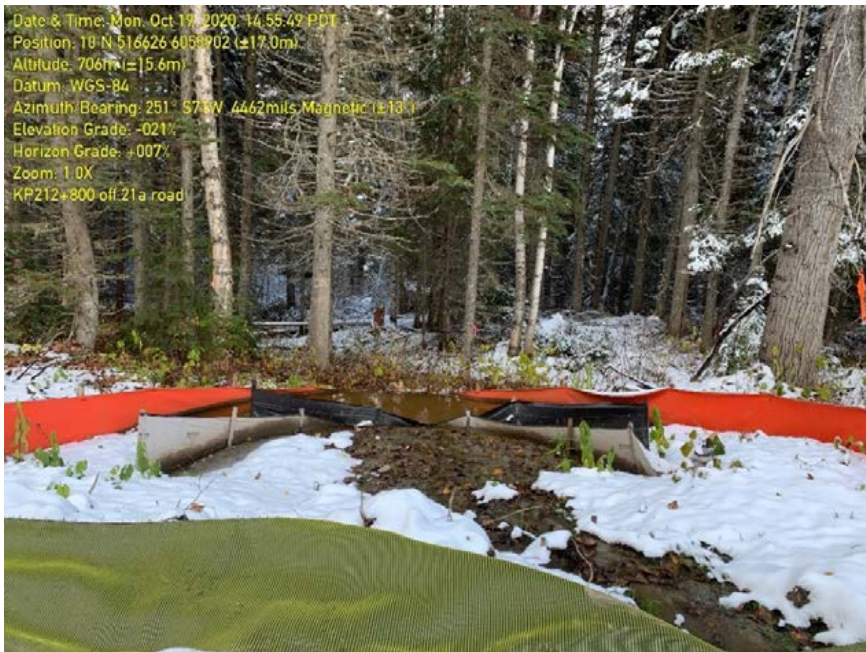
Photo 24: Sediment fence across channel at culvert outlet on 21a road. Fencing overwhelmed, not maintained and sediment laden water discharging off site.

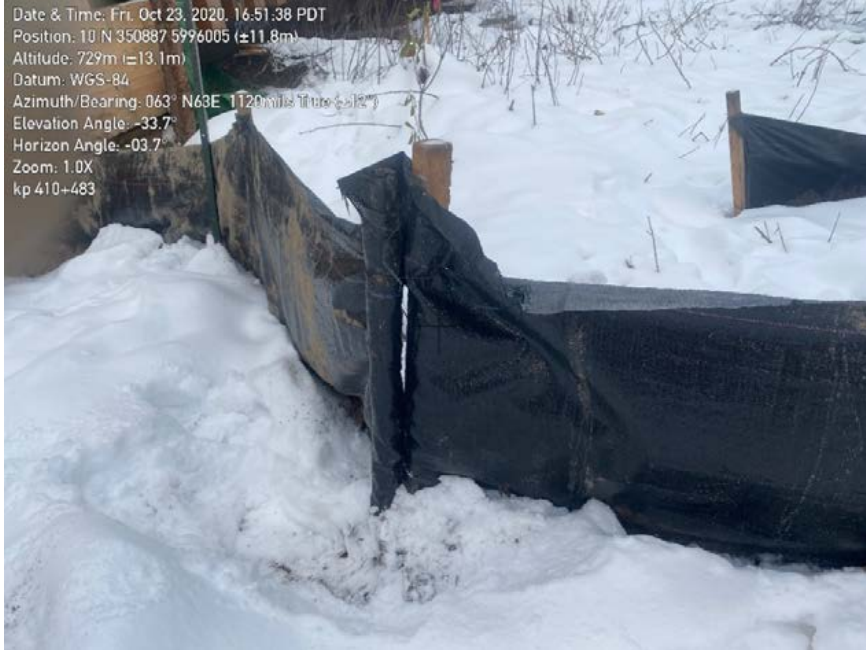
Photo 31: Gap left between sections of sediment fence. Water can pass through this gap. This incorrect installation practice was commonly seen including at KP402+803, 404+200 and 408+592.

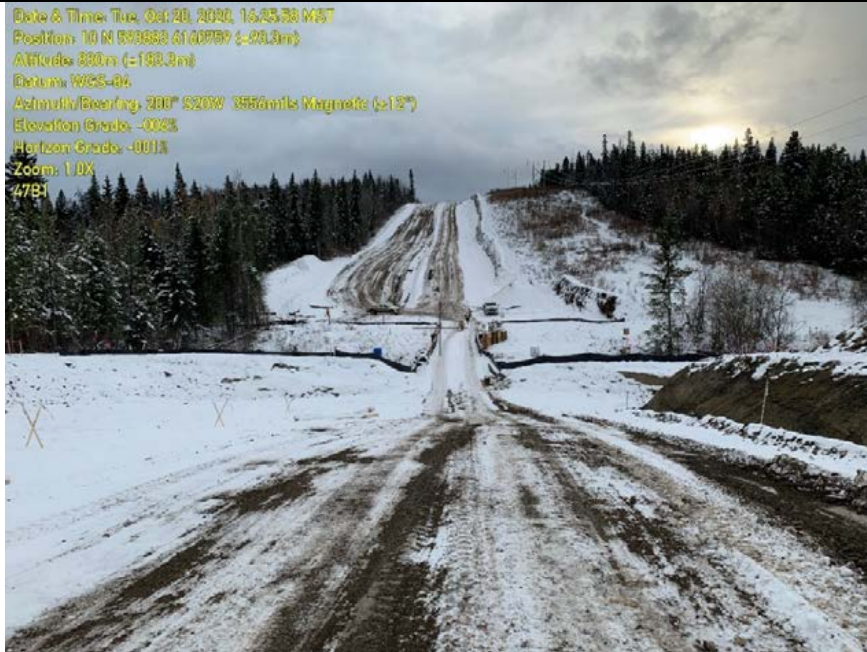
Photo 35: Work package 1, KP55+310. Right bank approach to S3 stream is roughly 390 m long. Single row of sediment fence at the base of the slope to protect the watercourse from sediment inputs.

EAO C&E notes that on November 5, 2020 a Water Quality Exceedance notification email was provided by Coastal GasLink to EAO and other Regulators. That email describes a 24-hour water quality exceedance at watercourse #47B1 (S3, KP55+310, photos 35 to 37 above) where “sediment inputs resulted from overwhelmed ESC measures”. Additionally, on November 8, 2020 EAO C&E received a Water Quality Exceedance notification email from Coastal GasLink indicating that, amongst other watercourses, watercourse WC46B1 (S3) at KP54+204 (photos 33 & 34 above) experienced a 24 hour water quality exceedance due to “sediment inputs from overwhelmed ESC measures from the right of way.”

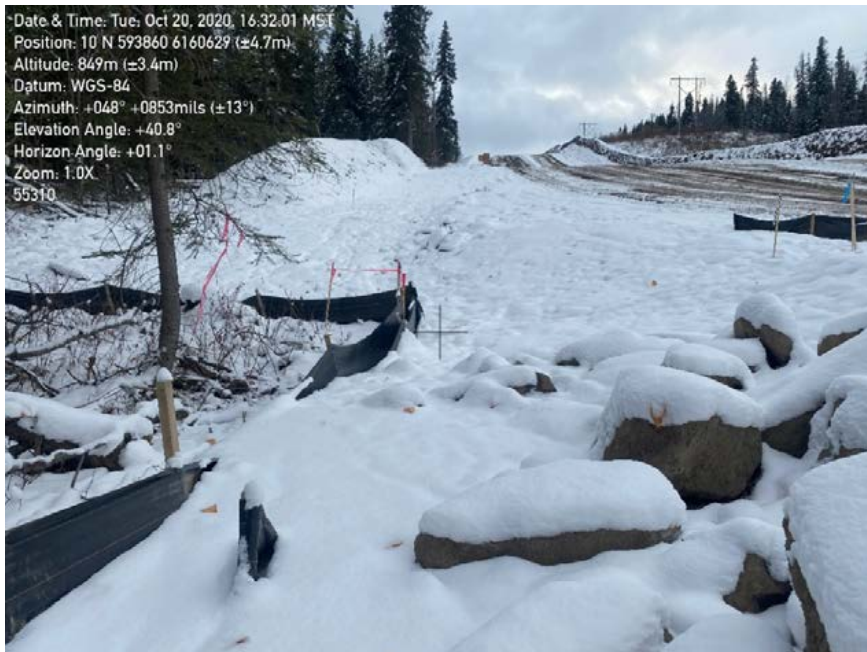
Photo 36: Work package 1, KP55+310. Material from ROW eroded and transported to this section of sediment fence. Sediment fence overwhelmed.

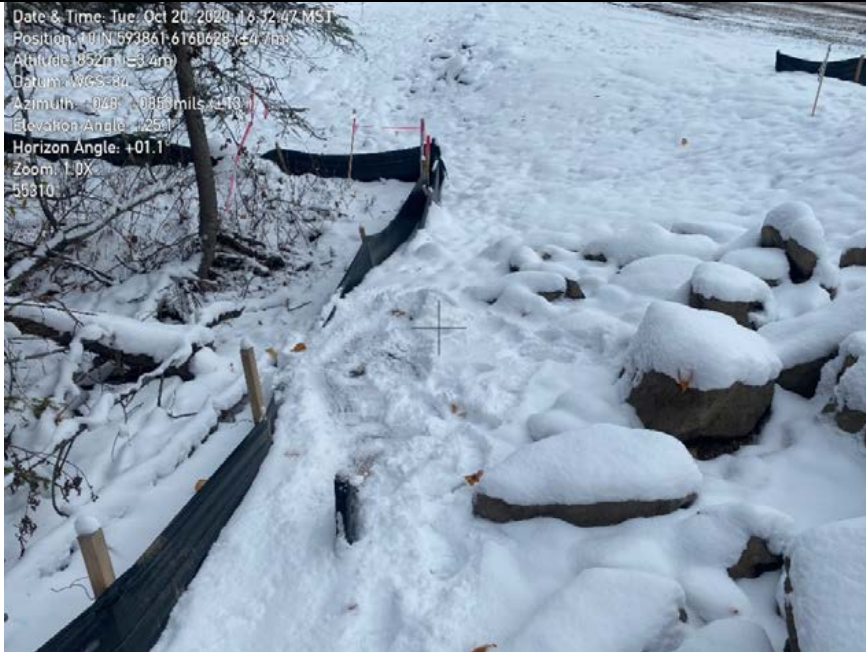
Photo 37: Same location as photo above. Sediment fence overwhelmed with material from the ROW. Material discharging off site.

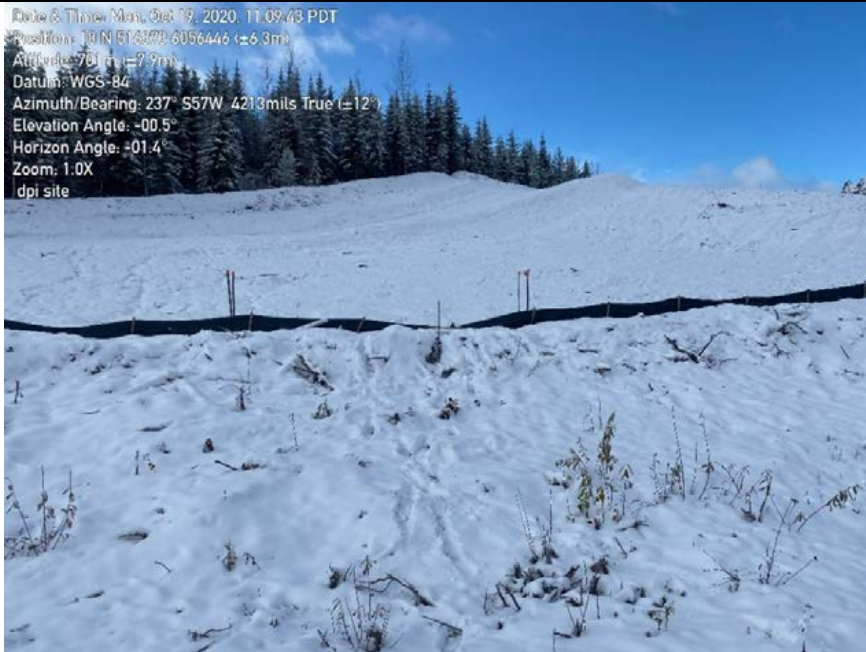
Photo 41: Work package 2. At the left bank side of Crooked River DPI site, low-chain looking towards high-chain. Long exposed slope draining to single row of sediment fence.

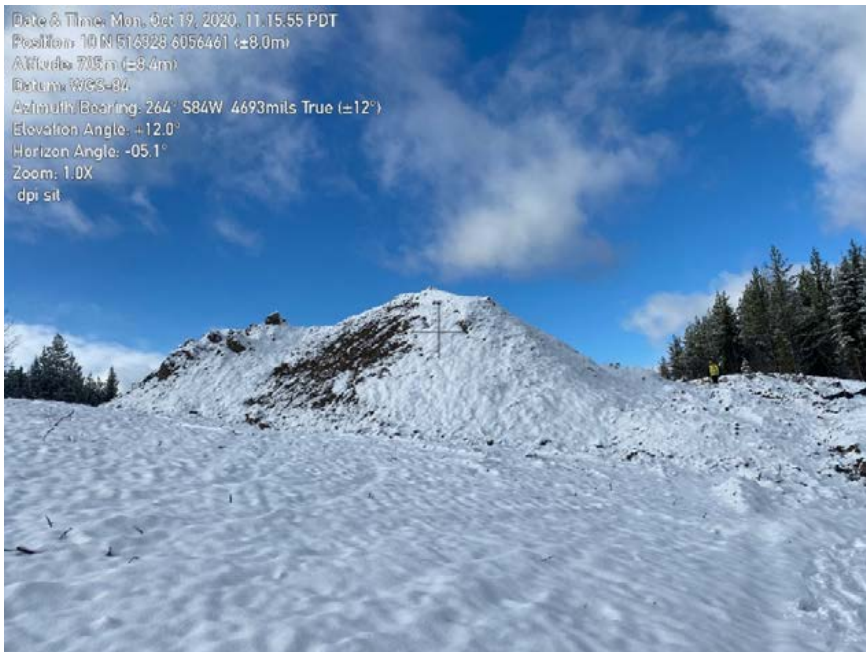
Photo 42: Work package 2. Exposed soil pile on top of slope on low chain side of Crooked River DPI site. Pile all drains to single row of sediment fence.

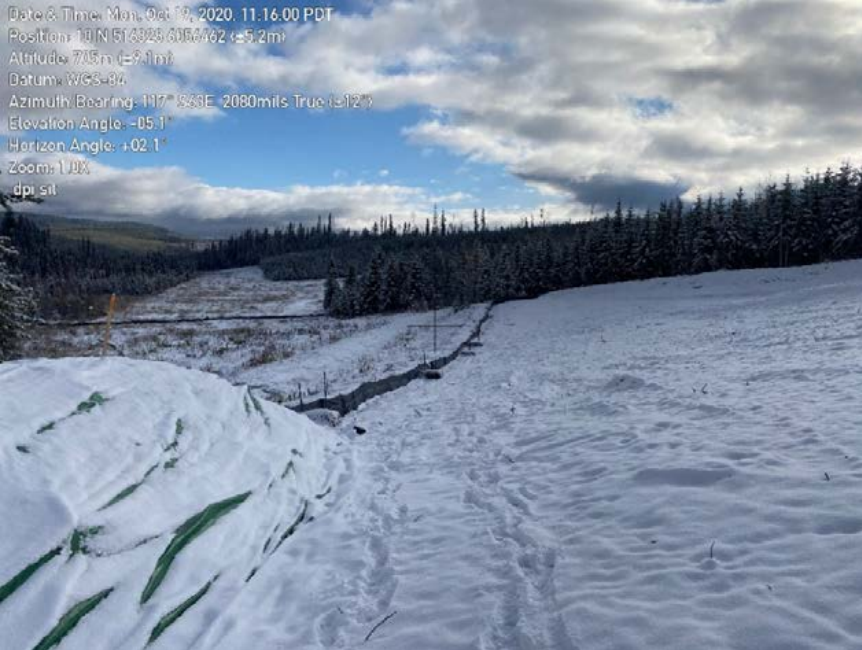
Photo 43: Work package 2. All flow from low chain side of Crooked River DPI site controlled by this row of sediment fence.

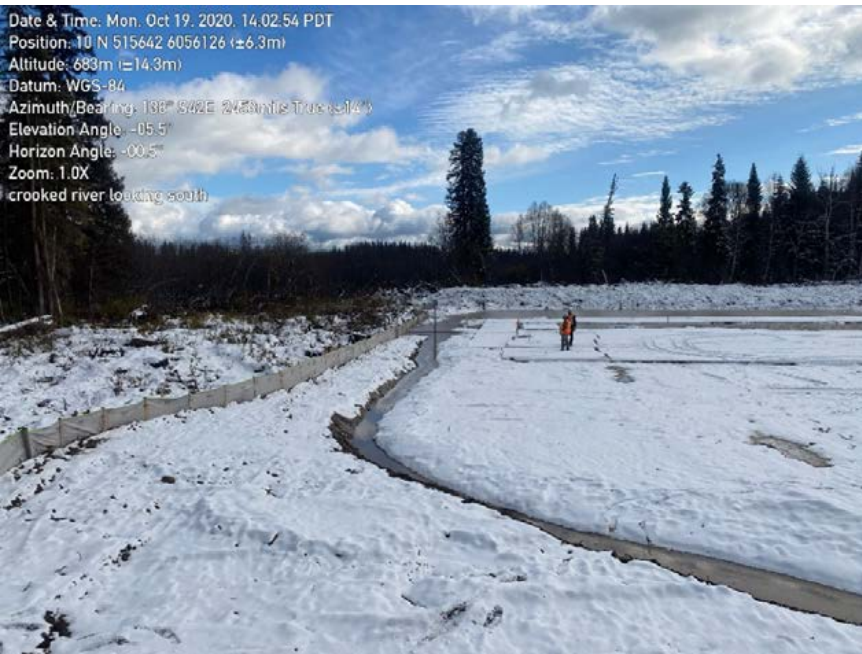
Photo 46: Work package 2. Right bank side of Crooked River. Location where water from right of way reports to. Crooked River out of frame to left of the photo.

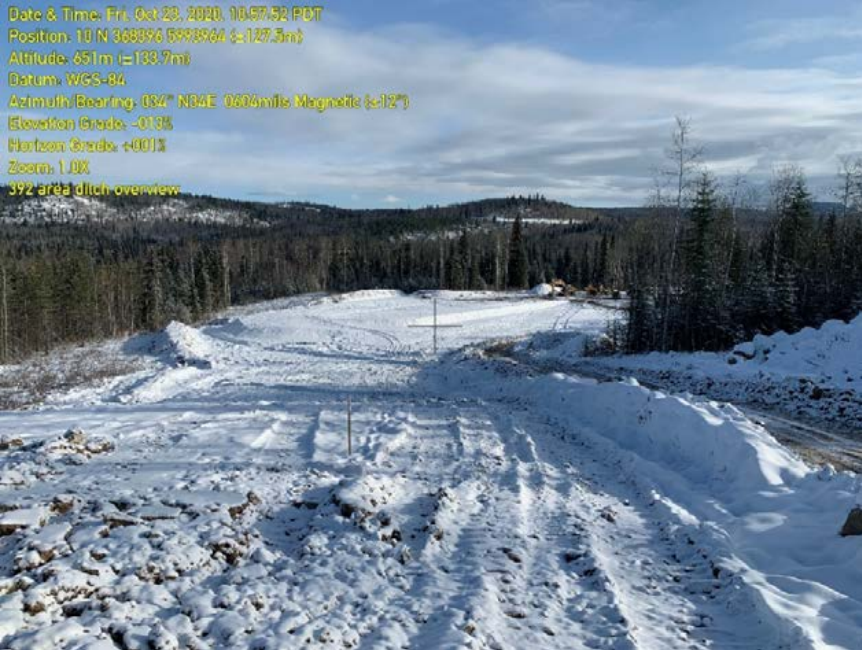
Photo 47. Work package 3, exposed soils on right of way draining towards single confined area. See Photo 57 below for image of where this material is designed to drain to.

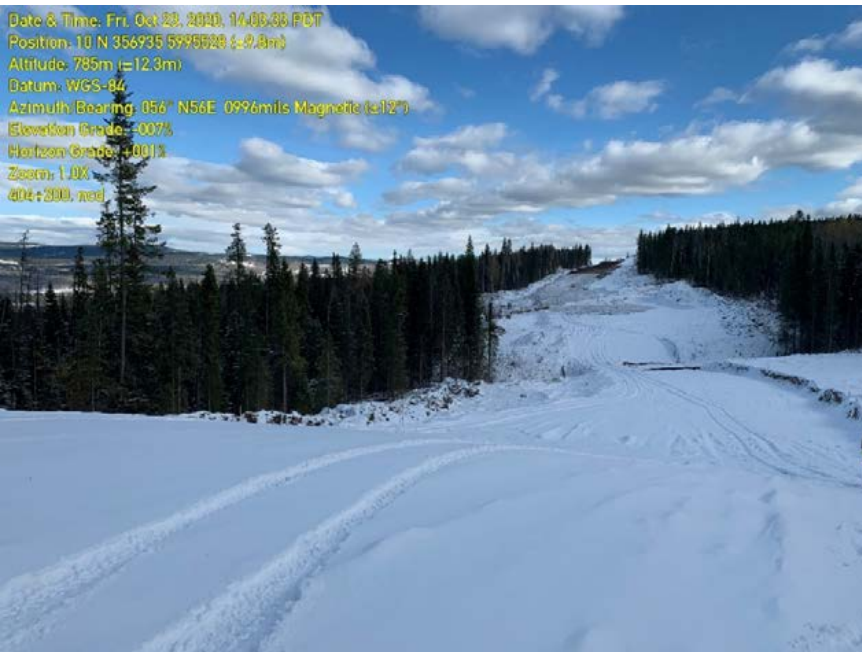
Photo 48: Work package 3. Exposed right of way sloping towards NCD feature. Single row of sediment fence installed adjacent to NCD.

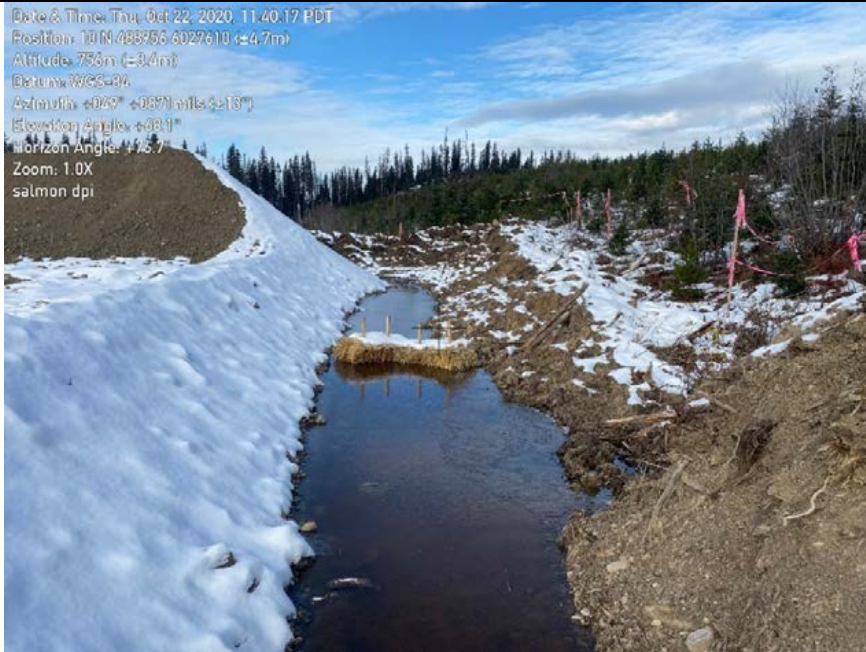
Photo 53: Non-functioning straw bails at Salmon River DPI site. Large volume of water around the straw bails.

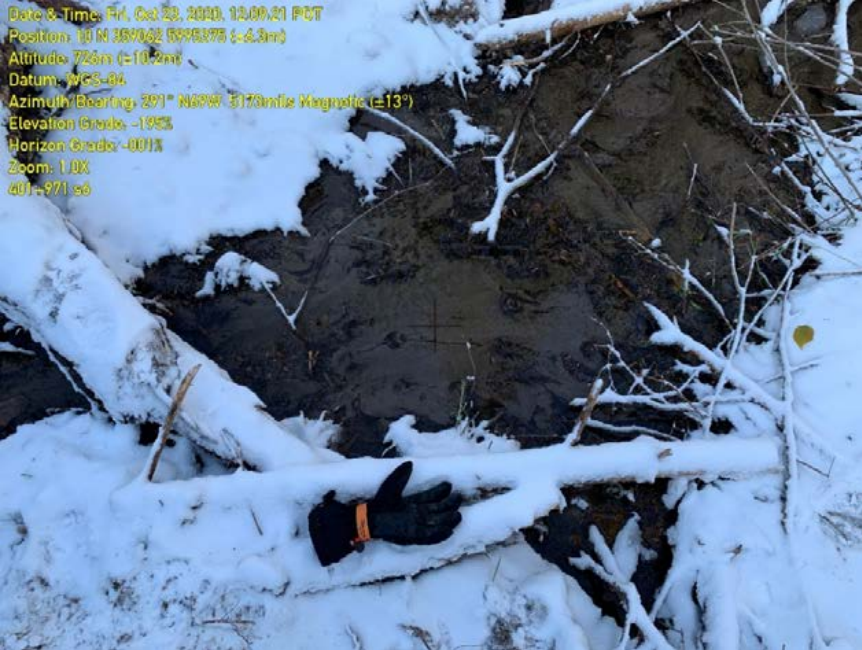
Photo 63: Sediment in S6 channel immediately downstream of the bridge shown in above photos.

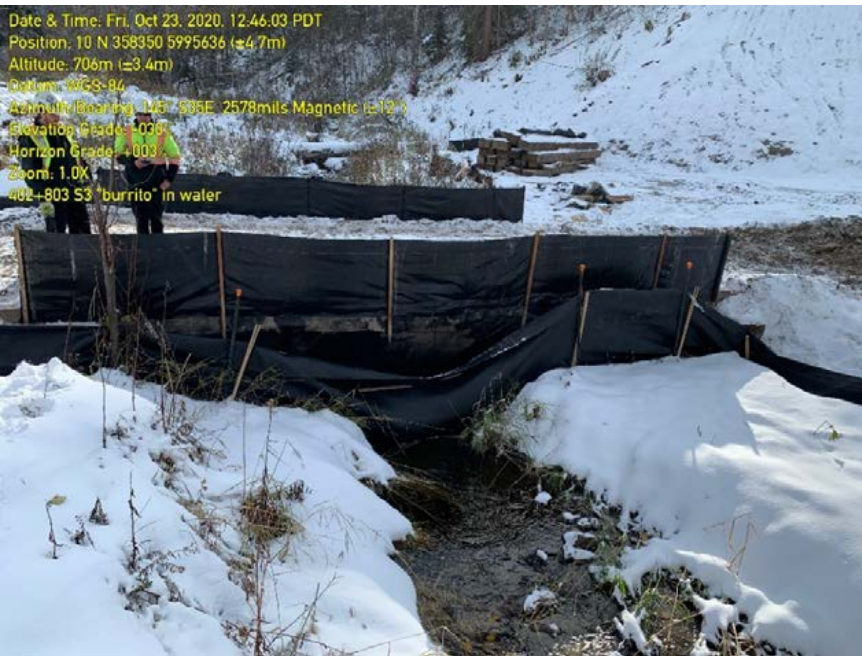
Photo 64: Work package 3. Geotextile beneath bridge containing sediment and sagging into the water of fish-bearing (S3) watercourse.

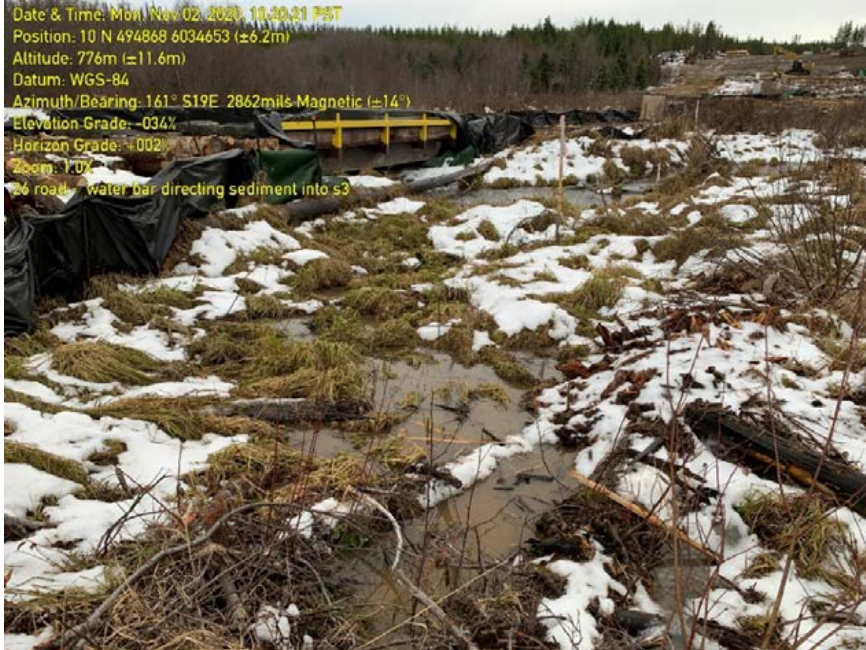
Photo 68: WC272, no ESC measures where turbid flow from erosion on right-of-way entering fish bearing watercourse.

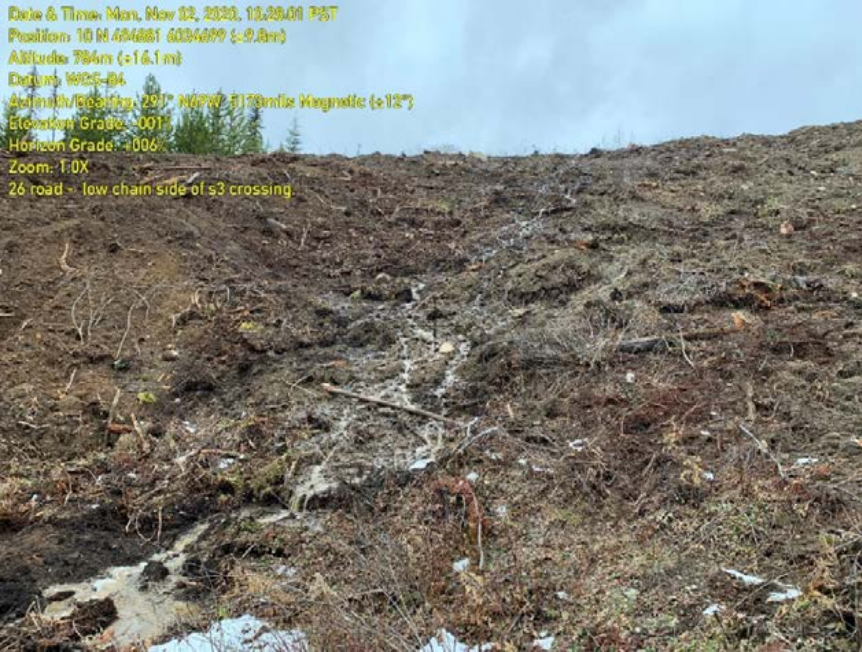
Photo 71: Exposed surface material eroding slope and draining towards fish-bearing watercourse.

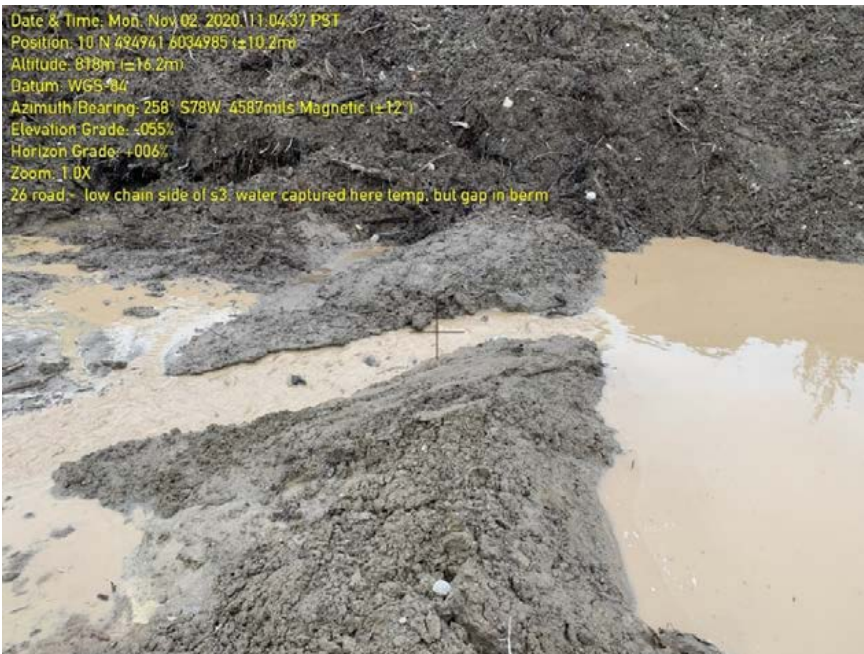
Photo 73: Notch in berm causing water to continue to travel down slope towards fish-bearing stream.

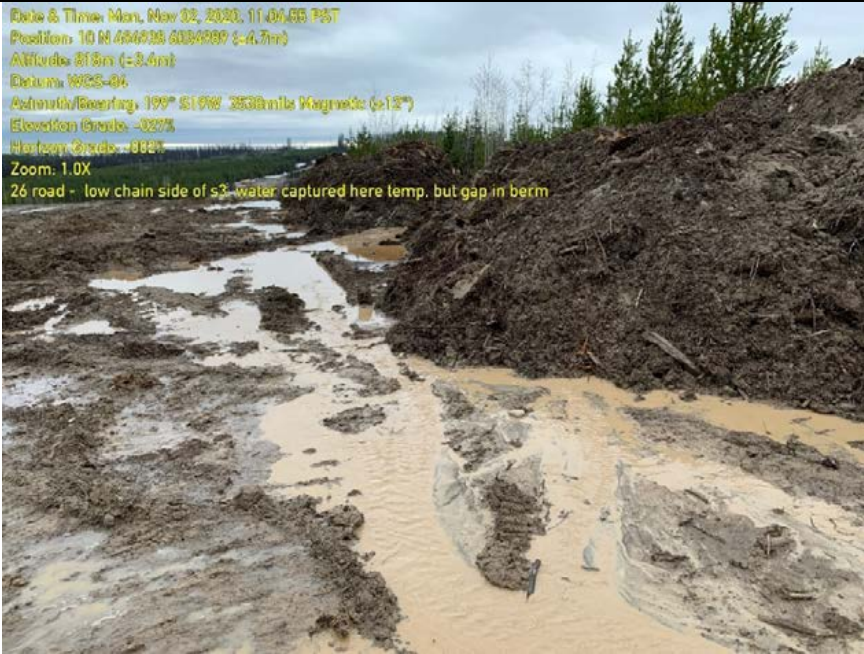
Photo 74: Flow down slope after the berm.

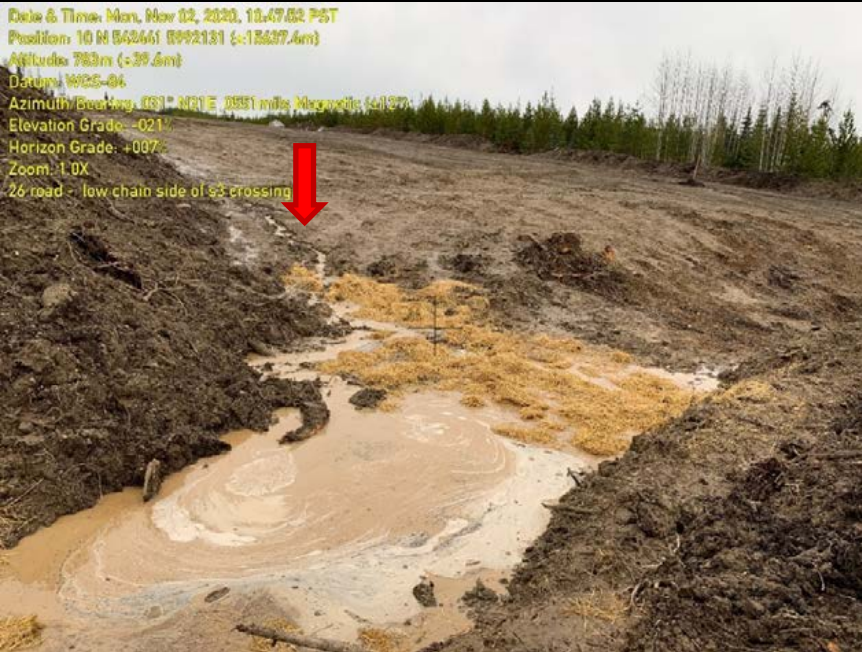
Photo 75: Sediment laden water pooling at low point of berm / water bar. Red arrow indicates erosion of exposed soils on ROW.

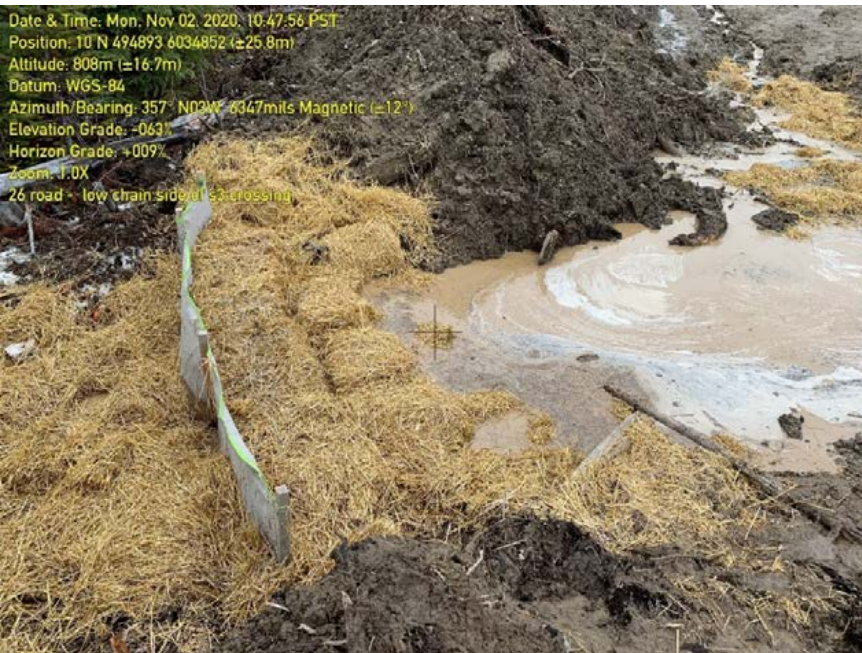
Photo 76: Gap in topsoil windrow. Sediment laden water passing through sediment fence and straw.

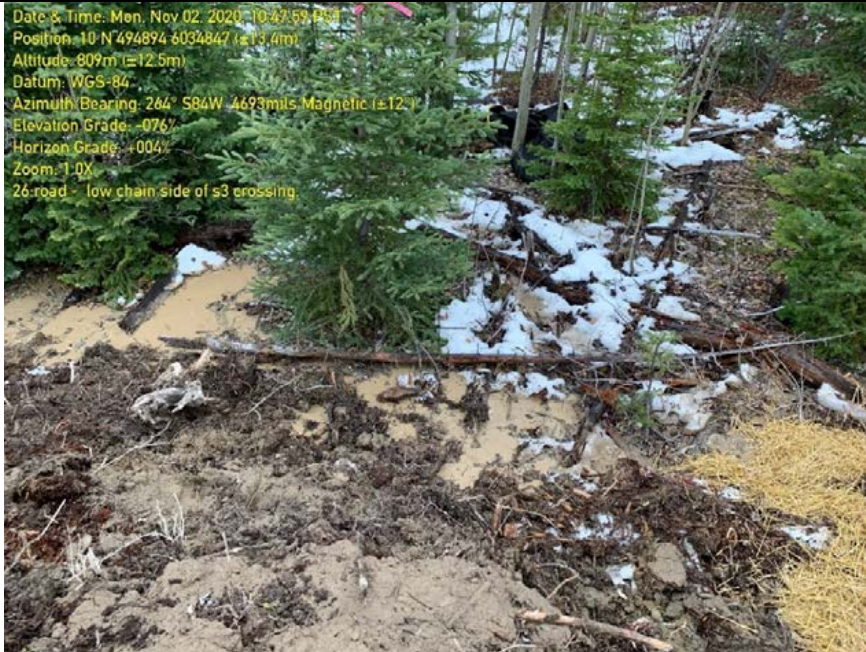
Photo 77: Opposite side of sediment fence. Sediment laden water now flowing down slope on opposite side of topsoil windrow.

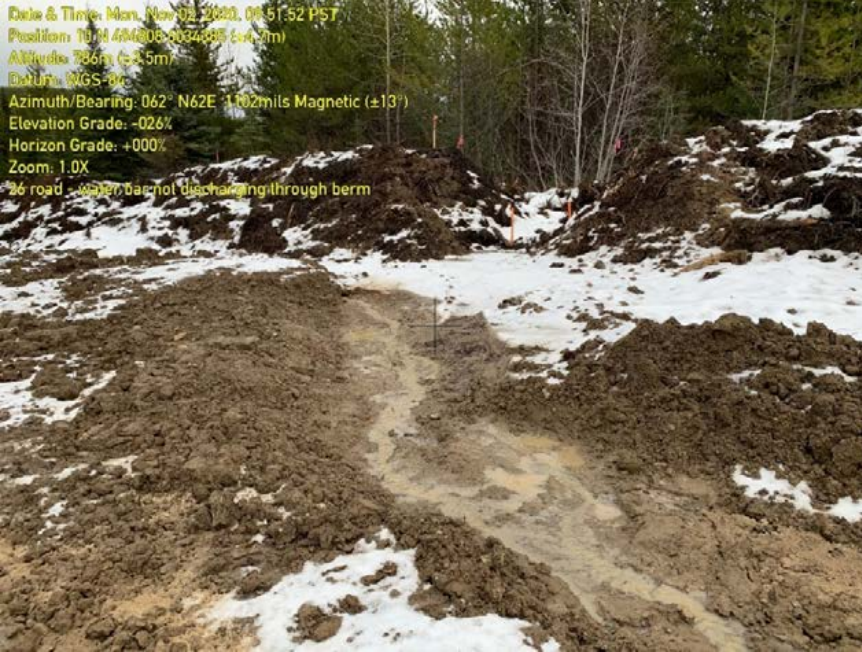
Photo 82: Exit point of upper water bar not functioning. Water continues to travel down ROW causing erosion.

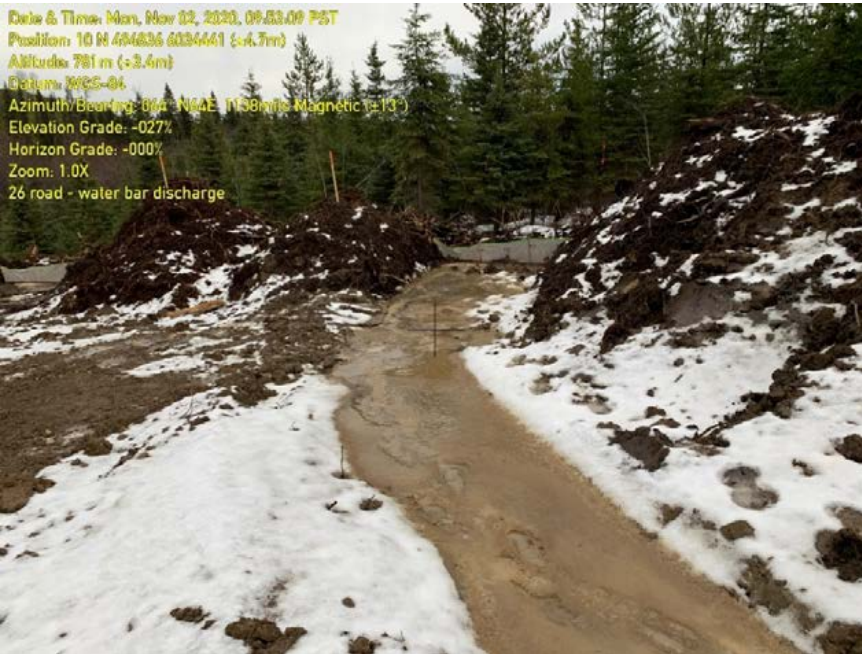
Photo 83: Water discharge location from lower most water bars.

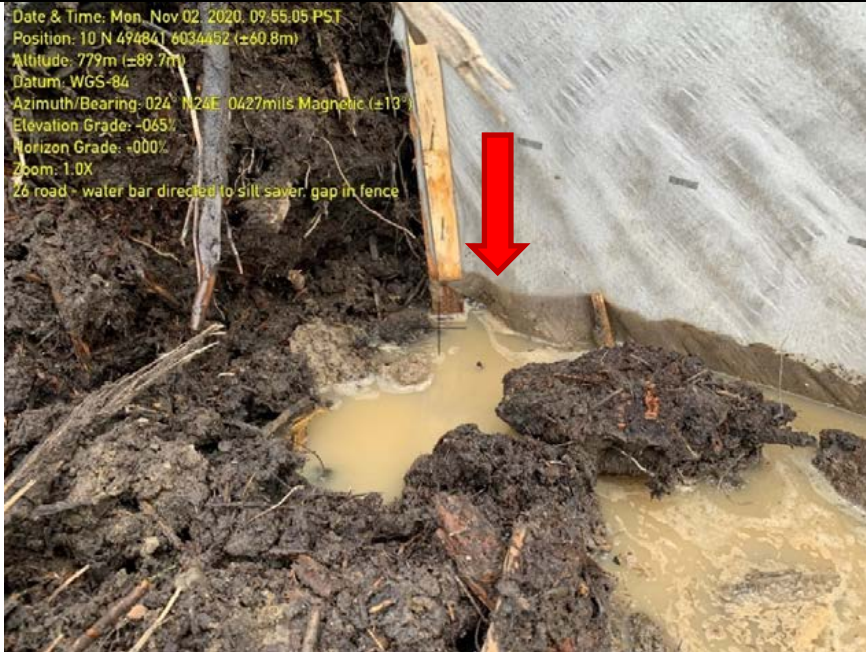
Photo 84: Gap in sediment fence at end of water bar.

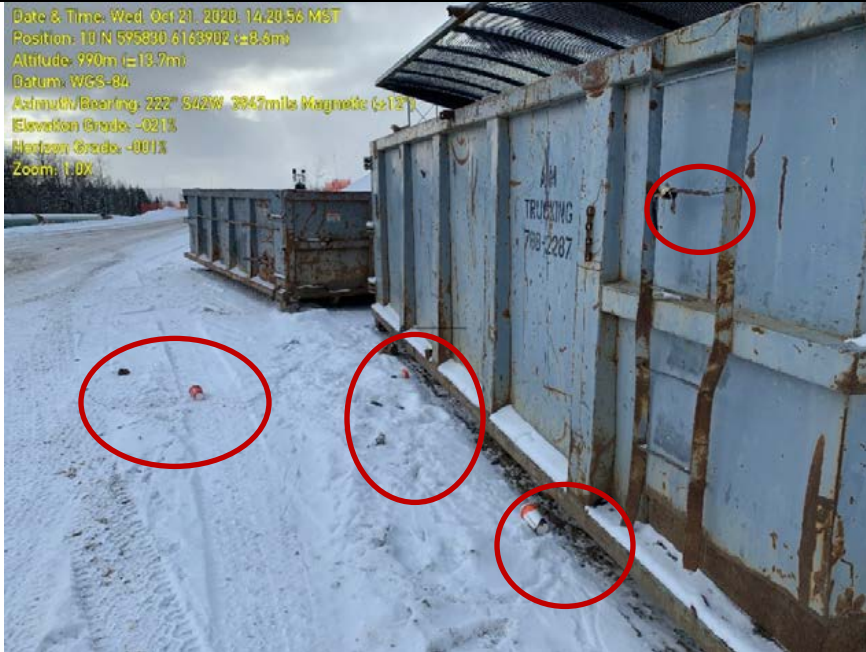
Photo 92: Banana peel, drink containers and food wrappers on ground outside of the bin.
