Project Name	Coastal GasLink Pipeline Project	Inspection Status	Final
EA Certificate #	E14-03	Inspection No.	IR2022-055
Project Status	Certified	Inspection Start	2022-11-02
Sector	Energy	UTM	10 N 552651 6093782
Trigger	Planned Inspection	Inspection Type	Field
Project Description	The Coastal GasLink Pipeline Project (Project) is an approximately 650 kilometer (km) long natural gas pipeline connecting facilities in northeast British Columbia (BC) to the LNG Canada facility near Kitimat.		
Location Description	The Project commences near Groundbirch (40 km west of Dawson Creek) in northeast BC and runs 650km west to the LNG Canada facility near Kitimat. This inspection covered work being carried out in Section 3 of Work Pack 2, in the upper Anzac River watershed. The Universal Transverse Mercator referenced above is approximately in the center of the sections of where the inspection took place.		
Inspection Summary	On November 2, 2022, Environmental Assessment Office (EAO) Environmental Assessment Office (EAO) Compliance and Enforcement Officer Chris Parks inspected the Project against requirements of the Environmental Assessment Certificate (EAC) #E14-03 (Appendix 1-4), specific Work

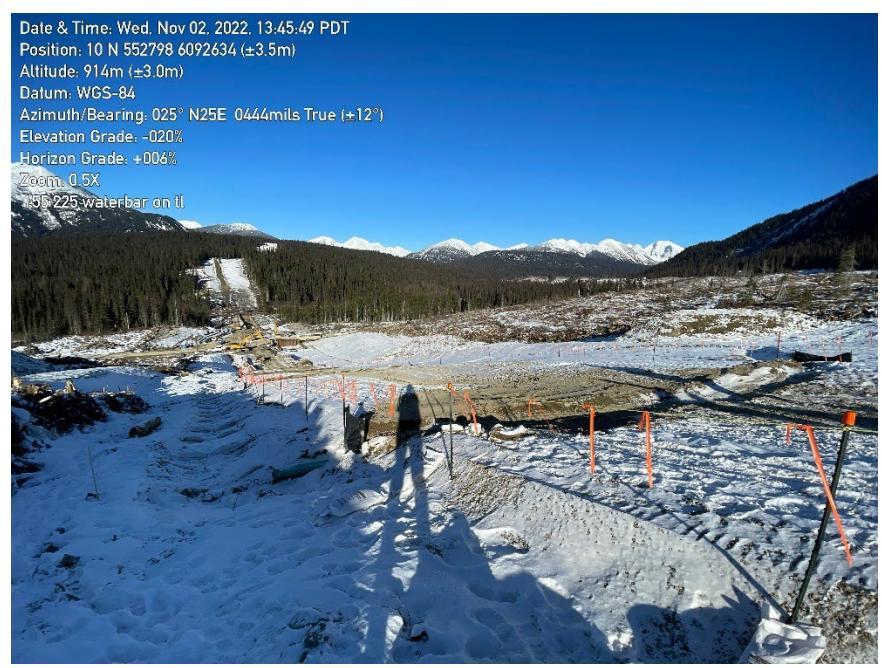
- Travel Lane and Waterbars. CGL has addressed this issue by establishing water bars as per the WEP across the travel lane (Photo 1). CGL representatives stated that where active work impacted these waterbars they would be re-established by crews at end of each workday. These features are now compliant with the Agreement.

Photo 1: Waterbars established across travel lane, approximately KP155+225.

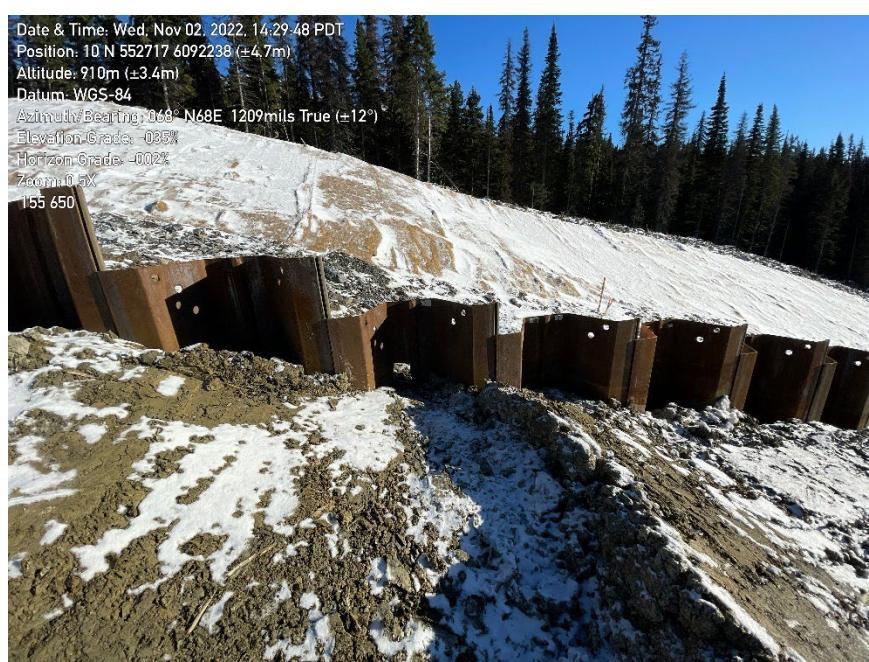
- Sheet Piles and Waterbars installed between approximately KP155+550 to 156+825. The sheet pile walls • intercept the waterbars specified by the WEPs in these locations. Openings were confirmed to have been cut in the sheet pile walls where they intercept waterbars to allow the waterbars to function as specified by the ESCPs (Photo 2). These features are now compliant with the Agreement.

Photo 2: Example of opening cut in sheet pile to allow water bar to function at approximately KP155+650.

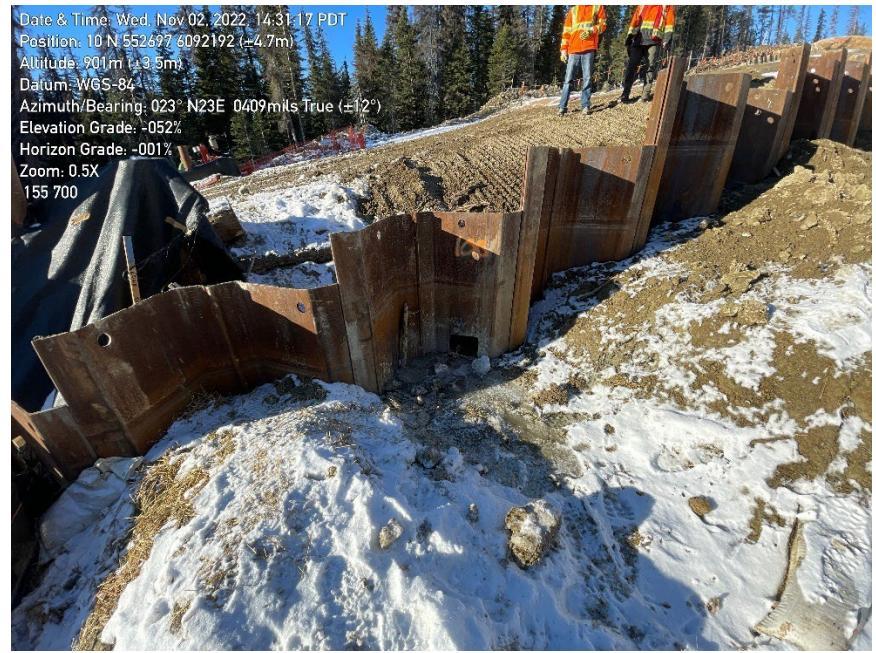
Photo 2: Example of maintenance completed, sheet pile waterbar opening, approximately KP155+700.
