EAO | Environmental Assessment Office

INSPECTION RECORD

Project Name:	Coastal GasLink	Inspection Report Status:	FINAL
EA Certificate #:	E14-03	Inspection No(s):	FY18/19-12 FY18/19-24
Certificate Status:	Certified	Inspection Date(s):	2018-06-19to 2018-06-21 and 2018-07-09
Region:	Omineca	Office:	Victoria
Trigger:	Planned	Inspector Name(s):	Chris Parks, Director, Compliance and Enforcement
Sector:	Energy	UTM:	See "Inspection Summary"
Location Description:	The Coastal GasLink Project is a an approximately 650 km long natural gas pipeline connecting facilities in the vicinity of Groundbirch (40 km west of Dawson Creek) in northeast BC to the proposed LNG Canada facility near Kitimat. This inspection focussed on six locations along the pipeline route. UTM's for these locations are noted in the "Inspection Summary" section of this record.		
Inspection Summary:	<p>EAO Compliance and Enforcement (C&E) received a complaint in January of 2018 regarding the Coastal Gas Link Project (Project). The Complainant alleged that physical works conducted by Coastal Gas Link Pipeline Limited (CGL) in 2013 and 2016 were not compliant with the requirements of the environmental assessment certificate (E

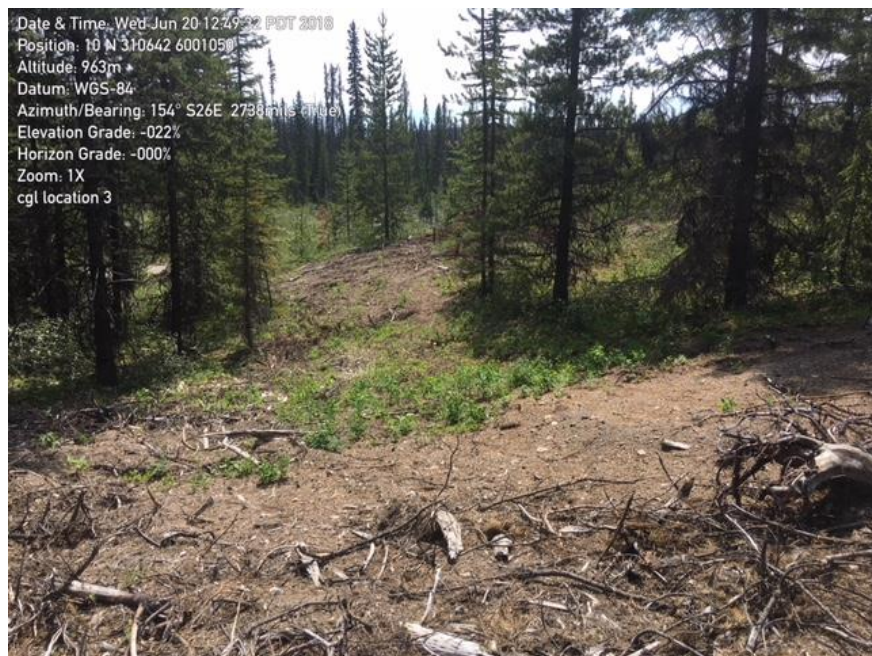
Photo 1: Vegetation clearing and ground disturbance at “West of Anders Lake 10U 310588E, 6000988N”, CGL descriptor “Borrow Site PBS52”.

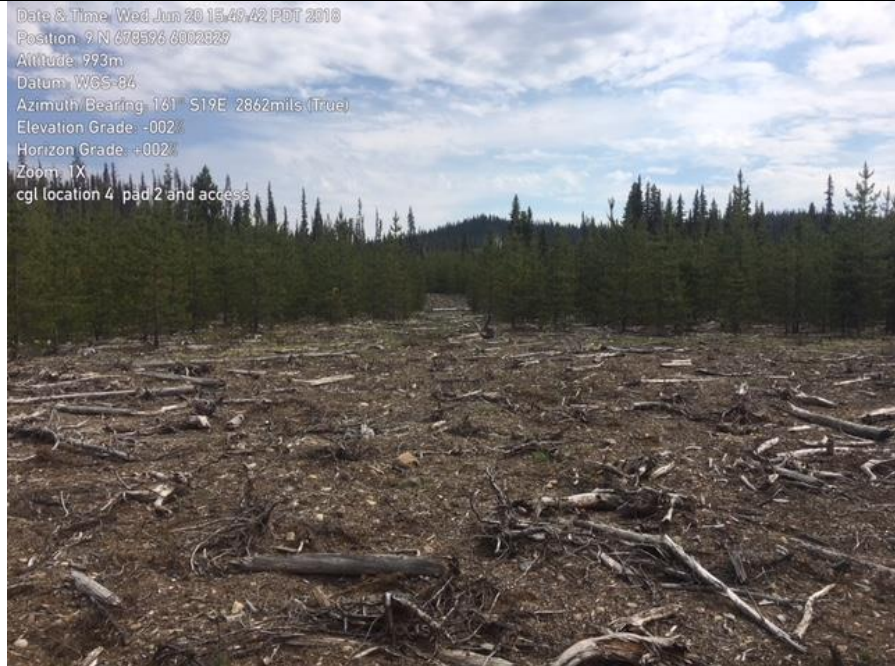
Photo 2: Vegetation clearing and ground disturbance at “East of Goosly FSR, 9U 678486E, 6002861N”, CGL descriptor “Borrow Site PBS28”.

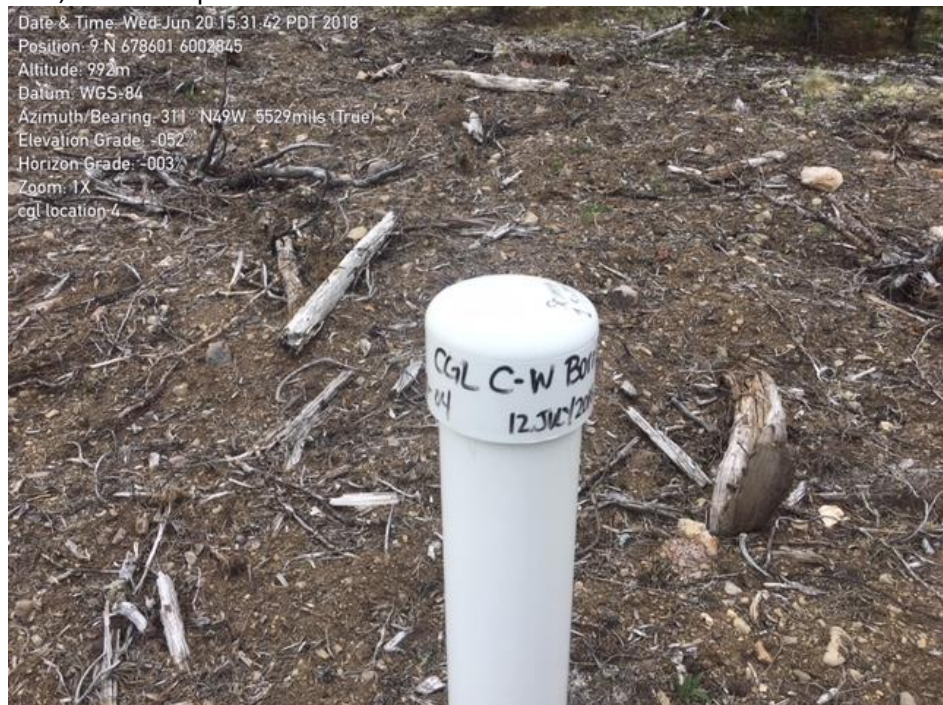
Photo 3: Monitoring well installed 12 July 2016 at “East of Goosly FSR, 9U 678486E, 6002861N”, CGL descriptor “Borrow Site PBS28”.

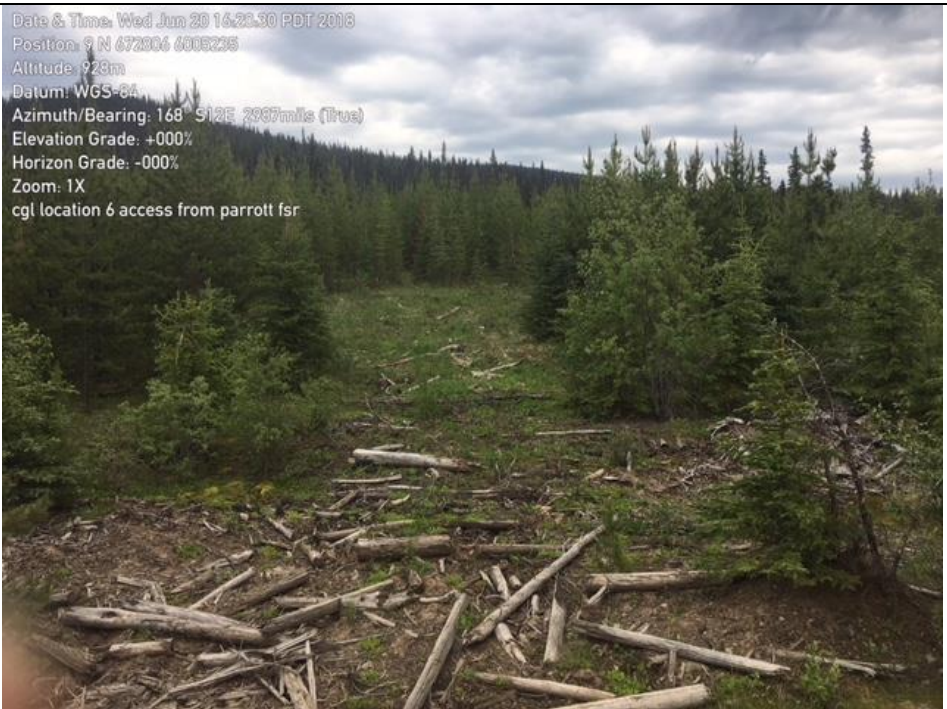
<p> Date & Time: Wed Jun 29 16:25:30 PDT 2016 Position: 9 N 672896 6005179N Altitude: 928m Datum: WGS-84 Azimuth/Bearing: 168° 512E 2937mils (True) Elevation Grade: +000% Horizon Grade: -000% Zoom: 1X cgl location 6 access from parrott fsr </p> <p>Photo 4: Vegetation clearing and ground disturbance at “Goosly Lake site 9U 672896E, 6005179N”, CGL descriptor “Borrow Site PBS23”.</p>
Compliance	Not Applicable
