<b>Project Name</b>	Woodfibre LNG Project	<b>Inspection Status</b>	Final
<b>EA Certificate #</b>	E15-02	<b>Inspection No.</b>	20250054_IR001
<b>Project Status</b>	Certified - construction	<b>Inspection Start</b>	2025-08-27
<b>Inspection Type</b>	Field and Administrative	<b>Initiation</b>	Planned Inspection
<b>UTM</b>	10U 481915E 5501445N		
<b>Project Description</b>	The Woodfibre LNG Project (Project) is a liquefied natural gas export facility that will have a storage capacity of 250,000 cubic metres and production capacity of up to 2.1 million tonnes per year of liquefied natural gas, currently under construction.		
<b>Location Description</b>	The Project is located on the previous Woodfibre Pulp and Paper Mill site located approximately seven kilometres west-southwest of the urban centre of Squamish, British Columbia.		
<b>Inspection Summary</b>	<p>On August 27, 2025, the Environmental Assessment Office (EAO) Compliance and Enforcement Branch (CEB) conducted a field inspection of the Project to verify compliance against EAC E15-02. The inspection also includes an administrative component which was initiated on August 6, 2025. The Project was in Construction at the time of the ins

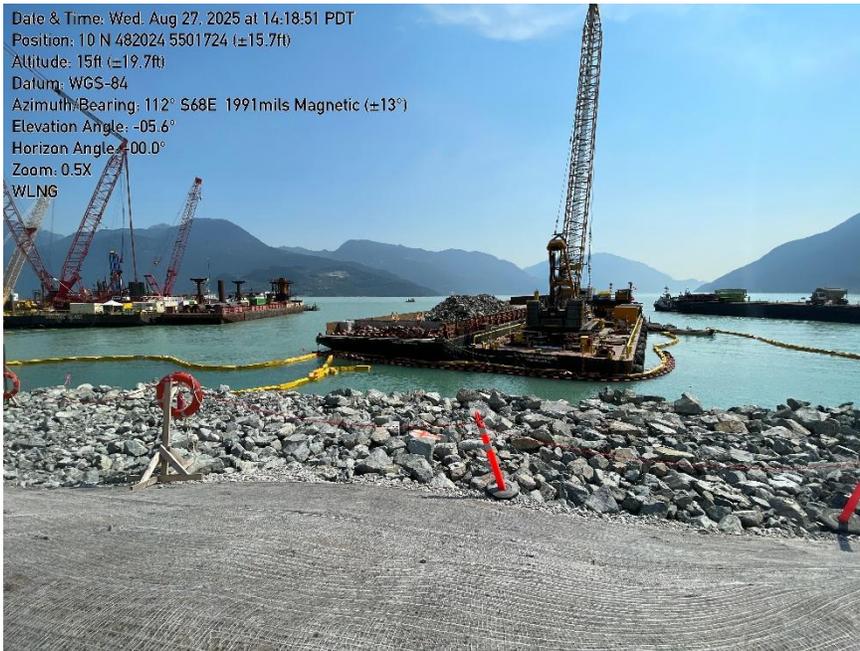
During the inspection, the EAO CEB observed silt control measures had been installed in the water adjacent to in water construction areas, including locations of riprap removal along the shoreline (Photo 1). The installed measures appeared to be functioning effectively at the time of the inspection.

The observations indicate that appropriate silt control measures have been properly implemented. These findings demonstrate compliance with the applicable environmental protection and sediment control requirements.

Photo 1: Yellow silt control booms located next to rip rap removal activities.

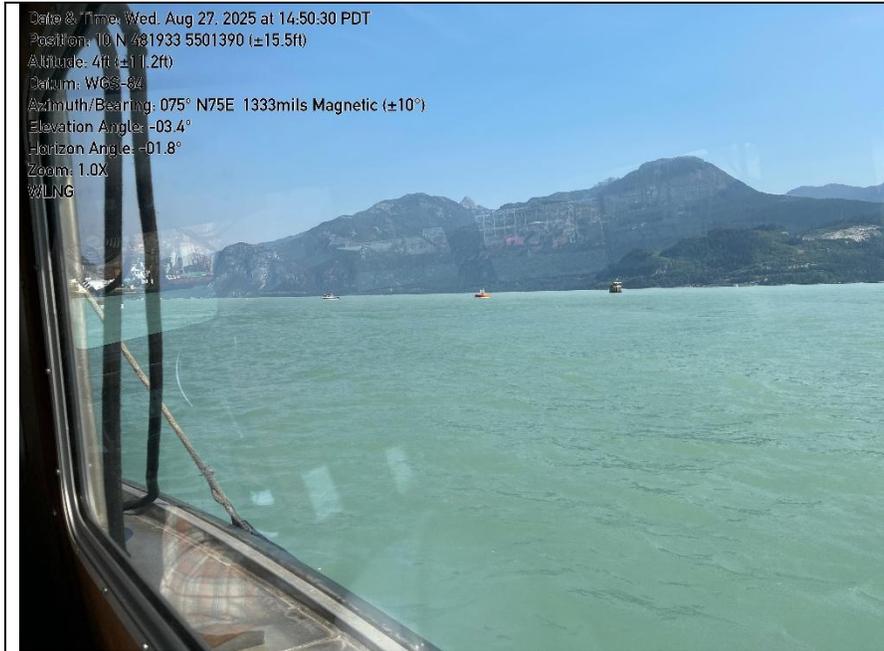
During the field inspection on August 27, 2025, the EAO CEB observed three small vessels positioned outside the established exclusion zone. Two vessels were stationary, while the third operated as a rover to support ongoing monitoring activities as well as hydrophone monitoring, all of which were identifiable with a small orange flag (Photo 2).

The EAO CEB also spoke with two Marine Mammal Observers (MMO’s) stationed near Mooring Structure One. The MMOs confirmed that a 30-minute pre-work scan for marine mammals is conducted prior to the commencement of any in-water works each day from both land and water.

Based on the information provided by the MMOs and the observations made during the inspection, the EAO CEB determined that the Project was in compliance with the requirements related to marine mammal monitoring at the time of inspection.

Photo 2: Marine Mammal Observer vessels.
